Why record trends and oscillography at the distribution level?
(A Case Study)

Bryan Gehringer
Alexander Apostolov, PhD.

Ninth Annual Fault and Disturbance Analysis Conference, Georgia Tech
May 1, 2006, Atlanta, Georgia

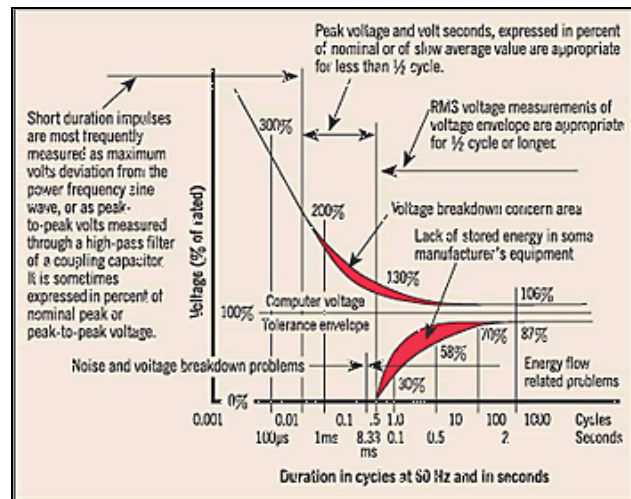
Upon removing the recorder in April 2005, the final download revealed twenty-eight spikes between 7:00 AM and 2:00 PM on Saturday, April 2 and a total outage of approximately one hour duration in the middle of the night on April 6. The cause of the outage was already known and was not related to the other disturbances. The twenty-eight spikes on April 2, however, coincided with a report of a 250 horsepower motor that failed at a manufacturing facility supplied by the station.

Most of the disturbances captured by the portable test sets were triggered by voltage deviations exceeding tolerances of the CBEMA¹ curve. Such voltage deviations are useful for describing power quality events that affect consumer loads like computers, but are pretty common at the distribution level, and do not help identify conditions that could damage substation equipment.
