# **ANALYSIS of a CASCADING EVENT at NATIONAL GRID**

By Jeffrey Pond, National Grid and Dave Bertagnolli, ISO-New England

On November 16, 2007 a shield wire failure within National Grid's Sandy Pond substation initiated an event that cascaded, resulting in the failure of a 345/115 kV transformer and the loss of the nearby HVDC Converter Terminal supply. Cascading events are of concern to utilities and the Regional Transmission Organizations (RTO). For the utility, the protection schemes need to work properly to isolate faults quickly, minimizing the impact on transmission system. Isolation of faulted components quickly is necessary in order to maintain system reliability and stability. For the RTO if the failed components are not isolated the impact on power system stability could potentially cause a wide-area event.

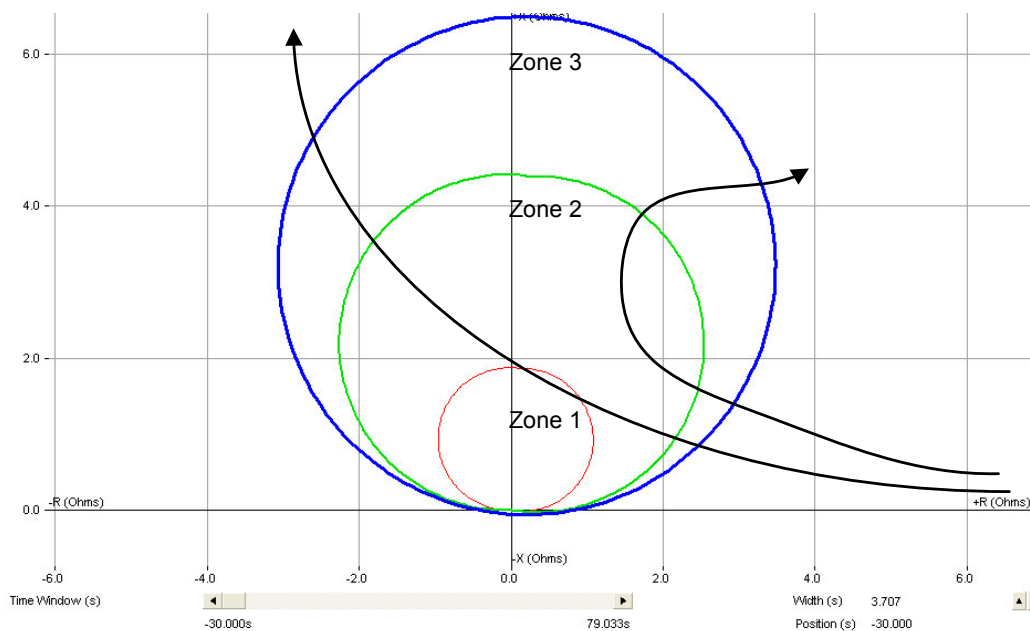
Figure 14 – Diagram of Swing Impact on Power System Protection

Power swings have caused impedance based protection systems to operate, typically when the power swing becomes unstable. The system impedance will vary during a swing and if the power swing becomes unstable the impedance of the system may pass through the impedance Zone 1 and/or Zone 2 distance protection, as shown in Figure 14. The protection system would operate, and this undesired trip could potentially initiate a wide area event.
