Investigation of Fault Activity on a 132KV Teed Circuit in Scotland and how Travelling Wave Technology is Locating the Fault Site

Ron Garrett – Scottish and Southern Electricity and David Cole – Qualitrol LLC

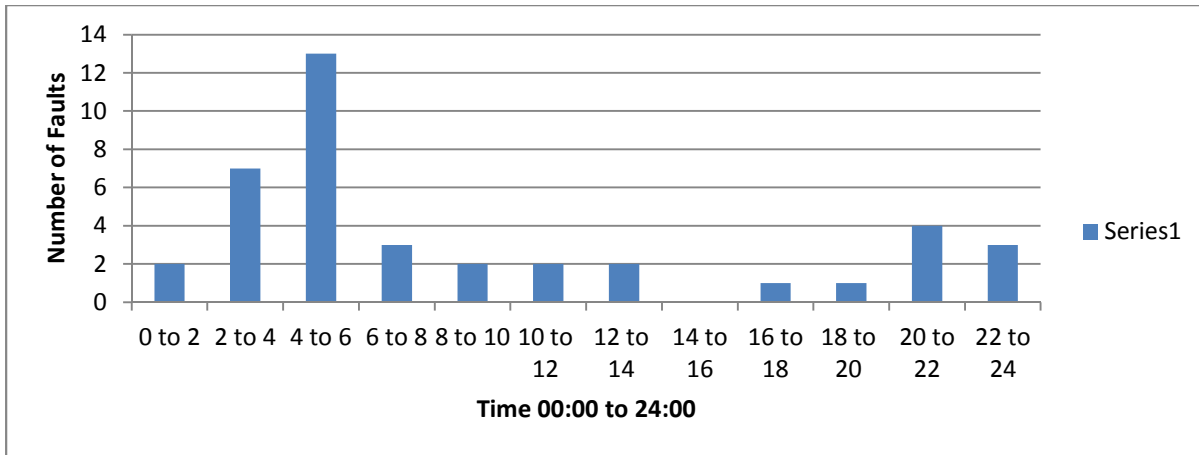
Fig 3 Distribution of Faults by Time of Day

Figure 3 shows the distribution of faults of GL1 and GL2 by time of day. The distribution on both circuits is similar and it can be seen that more occur during the night particularly between 4am and 6am in the morning.

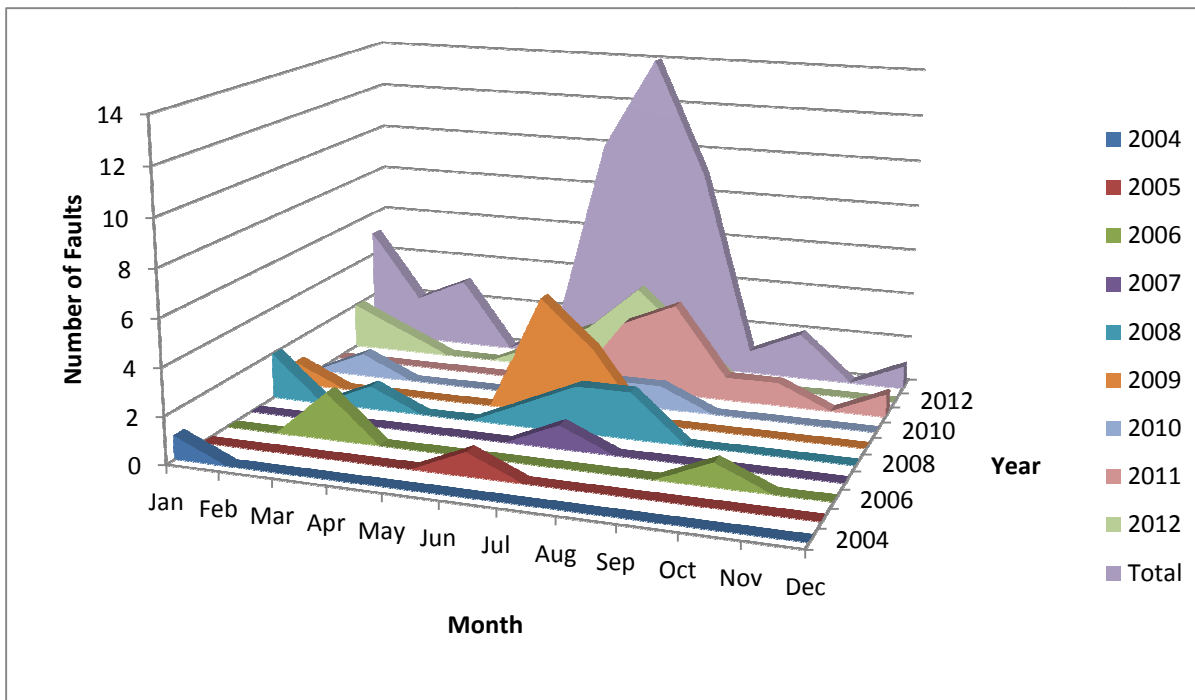
Fig 4 Distribution of Faults by Time of Year

Figure 4 shows the distribution of faults by time of year. It can be seen that most occur between June and September with the number rising annually.

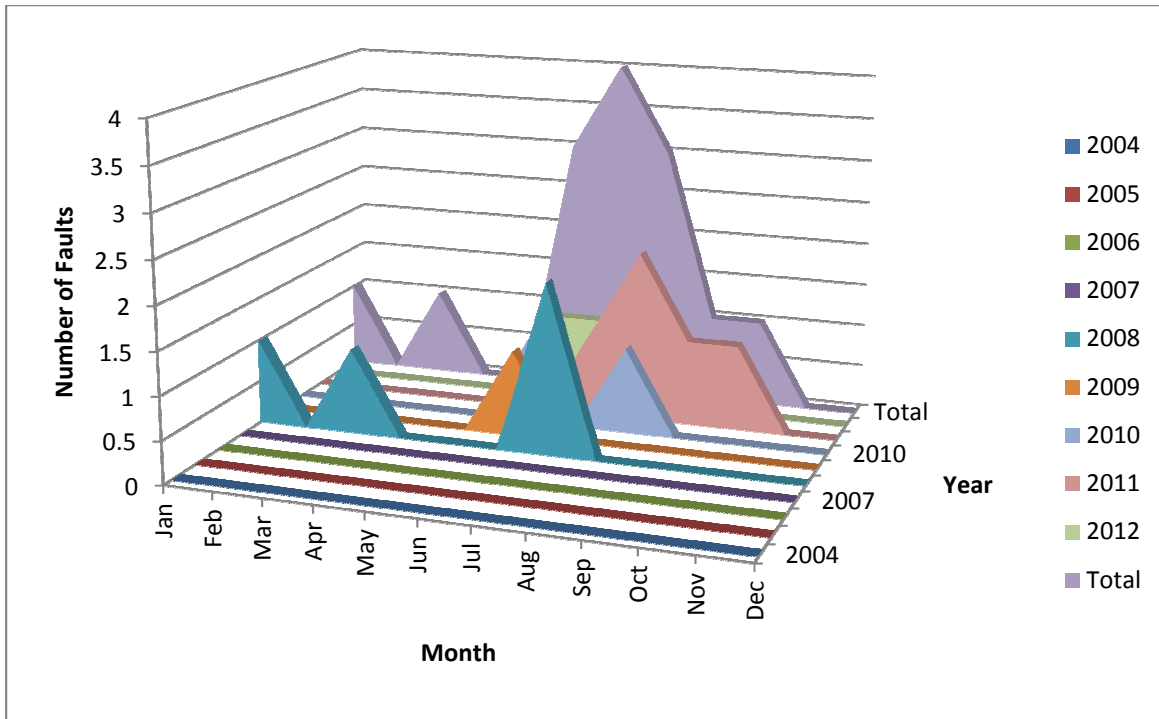
Fig 5 Distribution of Faults on GL1 Top Phase

The last analysis examined which phases were involved in the faults. Again the distribution on the two circuits was similar. Only the faults from GL1 are shown. Figure 5 is the distribution of faults affecting the top red phase and figure 6 the distribution of faults on the middle yellow phase.

Most faults occurred on the top phase with about 50% on the middle phase and very few on the lower phase. In the analysis SSE considered the following:

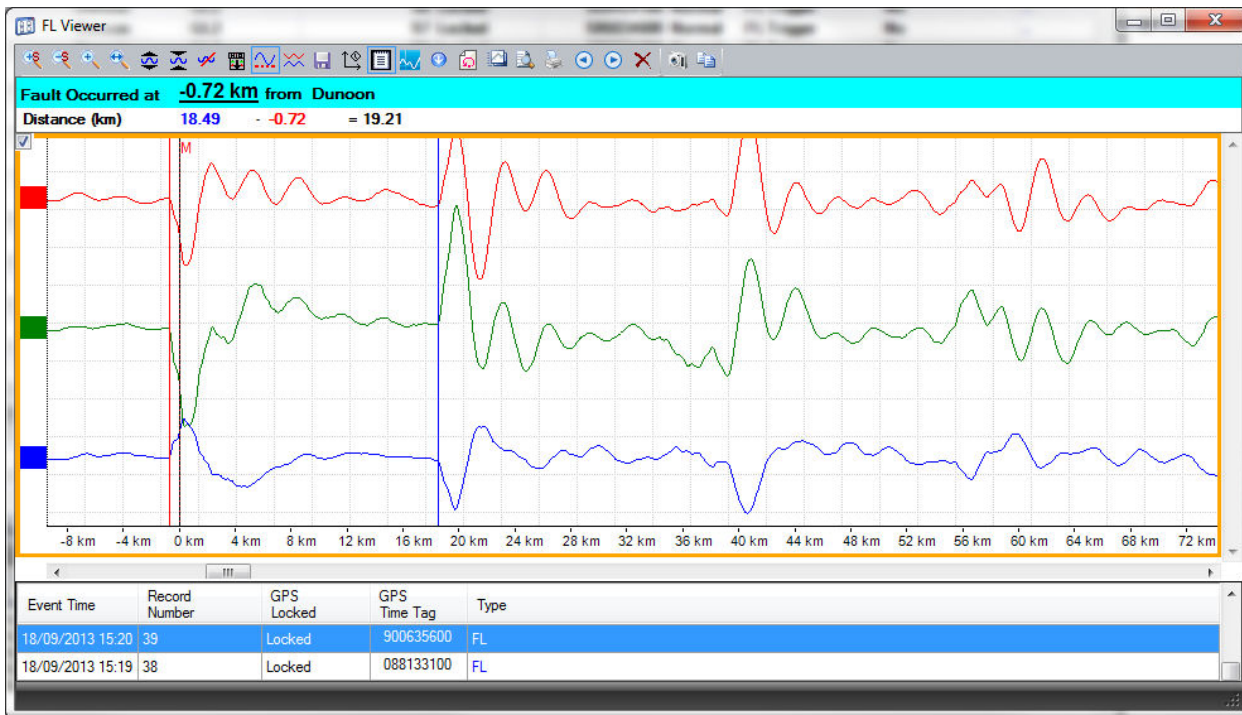
Fig 11 Energising GL2 from Windyhill

Figure 11 shows the waveform captured on 18th September 2013 from the TWS at Dunoon when the tee'd circuit was energised by closing the circuit breaker at Windyhill. After adjusting the trigger point the opposite polarity reflection from Whistlefield can be identified 19.21km from Dunoon proving correct operation of the bushing coupler assembly. Whistlefield produces a relatively large reflection because short underground cables are used to connect from the lines to the transformers creating a significant impedance change.
