A Most Unusual Event Analysis

1. Introduction:

On Saturday night 2/25/2017 at 20:51:15 a transformer differential relay associated with the Sheffield wind farm 115KV/34.5KV GSU transformer misoperated resulting in the tripping of the 115KV interconnection and wind farm collector 34.5KV circuit breakers. A severe lightning storm was in progress at the time with a trip/reclose of a nearby 115KV transmission line occurring 8 seconds prior. The transformer and wind farm were returned to service after an Operations Analysis had determined that the transformer differential relay had misoperated.

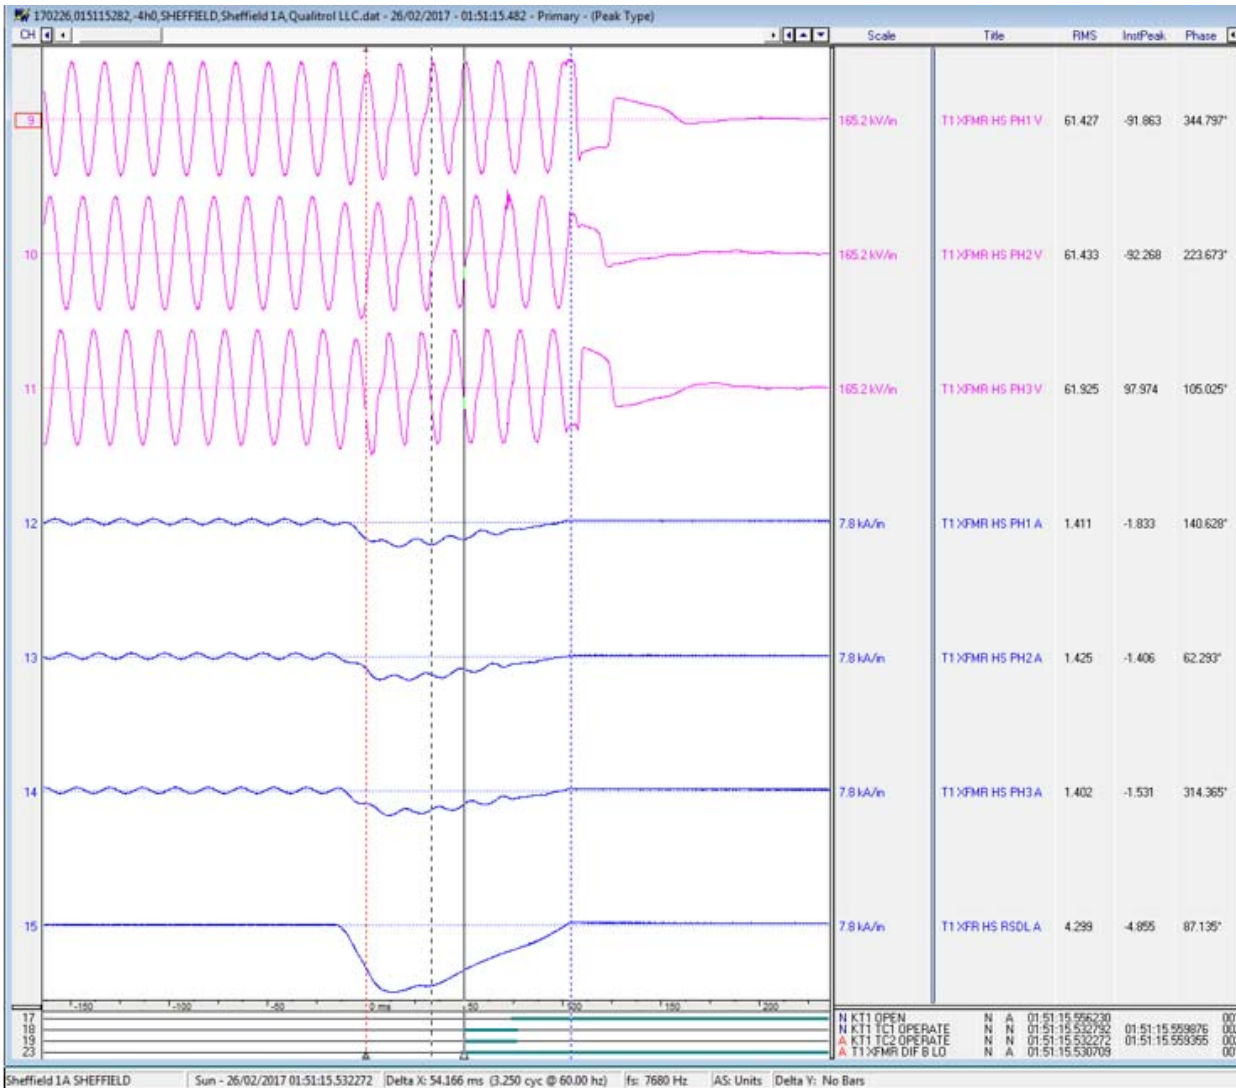
Sheffield T1 115KV/34.5KV/13.8KV three winding transformer

The DFR recording of the DC current pulse at Sheffield T1 is shown below. The duration of the DC current pulse was approximately 120 milliseconds with a linear decay starting ~50 ms after the pulse started. The DFR record below provides the Sheffield T1 115KV currents and voltages. The RMS quantities shown are KV and KA. The time/date noted is UTC time (EST = -5hr). The DC ground currents peaked at approximately $3I_0 = 5200A$ DC, $I_{Phase} = 1730A$ DC.

The below DFR record provides the Sheffield T1 115KV currents and voltages. The RMS quantities shown are KV and KA. The time/date noted is UTC time (EST = -5hr). The DC ground currents peaked at approximately $3I_0 = 5200A$ DC, $I_{\text{phase}} = 1730A$ DC. The currents at the time of trip coil operation were $3I_0 = 4300A$, $I_{\text{phase}} = 1430A$ DC. The DC current extinguished 3.25 cycles after the KT1 and K47 trip coil operation.
