# Event Investigation of 69 kV Double-Circuit Faults

Ahsan Mirza, Christopher Bolton, Girolamo Rosselli, and Sergio Flores, *San Diego Gas & Electric*  
Amanvir Sudan, *Schweitzer Engineering Laboratories, Inc.*

**Abstract**—Two rare yet similar faults occurred within hours on SDG&E’s 69 kV parallel circuits. Because the faults involved two parallel lines, they caused unconventional fault waveforms seen by multiple relays. This, in turn, challenged the directional elements and overcurrent coordination, producing unexpected relay operations.

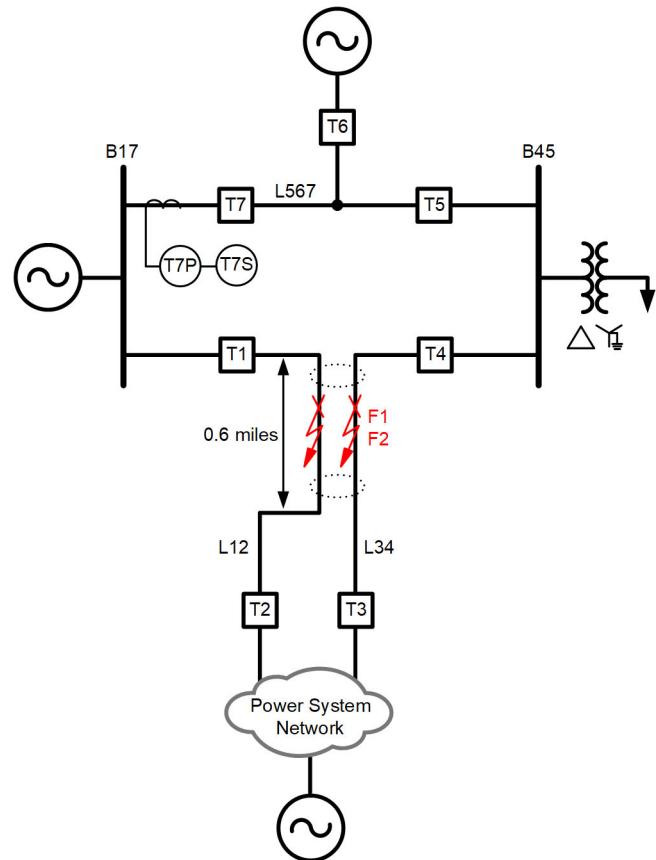
Fig. 1. SDG&E 69 kV System

All of the system lines shown in Fig. 1 are overhead conductors. Line L12 is 8.52 miles long and connects Terminals T1 and T2. Similarly, Line L34 connects Terminals T3 and T4 and is 4.6 miles long. Terminals T2 and T3 do not terminate in

the same substation, but are instead connected through the rest of SDG&E’s 69 kV grid comprising multiple other lines. Line L567 makes up the three-terminal line interconnecting Terminals T5, T6, and T7. The length of Line L567 from T5 to T7 is 1.89 miles. Terminal T6 is tapped at 0.5 miles from T5. In addition, Terminal T6 is itself 0.9 miles long measuring from the tapped point.

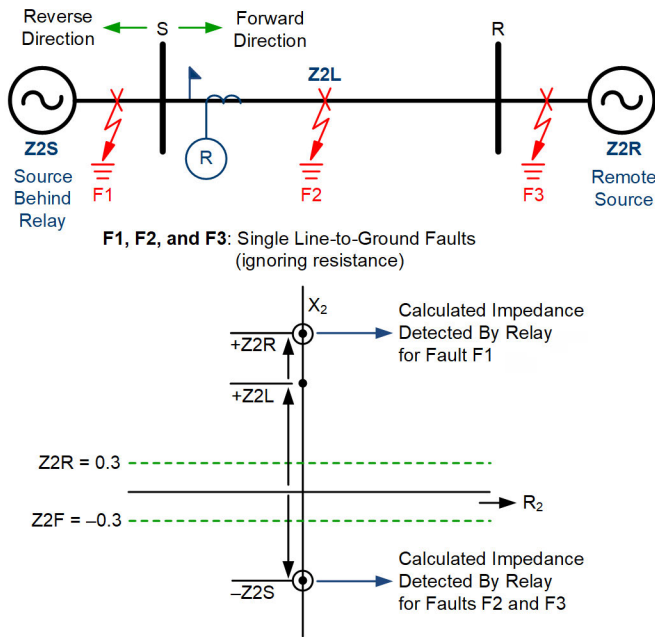
Fig. 4. Negative-Sequence Impedance Plot for a Forward and Reverse Single-Line-to-Ground Fault

Fig. 4 illustrates this concept. The calculated point of  $Z2L+Z2R$  is fixed regardless of the distance between the reverse fault and the relay. Given the separation between the  $-Z2S$  and  $Z2L+Z2R$  points in Fig. 4, the relay uses two blinders placed between these points to distinguish whether a fault is forward or reverse. The blinder at the bottom is the forward negative-sequence threshold ( $Z2F$ ). Similarly, we have threshold  $Z2R$  as the top blinder for the reverse fault detection. If the calculated negative-sequence impedance seen by the relay for a fault falls under the  $Z2F$  forward blinder threshold, the fault is forward. If the calculated impedance is above the  $Z2R$  reverse blinder threshold, the fault is reverse.

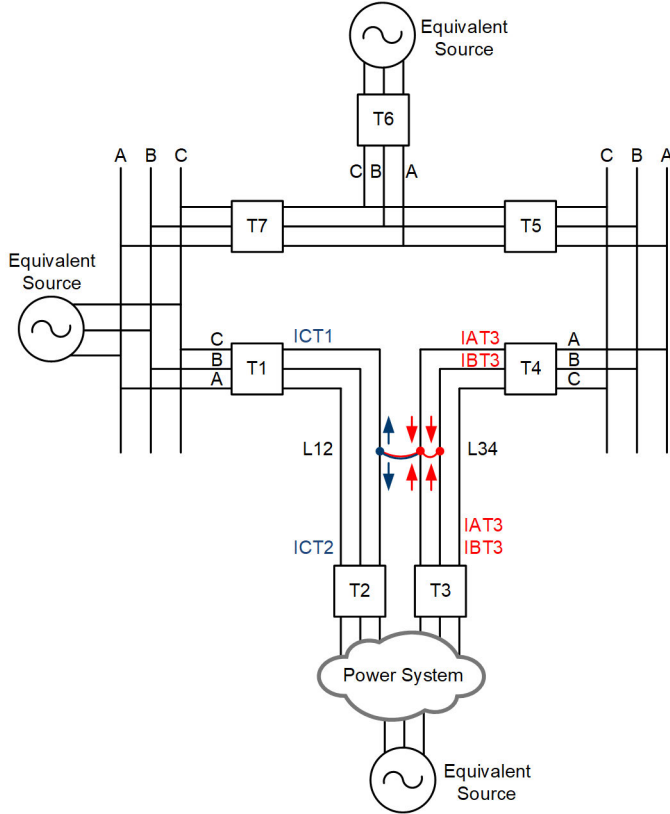
Fig. 9. Intercircuit Fault Illustration

We start by exploring the option of an intercircuit fault between Lines L12 and L34 shared on the same poles. A flashover between multiple phases of two lines in close proximity to each other (due to shared poles) seems plausible.

To start, we transform the one-line diagram of Fig. 1 into its three-phase view and place a short between C-phase of L12 and A-phase and B-phase of L34, as shown in Fig. 9.

To find out if this is an intercircuit fault, we take the Kirchhoff's Current Law (KCL) approach. If it is indeed a case of an intercircuit fault with no ground involved, then adding all the current flows into the fault point should give us a value of zero in accordance with KCL. If the currents add up to a significant non-zero value, then that non-zero value represents the ground current, and it is instead a case of a double-circuit fault involving ground.

The currents to add up are C-phase currents at T1 and T2 (shown as ICT1 and ICT2 in Fig. 9), and IA and IB pairs at T3 and T4 (shown as IAT3, IBT3, IAT4, and IBT4, respectively, in Fig. 9). To add the currents, we simply combine the event reports from the T1, T2, T3, and T4 relays and perform custom calculations in the event viewer software to obtain the KCL summation in (1).

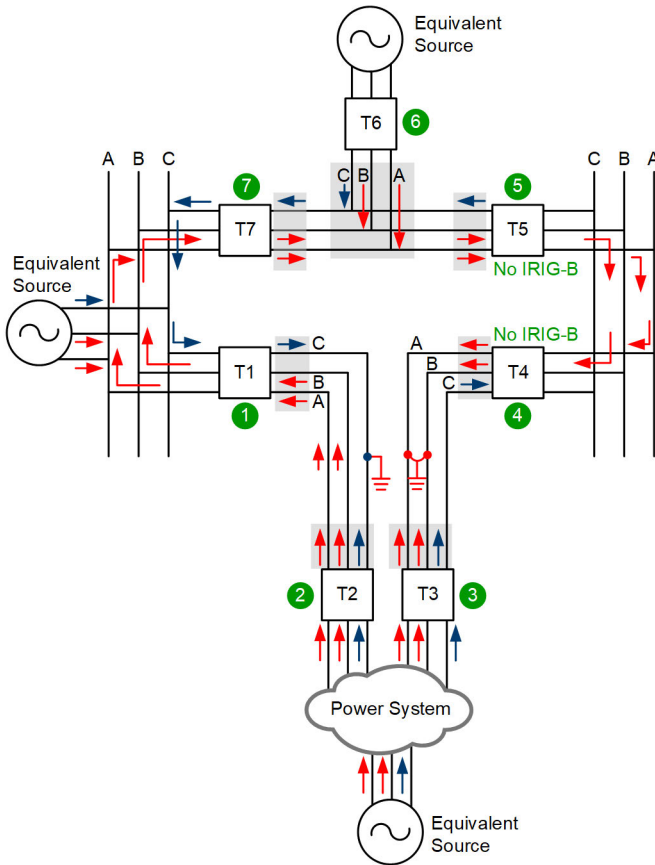
Fig. 12. Hypothetical Three-Phase Current Flow for Simultaneous Double-Circuit Ground Faults

We start by drawing the three-phase current flow distribution that would best represent the simultaneous double-circuit faults. Fig. 12 captures this hypothetical per-phase current flow.

Since the fault on Line L34 only involves A-phase and B-phase, the C-phase is unscathed, as is evident by magnitudes of 2,144 A seen at both terminals of T3 and T4 (see Fig. 7 and Fig. 8). The magnitudes being equal suggests current came in through one terminal and out of the other, matching the current flow distribution in Fig. 12.

A close examination of phasors in Fig. 13 reveals current flow distribution matching Fig. 12.

- Drawing a system-wide view and analyzing on a per-phase basis (Fig. 12) helped understand the unconventional current flows captured in relay event reports for the double-circuit fault.

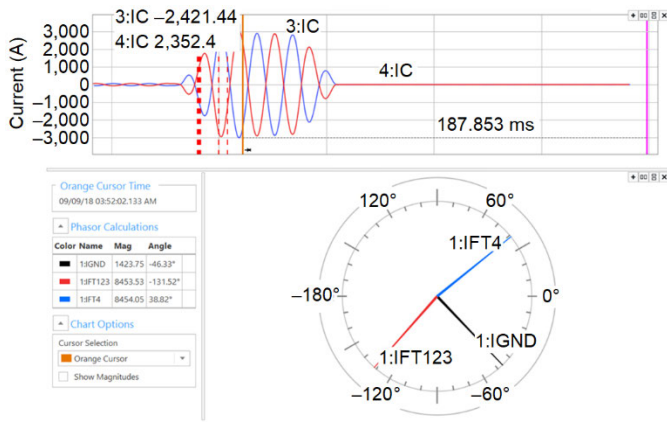
Fig. 14. Ground Current (IGND) of (5) Obtained Through Event Report Custom Calculations and Time Alignment

Fig. 14 shows the phasor value of IGND obtained through custom calculations in the event viewer software.
