# **Fault Analysis Using Protective Relay Digital Fault Records From the Big Rivers Electric Corporation 161 kV System**

**Elmo Price**

**Bob Warren**

**Fault and Disturbance Analysis Conference**

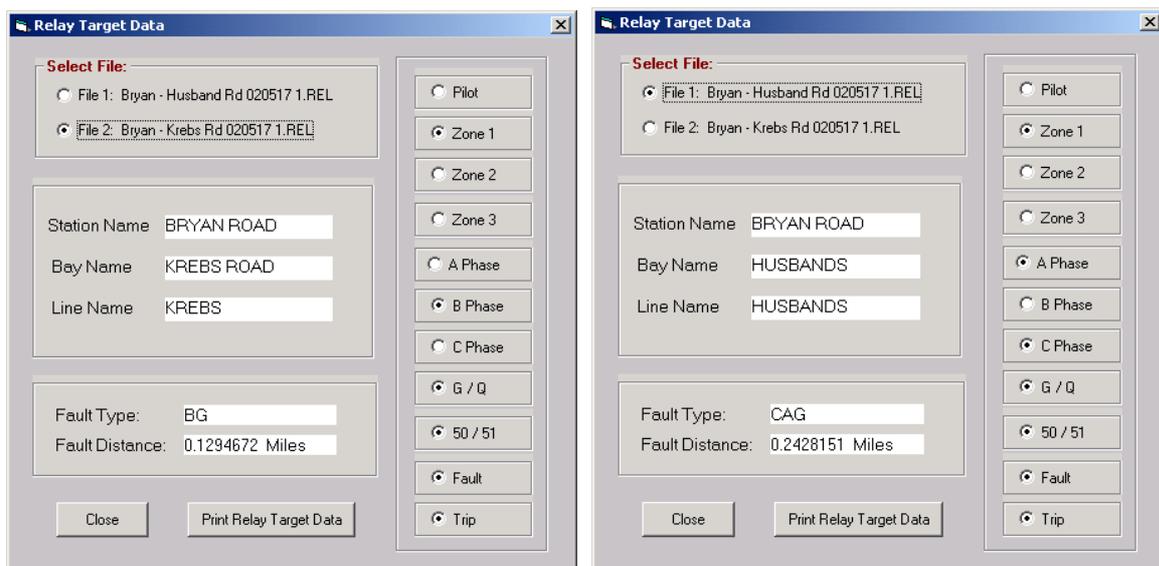
Figure 12. Relay Fault Targets

A double circuit [cross-country] fault occurred May 17, 2002 outside the Bryan Road substation on the Krebs Road and Husband Roads lines. The substation and protected line configuration are shown in Figure 11. Both relays protecting the two lines correctly tripped but gave different fault locations. The fault targets of each relay are shown in Figure 12. The fault appeared as a single phase B-to-ground fault at 0.1294 miles on the Krebs Road line and as a two-phase AC-to-ground fault at 0.2428 miles on the Husbands Road Line. Figure 13 shows the line tower structure and the conductor arrangement. Following is the event analysis that shows that the event is indeed a double circuit fault, determines the correct fault location, identifies operational issues, identifies dependable tripping units and allows us to better understand this particular double-circuit fault.
