Analysis of unfaulted 115kV line over-trip by multiple grounds in VT secondary circuits at National Grid

By: Song Ji and Yujie Irene Lu, National Grid USA

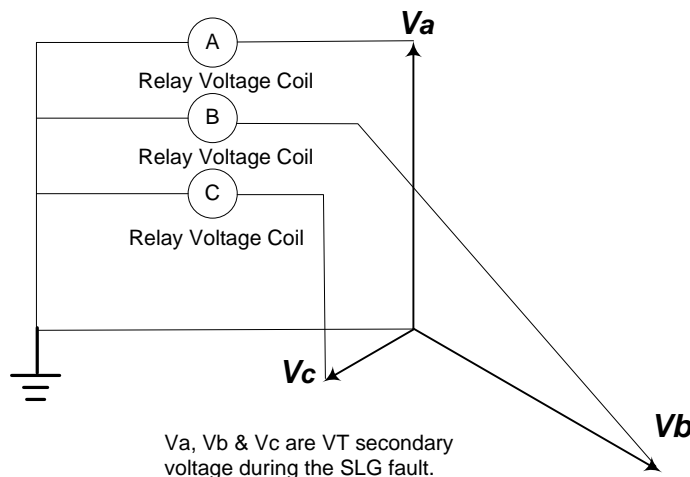
Figure 8: Single ground point on PT secondary circuit

For the single ground point in VT secondary circuit, the VT secondary voltage of faulted phase collapsed and GPR difference has no impacts on relay voltage measurement. The relay coils sense the true VT secondary voltages.

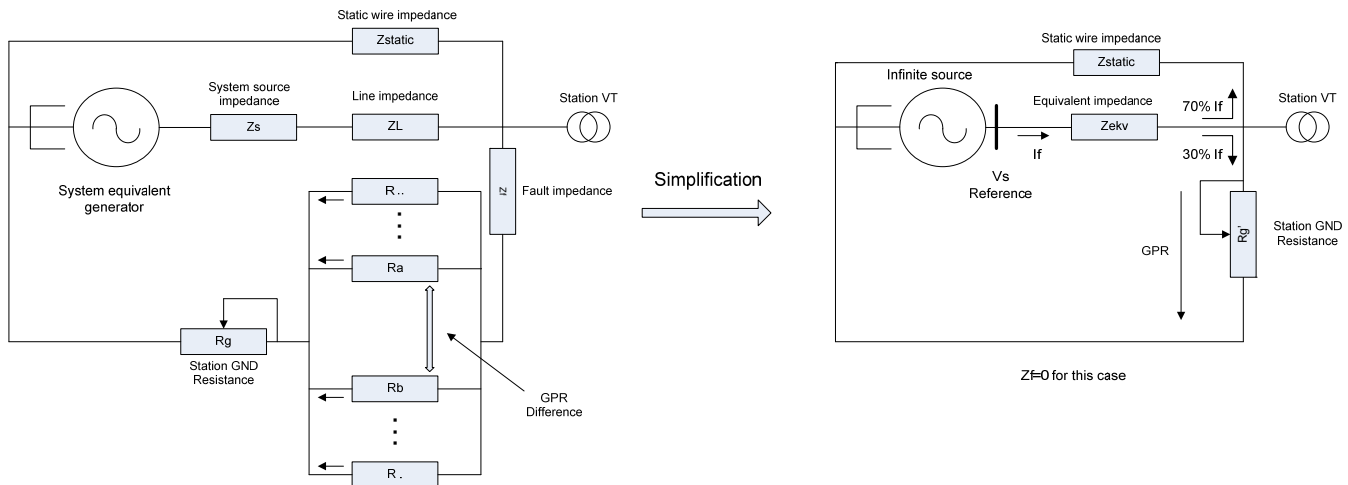
Figure 10, Fault current loop and GPR at Station L on September 2nd of 2011

For this particular case, the magnitude of VT secondary voltage for the faulted phase is the voltage drop across the fault impedance. It would be zero if the fault impedance is zero. The vector illustration of the simplified circuit is shown in Figure 11.

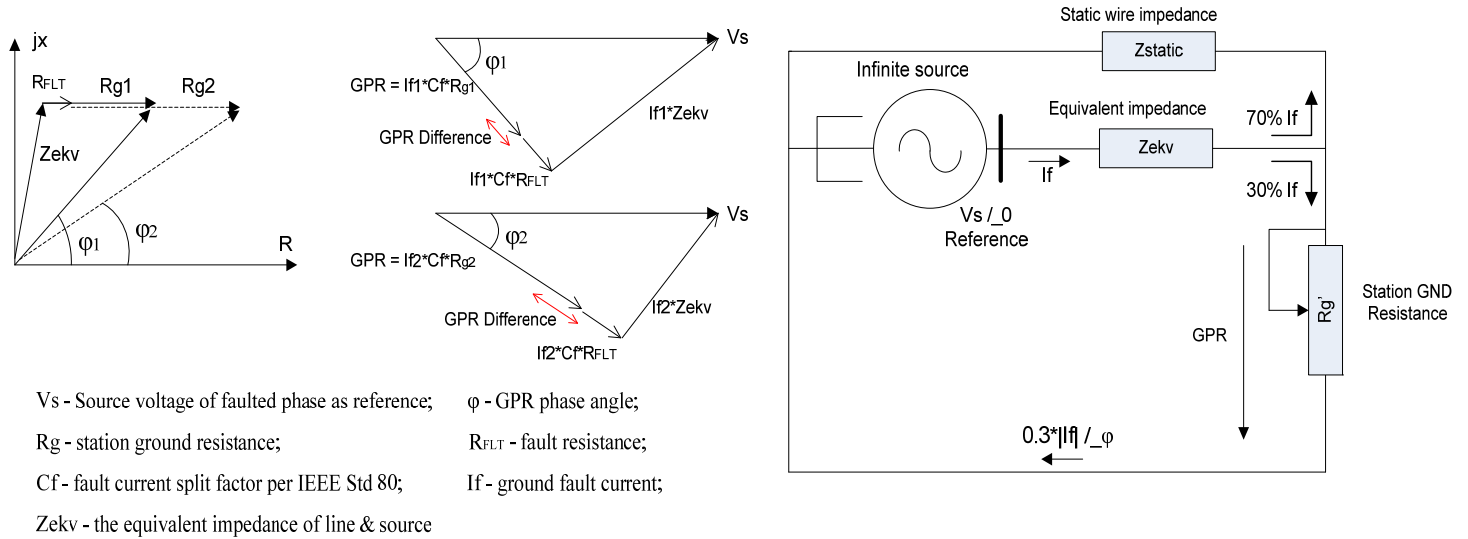
Figure 11 Station ground grid resistance and influence on GPR phase angle

From the voltage vector diagram, it can be derived that the angle of GPR or GPR difference and ground grid current is in phase. Large ground grid resistance would result in smaller phase angle if system voltage is used as a reference.
