A Collection of Bedtime Stories for Protection Engineers - Volume 1

Ed Chen, Jianzhuang Huang, Pallavi Kuchikulla, Naresh Malla, Khawla Munawwer, Lizhong Situ & Daniel Taft,
Consolidated Edison Company of New York, Inc.

Abstract— This technical paper is a collection of recent events on Con Edison’s power system. Each event will have its own section for background, root cause analysis, fault calculation study and corrective action plan. These events demonstrate the uniqueness of the Con Edison power system, challenges, and lesson learns. Highlights of each are below:

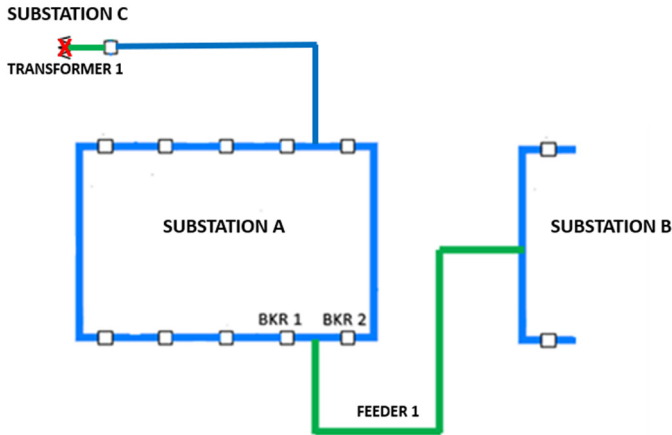
Figure 1a. Substation A arrangement

In Summer of 2014, 345 kV (Transmission Line) Feeder 1 between Substation A and Substation B overtripped for a Phase-C fault on Transformer 1 at Substation C. The Transformer 1 tripped correctly for a Phase-C fault. Feeder 1

overtripped via the incorrect operation (Phase-B) of System #2's feeder current-differential relay system.

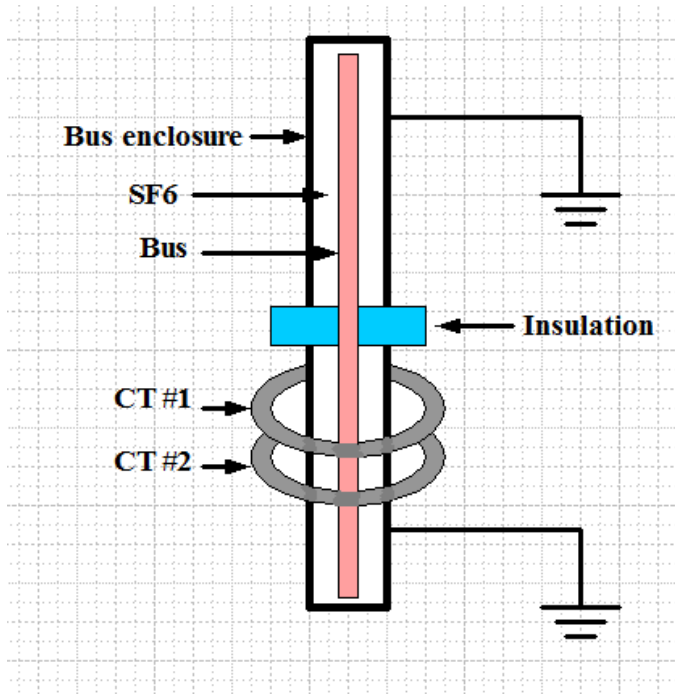
Figure 1c. Cross-section of Bus Enclosure

The Inter-core coupling is caused when a conductive loop is formed around a few CTs stacked together. CT inter-core coupling occurs when the grounded circuit breaker enclosure is conductively connected to the grounded GIS SF6 bus enclosures. The breaker and bus enclosures are grounded at different points, and there must be a separation at the CT housing to prevent ground current (a portion of the return current from the external fault) from flowing through the CT core. The separation is insulated to prevent this, although the insulation need not be for more than a few hundred volts. So, there is insulation on the bus enclosure itself which prevents circulating ground current through the CT. And then there's also insulation inside the CT cover which prevents the metallic loop around the CT.

Figure 1c below shows the bus enclosure above and below the CTs is grounded. The top and bottom part of the bus enclosure is isolated near the CTs to prevent a continuous conductive loop that will cause inter-core coupling.

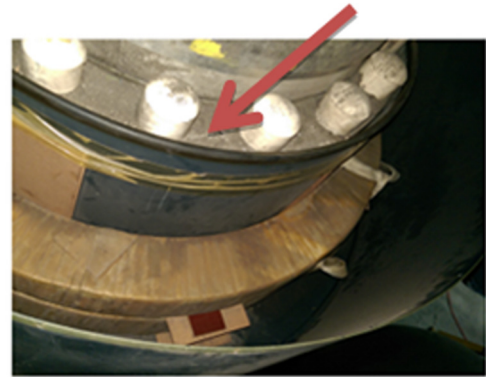
Figure 1e.

Figure 1d below shows detail of the CT enclosure with the top metallic cover. To prevent the conductive loop around the CTs, the top cover is insulated from the CT enclosure casing by rubber insulation (red). Figure 1e shows this insulation around the inner circle of the CT enclosure. Figure 1f shows the CT enclosure.

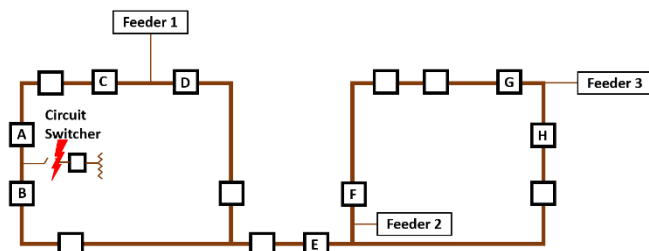
Figure 2a. Transmission line feeders' arrangement

In Winter of 2021, several 138kV breakers opened automatically at a 138kV substation, promoting System Operations to declare a Condition Yellow this involving three (transmission line) feeder mis-operations due to an adjacent bus section C phase fault on a circuit switcher. For the fault on the circuit switcher, the electromechanical bus differential relay 87 operated on C phase. This bus differential relay operated as per design to trip breakers A and B. As illustrated in figure 2a. This bus differential relay covers the bus section AB (between breakers A and B) up to the circuit switcher. The feeder and transformer associated with the circuit switcher had their own independent protection, which did not operate as designed because the circuit switcher was not within their protection zone. The backup protection for the bus section and the circuit switcher was provided by a digital ground overcurrent (51N) relay.

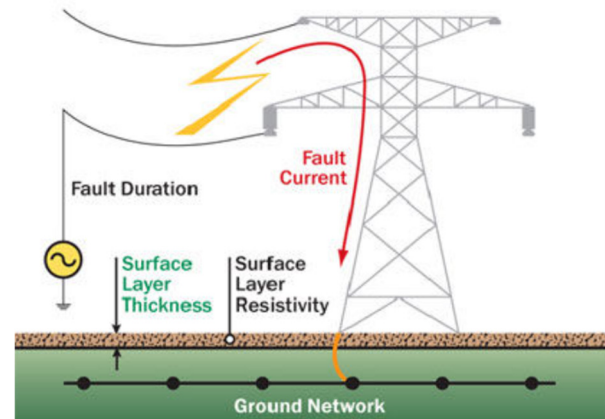
Figure 2e. Ground Potential Rise

2. For the Feeder 2 misoperation, it was initially suspected that the pilot wire relay was out of calibration. A comprehensive test of the relays (included the pilot wire monitoring relays) and its associated pilot wire yielded satisfactory results. In reference to the technical paper "Ways to Assure Misoperation of Electromechanical Pilot-Wire Relays" by Walter A. Emore [4], a comprehensive process of elimination was employed for this pilot wire relay. The evaluation included verifying the following conditions: reversed pilot wires, differing settings at the two terminals, varying CT ratios and CT

accuracy classes at the terminals, resistance and capacitance of the pilot wires exceeding specified limits, phase swapping, ground-mat voltage rise issues, induced voltage complications, different relay designs, different ratio insulating transformers at the terminals, currents being shorted at one end, pilot wires being open-circuited or shorted, failure to use insulating barriers during in-service tests, and failure to use exciting capacitors with neutralizing reactors. All these factors were examined and found to be satisfactory, except for the ground-mat voltage rise issue, which was identified as the root cause of the event. Ground-mat voltage rise in pilot wire relays refers to the increase in voltage potential between the ground grid and the surrounding earth. This can occur due to factors like elevation differences, soil resistivity, induced voltages. Higher elevations often have drier soil and rockier terrain, leading to increase in ground resistance. This voltage rise can cause unintended current flow through the pilot wires, potentially resulting in relay misoperation, as illustrated in figure 2e and figure 2f. Proper grounding practices and regular monitoring are essential to mitigate these issues and ensure reliable relay operation.

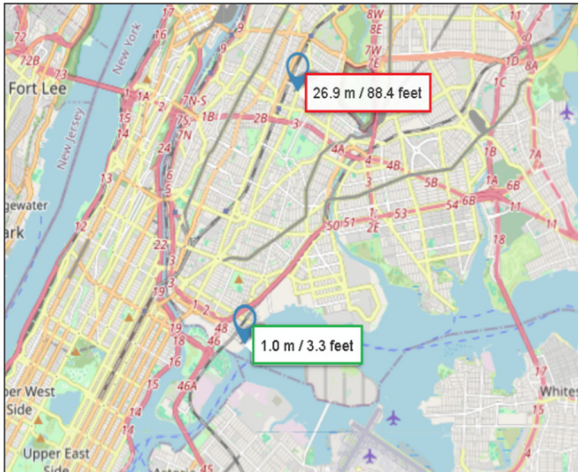
Figure 2g. Stations associated with Feeder 2 with elevation

indicated that the pilot wire medium itself for Feeder 2 was in acceptable condition. Certain portions of this substation's ground grid were known as ineffective, due to corrosion. Therefore, the ground grid reinforcement project was in place before the misoperation. Additionally, the two ends of the feeder were at different topographical elevation levels. One end of the feeder is located at a higher elevation with rock ledge while the other end is at sea level, as shown in figure 2g. In other words, higher elevation results in increase ground resistance due to the drier soil and rockier terrain.

This investigation determined that during the 2021 misoperation event, the momentary rise in ground mat voltage affected the pilot-wires and/or the relay case of the supervisory relay during the external fault, and caused a false trip (reference to “Ground-Mat Voltage Rise” problem in [4]).

2. The pilot wires relays for Feeder 2 and Feeder 3 were replaced with microprocessor-based relays with new modern communication channels in September 2022 and March 2022, respectively.

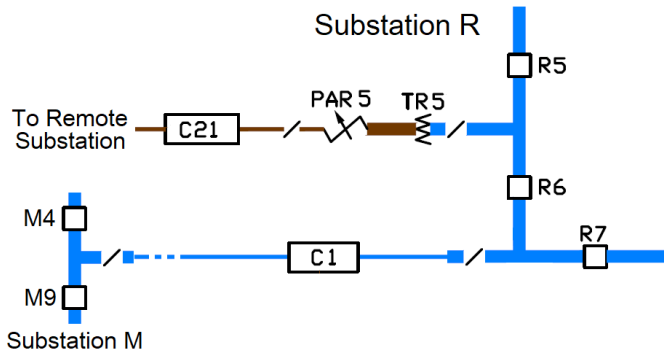
Figure 3a. Topology of the Affected Areas

In Spring of 2023, 345kV Transmission Line C1 between Substation R Breakers R6 and R7 and Substation M Breakers M4 and M9 tripped. Breakers R7, M4, and M9 were tripped while Breaker R6 was previously opened. At the time of the trip, the operator at Substation R was on orders associated with commissioning of new 138kV Transmission Line C21, which connects to the 138kV Phase Anger Regulator PAR5 and then to the 345kV/138kV Auto Transformer TR5 between Breaker R5 and R6 adjacent to Line C1 as shown in Figure 3a.

Both Breakers R5 and R6 were previously opened, and the remote terminal of Line C21 was also opened. As a result, Line C21, PAR5 and TR5 were all supposed to be deenergized. The operator at Substation R was trying to exercise a set of three phase disconnect switches associated with Line C21 next to PAR5, and reported seeing arcing at the disconnect switch of Line C21 right before the 345kV Line C1 was tripped open.

Relay targets reported that Line C1 was tripped by both systems of line current differential relays. PAR differential relays and auto transformer differential relays at Substation R also showed trip targets. Field reports showed that the Phase A surge arrester installed between TR5 and PAR5 had failed, and Breaker R6 showed a Phase C fault at Line C1 side.

Later investigation found that a loose nut caused Phase C of Breaker R6 to be connected after the breaker was switched open hours prior to the event. TR5 and PAR5 were kept energized through Phase C of Breaker R6 until the trip-out. Line C21 was deenergized since the disconnect switch and the remote terminal were both open.

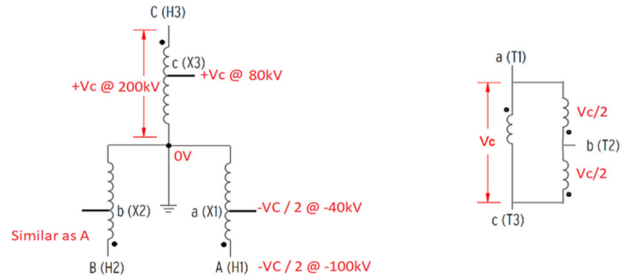
Figure 3b. Voltage Induction due to Delta Tertiary Windings

Auto transformer TR5 has a delta connected tertiary windings. When energizing through only Phase C of Breaker R6, the 1 pu voltage V_c was induced to the tertiary windings as

shown in Figure 3b. With delta connection, V_c was equal to negative of the sum of V_a plus V_b . Thus, V_a and V_b both had the magnitude of 0.5 pu and 180 degrees out of phase to V_c . The two voltages were then induced from the tertiary windings back to the primary and secondary windings of TR5. Figure 3c shows the voltages at Line C21 captured by the relay oscillography.

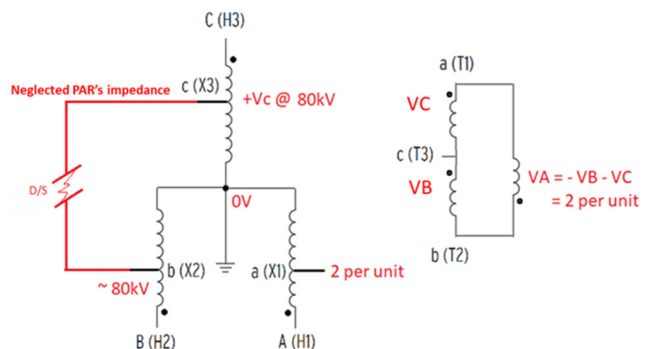
Figure 3d. New Voltage Induction during Arcing

Prior to the event, V_{ab} at the disconnect switch of Line C21 was at about 0V while V_{bc} was at about 1.5 pu. Phase B was the middle phase and the other two were the outer phases. When the operator exercised the disconnect switch, Line C21 was inadvertently energized. The charging current with the potential difference of 1.5 pu caused arcing, between phase B and phase C, and caused a temporary short between the two phases. That forced V_b to be in phase to V_c with similar magnitude of 1 pu as shown in Figure 3d.

The new voltages were induced back to the tertiary windings of the auto transformer. Since V_a was equal to the negative of the sum of V_b plus V_c within the delta windings, V_a at that moment had the magnitude of 2 pu and 180 degrees out of phase. With induction back to primary and secondary windings

at Phase A, 2 pu voltage was presented at the surge arrester, causing it to fail with a Phase A to ground fault. Figure 3e shows the voltages at Line C21 captured by the relay oscillography during the arcing.

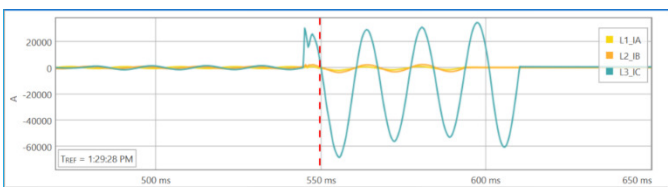
Figure 3g. Fault Currents at Line C1 during Breaker 6R Fault

Even though both the transformer and PAR differential relays tripped during the surge arrester failure, Breakers R5 and R6 were already opened. The fault could not be interrupted and continued to be fed through phase C of Breaker R6. A few cycles later, phase C of Breaker R6 failed. That resulted in a Phase C to ground fault at the source side of Breaker R6 that fell into the protection zone of the adjacent Transmission Line C1. Line C1 therefore was tripped open. The fault currents at Line C1 during the fault were shown in Figure 3g.

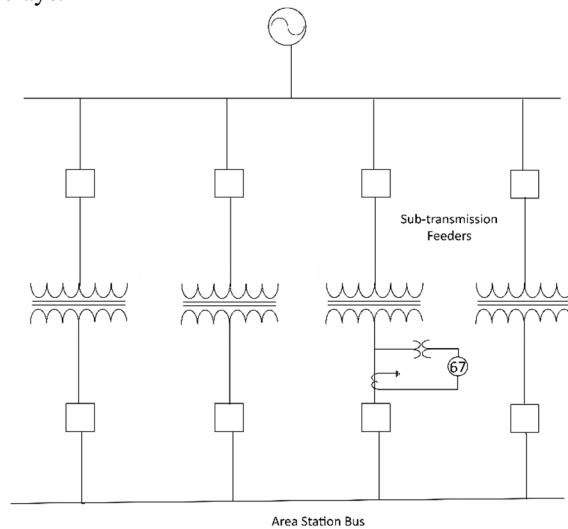
In Summer of 2023, 13kV Substation low side Breakers tripped. As a result, the substation transformer became unavailable to the system. A CMVM (contact-making voltmeter for load tap changer operation) issue caused the transformer's tap changer to go to 16L, the potential differences between the transformer & its adjacent transformers caused circulating current between them. A high-level arrangement of an area (distribution) substation is shown in Figure 4a. The transformers are running in parallel, causing the circulating current. The relay targets show one of the two systems of phase directional overcurrent element (67) operated that are intended to clear back-feed during phase-to-phase and three-phase faults on the 138 kV sub-transmission feeder. These two protection systems are supplied by the same 13kV PTs but by different 13kV CTs. Two systems of directional phase overcurrent elements are identical, residing within separate microprocessor relays.

4a. High level arrangement of an area substation showing CTs and PTs for the directional element that operated.

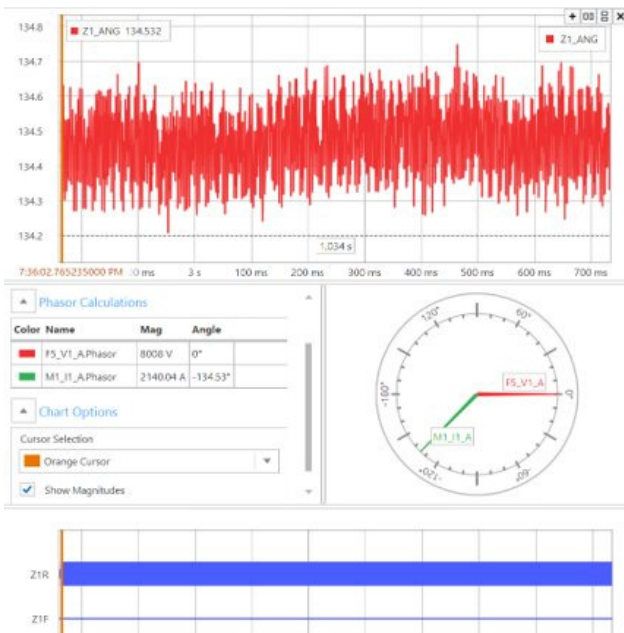
Figure 4e. Positive sequence Directional Element response to the event

The positive sequence directional element is another method where positive sequence voltage is used as a reference [2]. If the positive sequence voltage angle is within 120° to 300° , the direction is declared as reverse. Similar to the quadrature polarizing method (where the forward and reverse plane are divided into 180° each), the directional element for this method can still be asserted under reactive power back feed condition. As shown in Figure 4e below, the positive sequence directional element would have seen the positive sequence voltage angle in the reverse plane based on the signals collected during the trip-out as shown by assertion of Z1R. Therefore, the positive sequence directional element is more secure and does not operate during the event. The main difference with quadrature polarizing method for positive sequence directional elements is the absence of ECA angle. However, in theory, under three phase balance load condition, the phase directional element has an equivalent of ECA setting of 60° . This phase sequence directional element could also tolerate higher MVAR backfeed (more than the CAP settings). However, for both phase-phase and phase-phase-ground unbalanced fault types, only positive and negative-sequence quantities are available. Therefore, for unbalanced fault directional element, negative-sequence quantities remain as viable inputs, since positive-sequence load quantities mislead a directional element for unbalanced faults. Therefore, for dependability and security, both positive and negative sequence directional elements are preferred over traditional collection of three-phase directional elements [2].

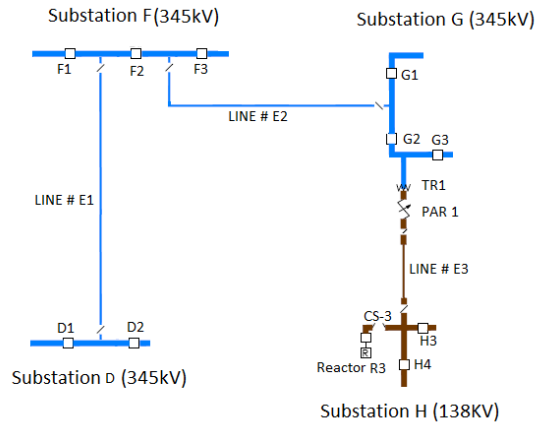
Figure 5a: System One-line diagram

In Summer of 2024, while removing Substation H Shunt Reactor R3 from service, Circuit Switch CS-3 failed and caused a B-C Phases fault at Circuit Switch CS-3. Subsequently, Substation H 138kV Bus Section 3 and associated outlet 138kV Transmission Line E3 to Substation G tripped. Breakers H3 and H4 were tripped at 138kV Substation H, and Breakers G2 and G3 were tripped at 345kV substation G. In addition, 345kV transmission Line E1 between Substation F and Substation D tripped. Breakers F1 and F2 were tripped at 345kV Substation F and Breakers D1 and D2 were tripped at 345kV Substation D.

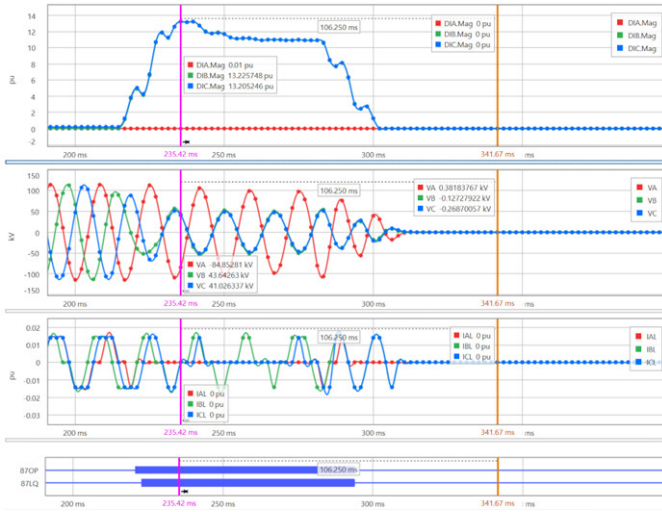
Figure 5b: Substation G Line # E3 Relay Event Record

Damage was found on Substation H 138kV Circuit Switch CS-3 B and C phases. Relay protection for the 138kV Transmission Line E3 operated correctly to clear the B-C phases fault at Circuit Switch CS-3. Relay targets reported that Transmission Line E3 was tripped by both Systems of line current differential schemes.

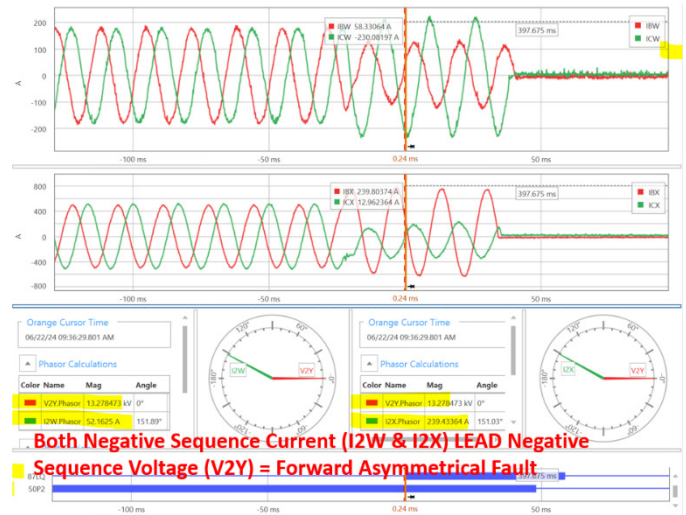
Figure 5d: V2 and I2 Relationship at Substation D Line # E1 from relay Event Record

their respective breakers' CTs. Per Substation D Line # E1's relay event file, we can see both negative sequence currents (I2W & I2X) from its respective breakers' CTs lead their respective negative sequence voltage (V2Y) about 151 degrees in Figure 5d. This supported the system fault current flow where we would expect Substation D would supply fault current to Substation F via Line # E1.
