Analysis and Troubleshooting of 500kV line operation with Unit feeder differential misoperation

Abstract—TVA experienced a tree-caused fault on one of the 500kV lines connected to a large generating plant. A feeder differential scheme on the high side of a generator step-up transformer (GSU) for an 1100MW generating unit misoperated 3 cycles after fault inception, followed by slow fault clearing at both 500kV line terminals (16 cycles and 18.5 cycles, respectively). This paper intends to provide analysis of the cause of slow clearing by the 500kV line protection, as well as the cause of the misoperation of the feeder differential. The reason for the slow clearing of the line fault was determined to be the insensitivity of the pilot ground protection for resistive faults. The reason for the misoperation of the feeder differential protection was much more difficult to determine. After some difficult and unsuccessful troubleshooting, a disconnected residual wire on one of the breaker CTs was found to be the cause. The reason why secondary injection testing was unsuccessful in pointing to the actual cause is discussed.

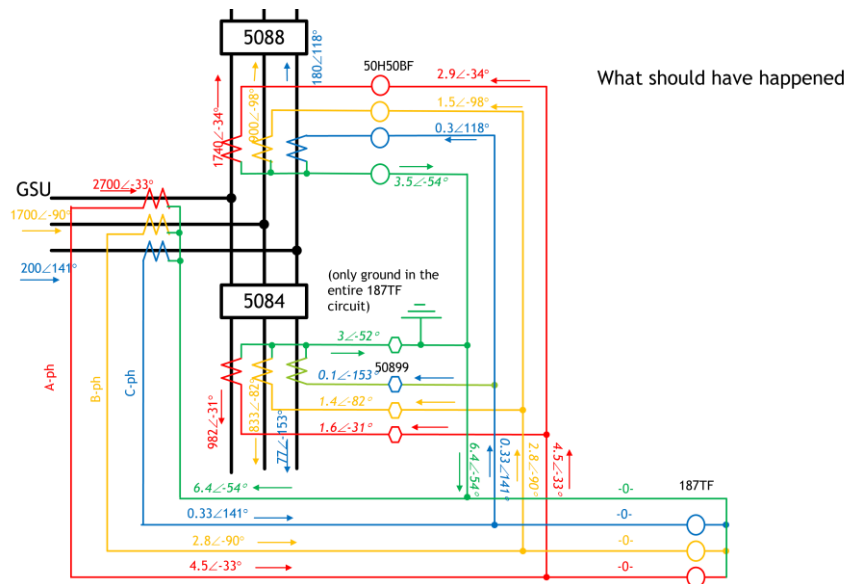
However, the third, which proved to be correct, was the discovery of a lifted residual wire in the 5088 CT circuit connected to the unit 1 feeder differential relays. This was found by visual inspection of the terminal blocks where the CT cables first terminated in the control building. See Figure 8.

This lifted wire was figured in to the analysis of the secondary circuits, and which produced a current of just over 3A secondary to the A-phase differential relay. See Figure 9. This is about 200% of pickup which for time dial 2 results in an operating time of about 10 cycles, which agrees with the clearing time of 13 cycles including lockout relay and breaker interrupting time. Note the 5088 A-phase secondary current should have been $2.9\angle-34^\circ\text{A}$ ($1716/600$) but was only $1\angle58^\circ\text{A}$ (remaining $3.1\angle-52^\circ\text{A}$ forced thru CT magnetizing branch, due to the

open residual wire). Compare Figure 9 with Figure 10 which shows what the differential relays would have seen if the residual wire had not been lifted.

Figure 10. Unit 1 feeder differential relay currents during initial fault - with no lifted 5088 residual wire
