# Analysis of the misoperation of DCB scheme for transmission line protection

Song Ji, Yujie Irene Lu, Michael Gregg & Jim Murphy, National Grid USA

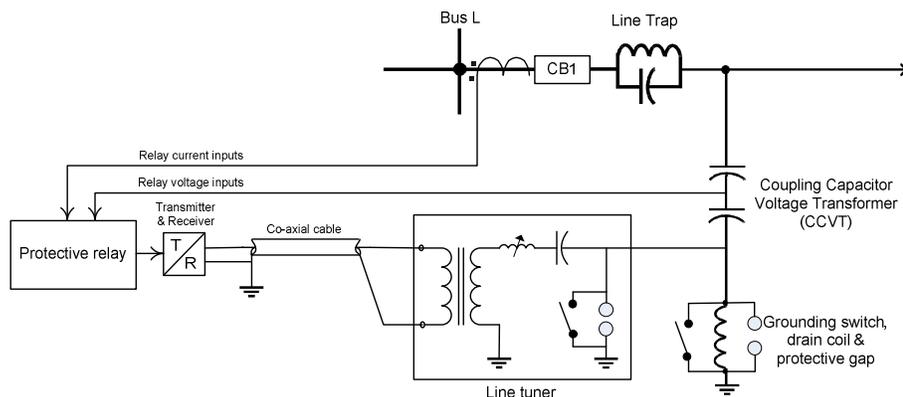
Figure 7: components of DCB scheme over PLC communication

As shown in Figure 7, any deterioration of communication path could lead to a carrier hole which could be at transmitting or receiving end. The presence of carrier hole would indicate the too much signal attenuation from bad line trap, the insulation break-down of coaxial cable, the flash-over of protective gap, and/or excessive external electromagnetic interferences.

Since the hi-frequency signal level was normal at both terminals during the tests, the issue of transmitter/receiver and line trap can be excluded; otherwise significant of signal attenuation would be observed.
