# Field Experience with CT Saturation Due To Forced Current Re-distribution

Hongbo Apollo Zhang and Ralph Peter Barone, BC Hydro

**Abstract** - This paper describes field experience with protection mis-operations caused by CT saturation subsequent to disturbance of CT secondary circuit connections. The increased excitation current associated with CT saturation allows the CT secondary currents to change in both magnitude and direction in order to accommodate the constraints of the circuit. By analyzing two system disturbance events described in this paper, the authors are able to use simple circuit analysis to explain why and how these changes occurred and to predict the new equilibrium state.

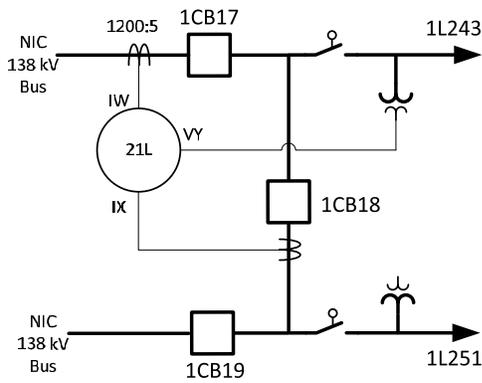
Fig. 2 Simplified 1L243 Protection One line Diagram

This event occurred at BC Hydro's Nicola Substation (NIC) located in the south interior of BC. The circuit in discussion is a 138 kV line terminal (1L243) at NIC. A simplified one line diagram is shown in Figure 2. In normal operation, 1CB17 carries the majority of 1L243 current while breaker 1CB18 only carries minimal current since the two line currents are relatively equal.

The line protection consists of two sets of identical protection equipment, such as relays, CTs, and VT. In this paper, only primary protection is relevant to the discussion. Therefore, Figure 2 only shows the primary protection (21L)
