GREGG 230 KV SUBSTATION SHUNT CAPACITOR BANK FAILURE AND CASCADING AREA DISTURBANCES

Leo B. Hisugan, Aaron M. Feathers, Fortino Arroyo Rivera
Pacific Gas & Electric Company

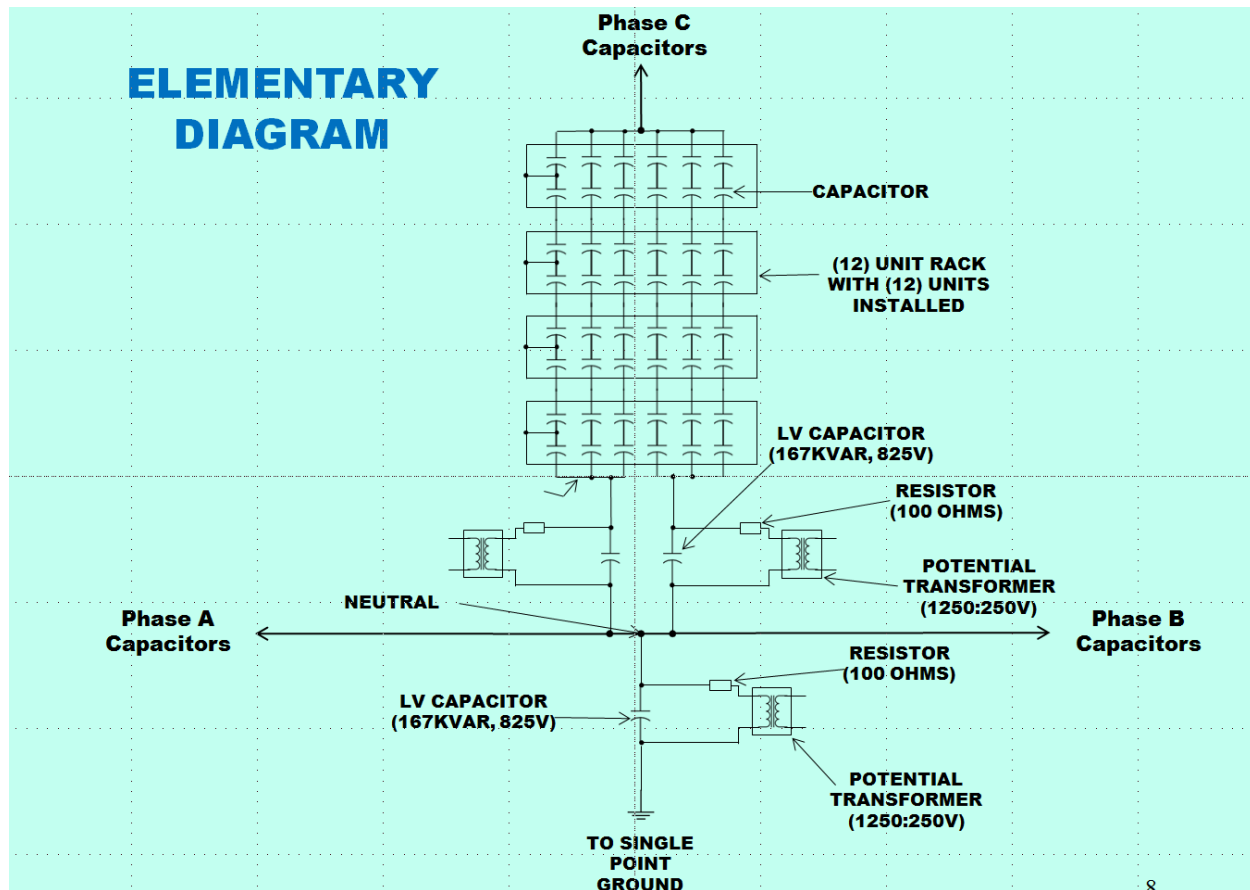
Figure 4 Shunt Capacitor Bank Elementary Diagram, Phase "C"

The partial energization of DSW 211 to the Capacitor Bank 1 on Phase C only, caused an unusual Phase Voltage Imbalance that produced a shift of Neutral (N) star point to Ground (G) point. The Phase C Voltage to Neutral, VCN, shifts to Phase C Voltage to Ground, VCG, when phase imbalance occurred without Phase "A" and Phase "B" of the Capacitor Bank energized.

Based on the events retrieved from microprocessor relays, prolonged voltage impressed on the neutral caps was seen exceeding 1100 volts rms, or 1556 volts peak voltage, and 2400 volts 3V0, Zero Sequence Voltage, for more than 65 seconds. This 1100 volts rms is 133% above the rated terminal voltage, 825 volts rms, of the Neutral Capacitors. This explain why the single line to ground fault took so long to develop (**65 seconds**) as it gradually broke down the LV Capacitor insulation until it catastrophically failed. **LV Capacitor voltage surge** was due to **single phase arcing of the disconnect switch 211 to the capacitor bank Phase C.**
