FDA Conference April 30 to May 1, 2018

# Gregg 230 kV SS Shunt Capacitor Bank Failure and Cascading Area Disturbances

Leo B. Hisugan, P.E., Supervising Protection Engineer, PG&E  
Aaron M. Feathers, P.E., Principal Protection Engineer, PG&E

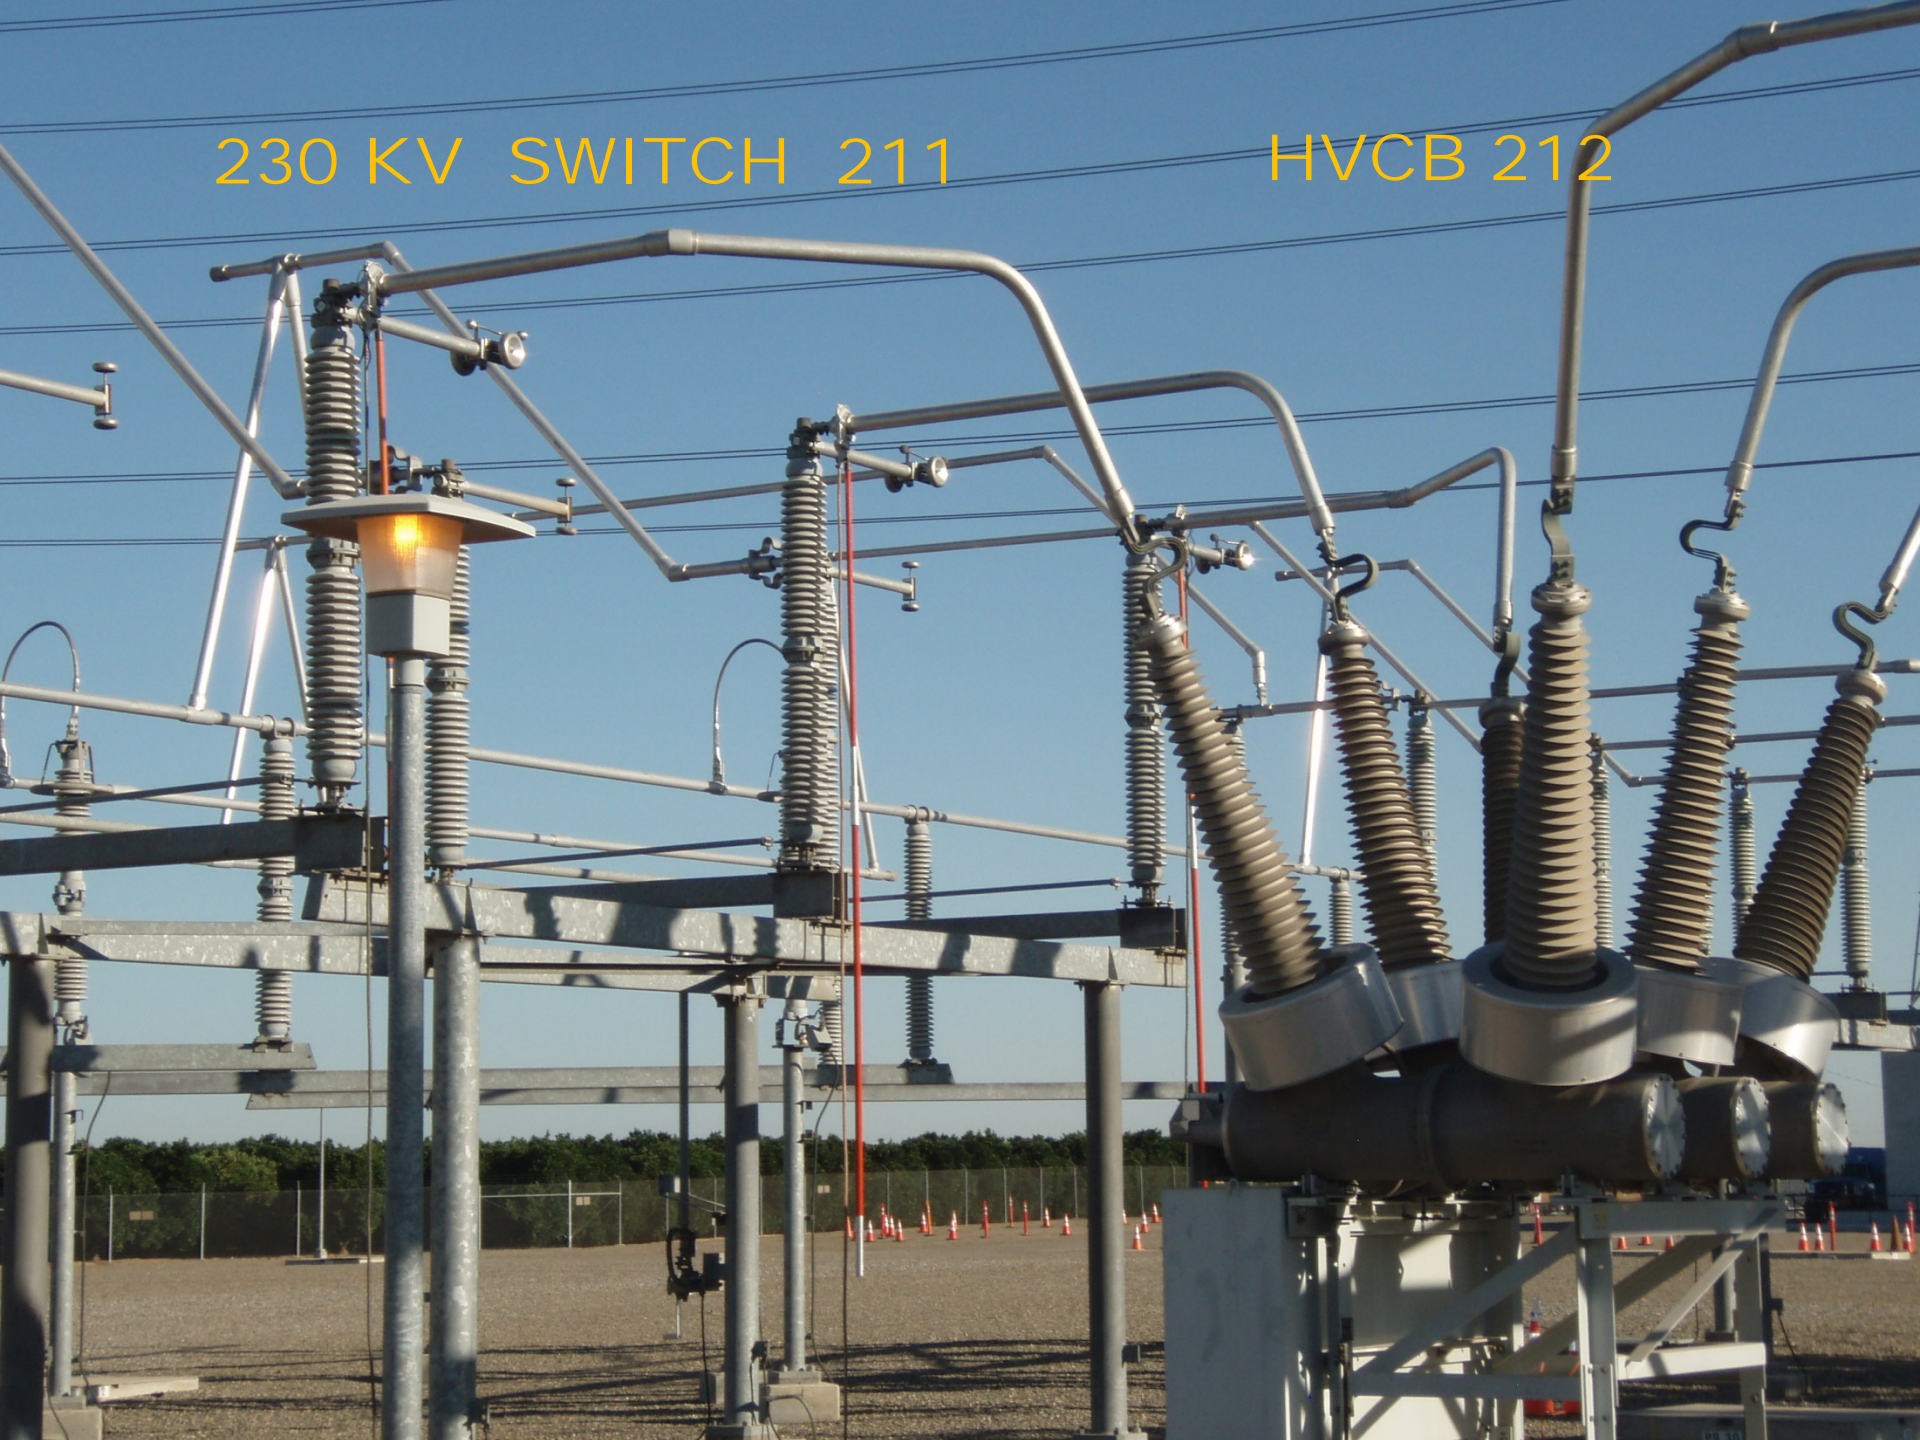
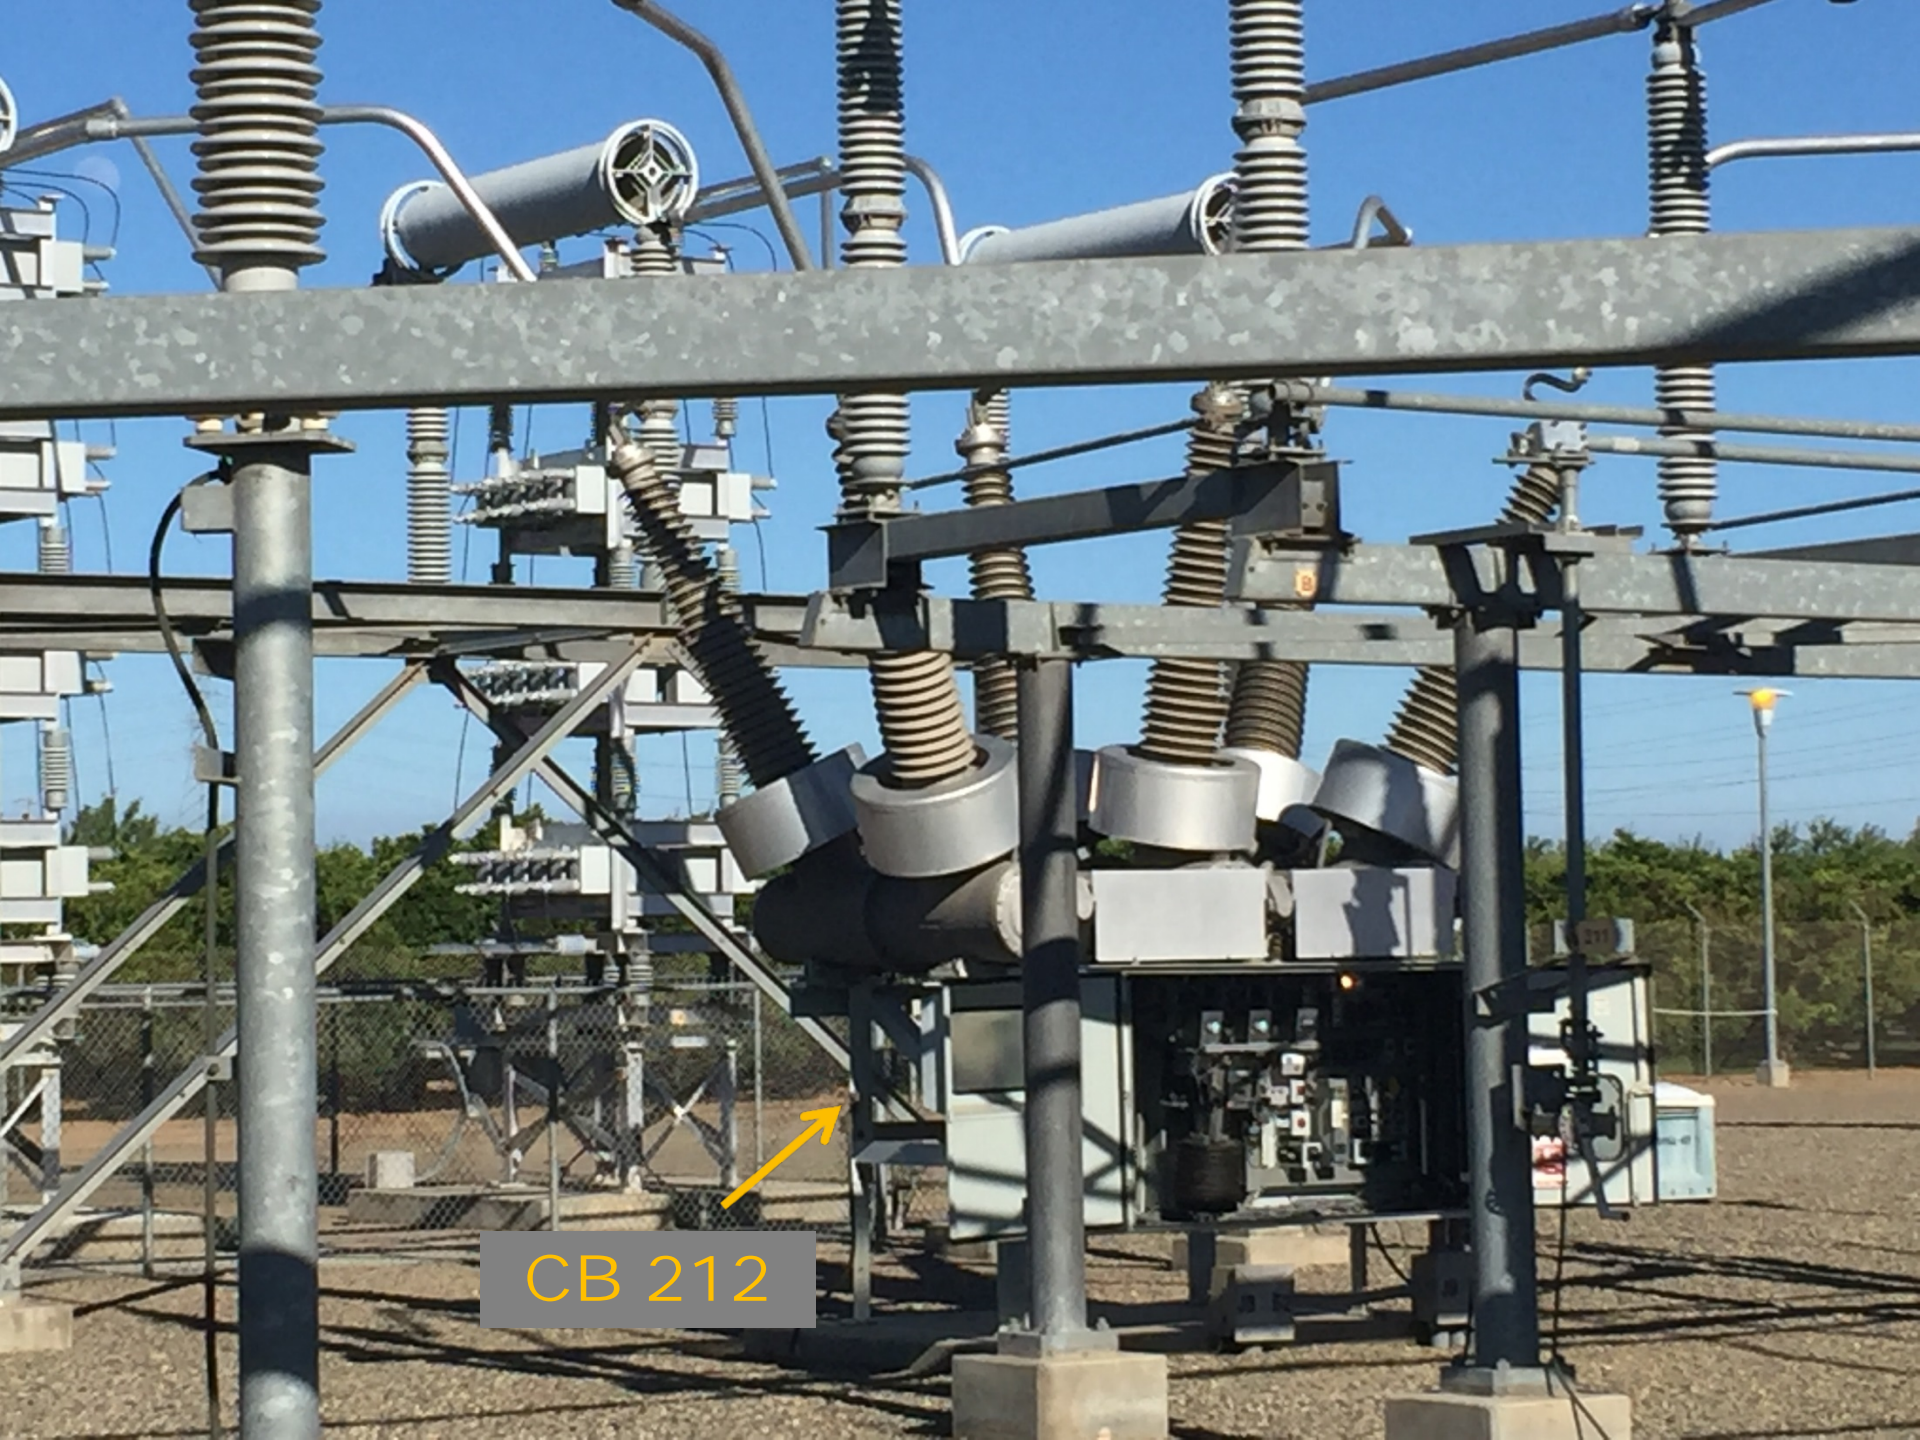
Initial Conditions:

- Gregg CB 212 indicates Open
- Gregg SW 211 Visual Open

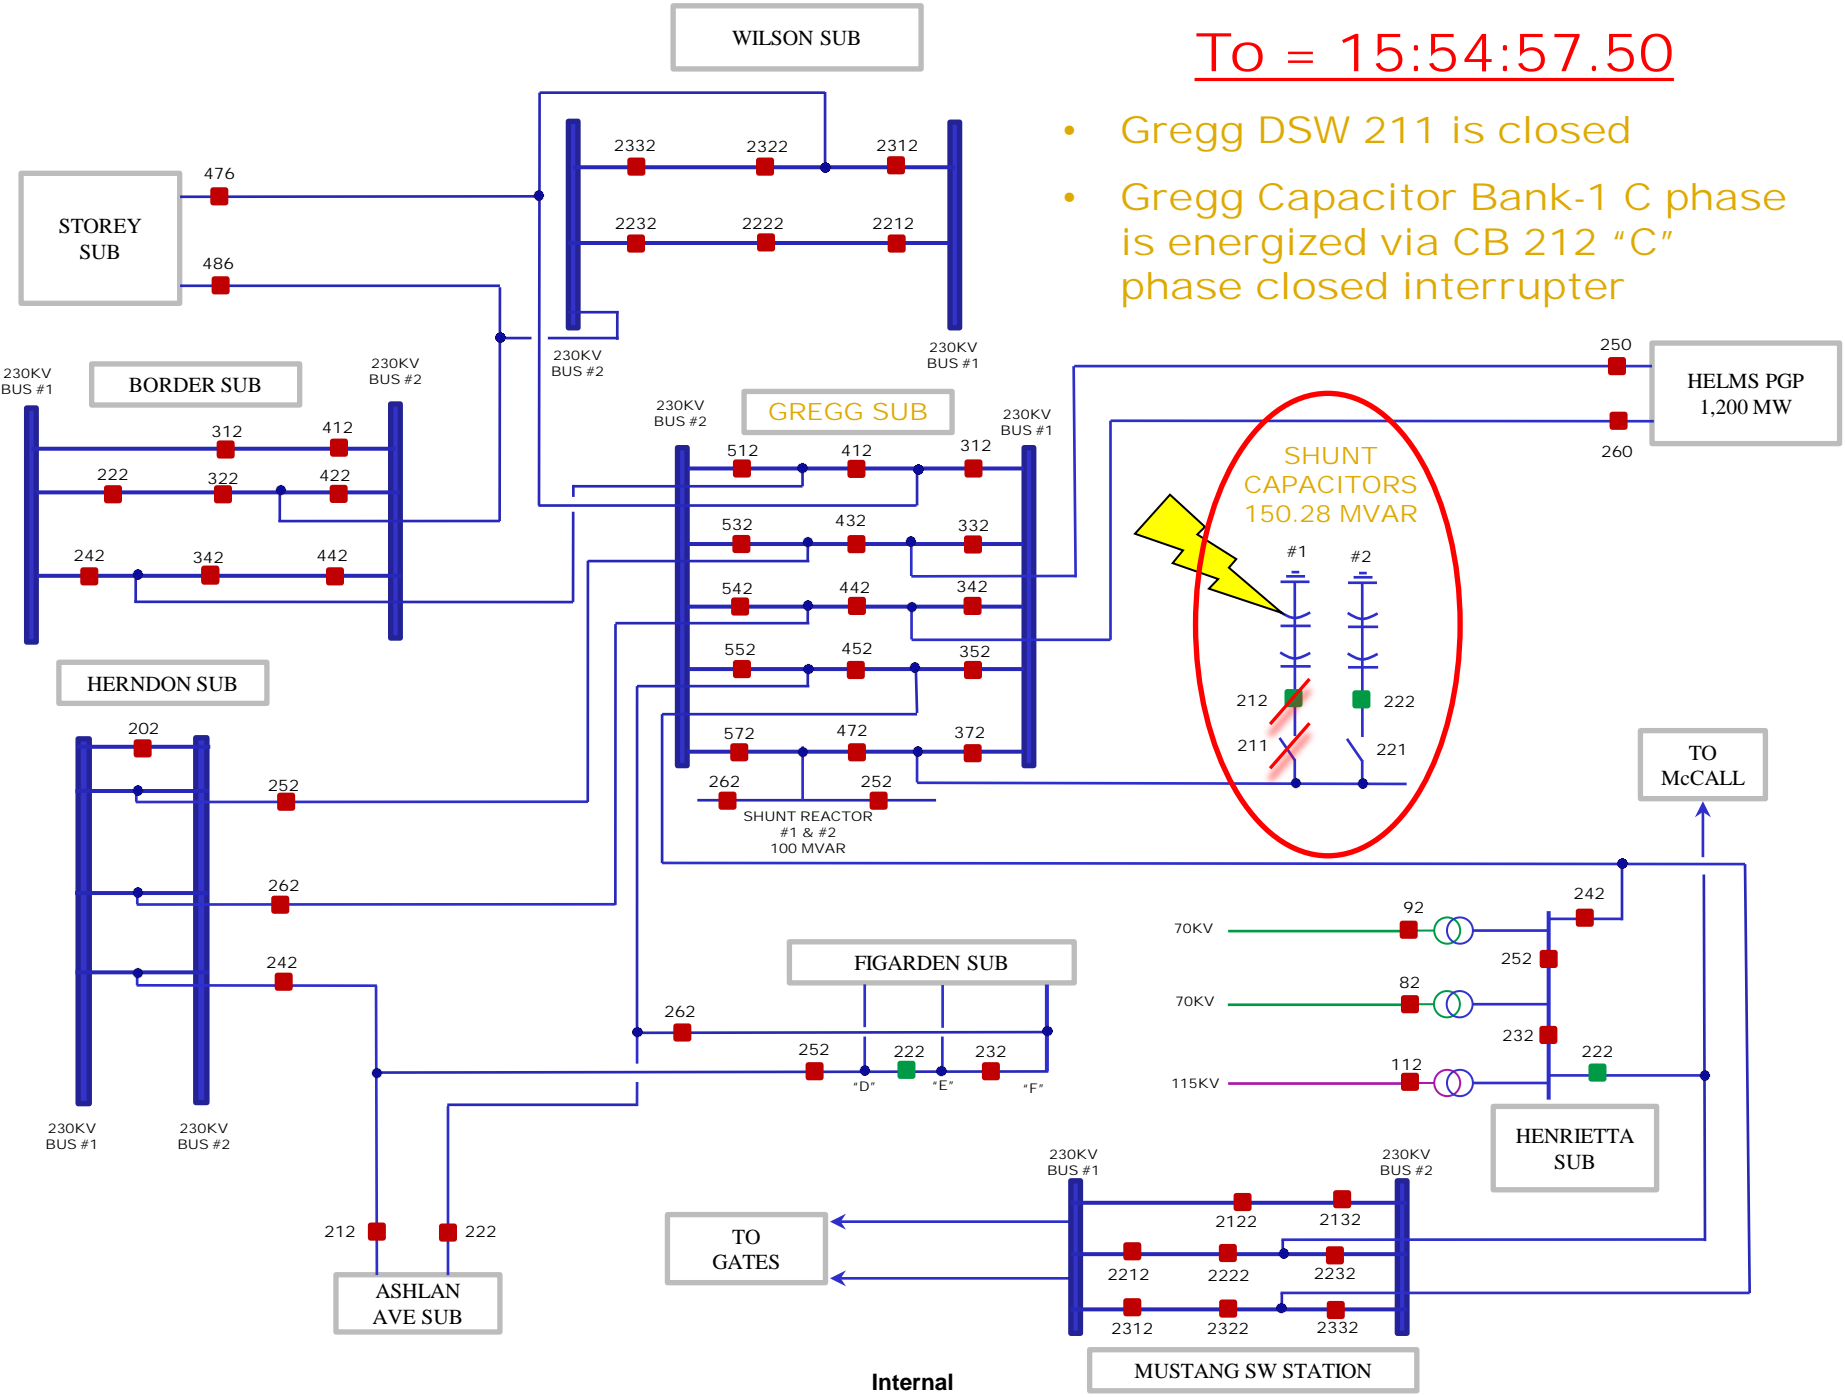
To = 15:54:57.50

- Gregg DSW 211 is closed
- Gregg Capacitor Bank-1 C phase is energized via CB 212 "C" phase closed interrupter

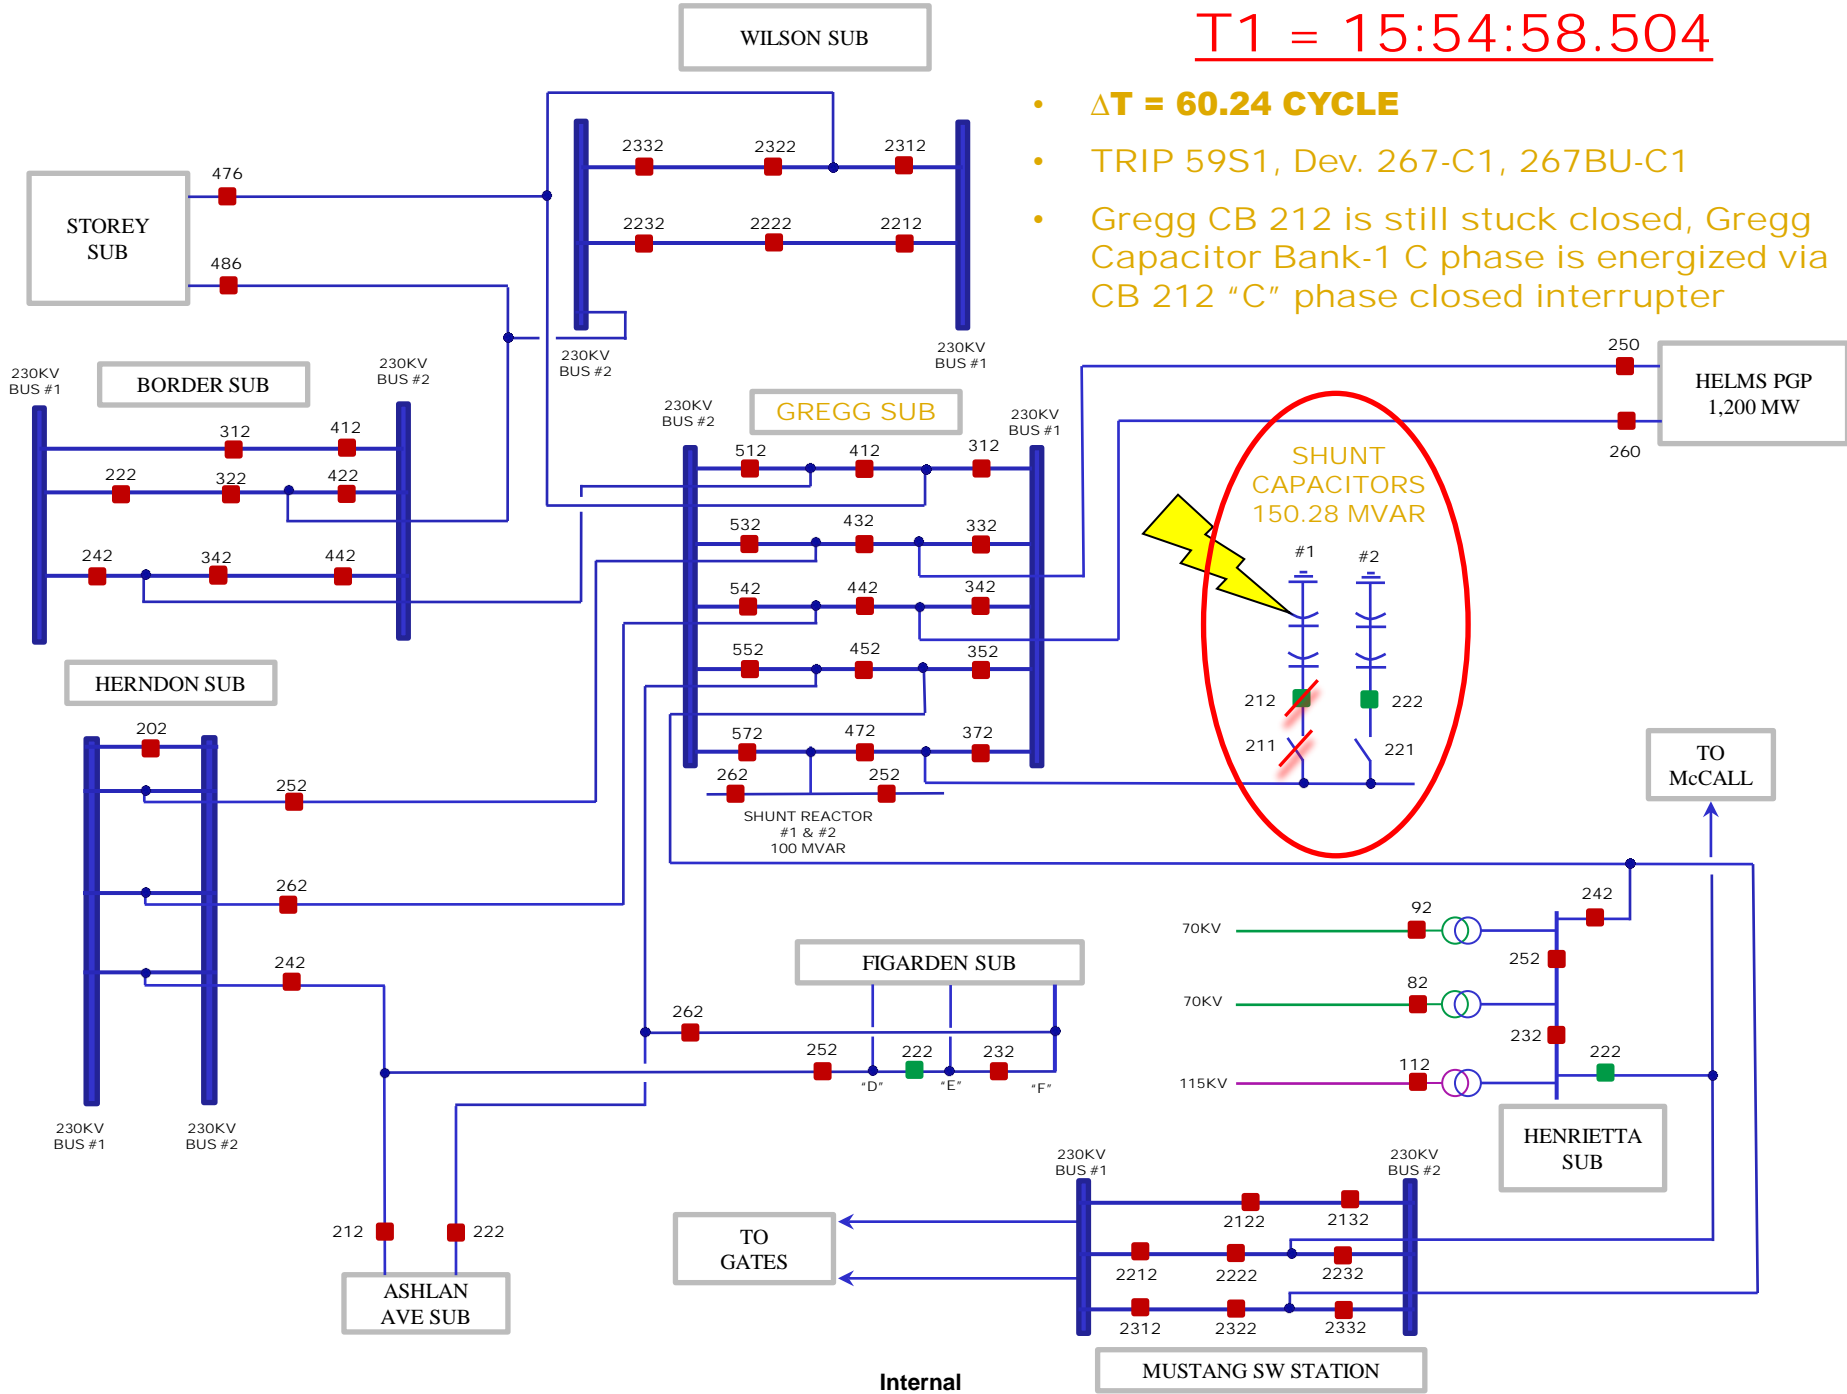
T1 = 15:54:58.504

- $\Delta T = 60.24$  CYCLE
- TRIP 59S1, Dev. 267-C1, 267BU-C1
- Gregg CB 212 is still stuck closed, Gregg Capacitor Bank-1 C phase is energized via CB 212 "C" phase closed interrupter

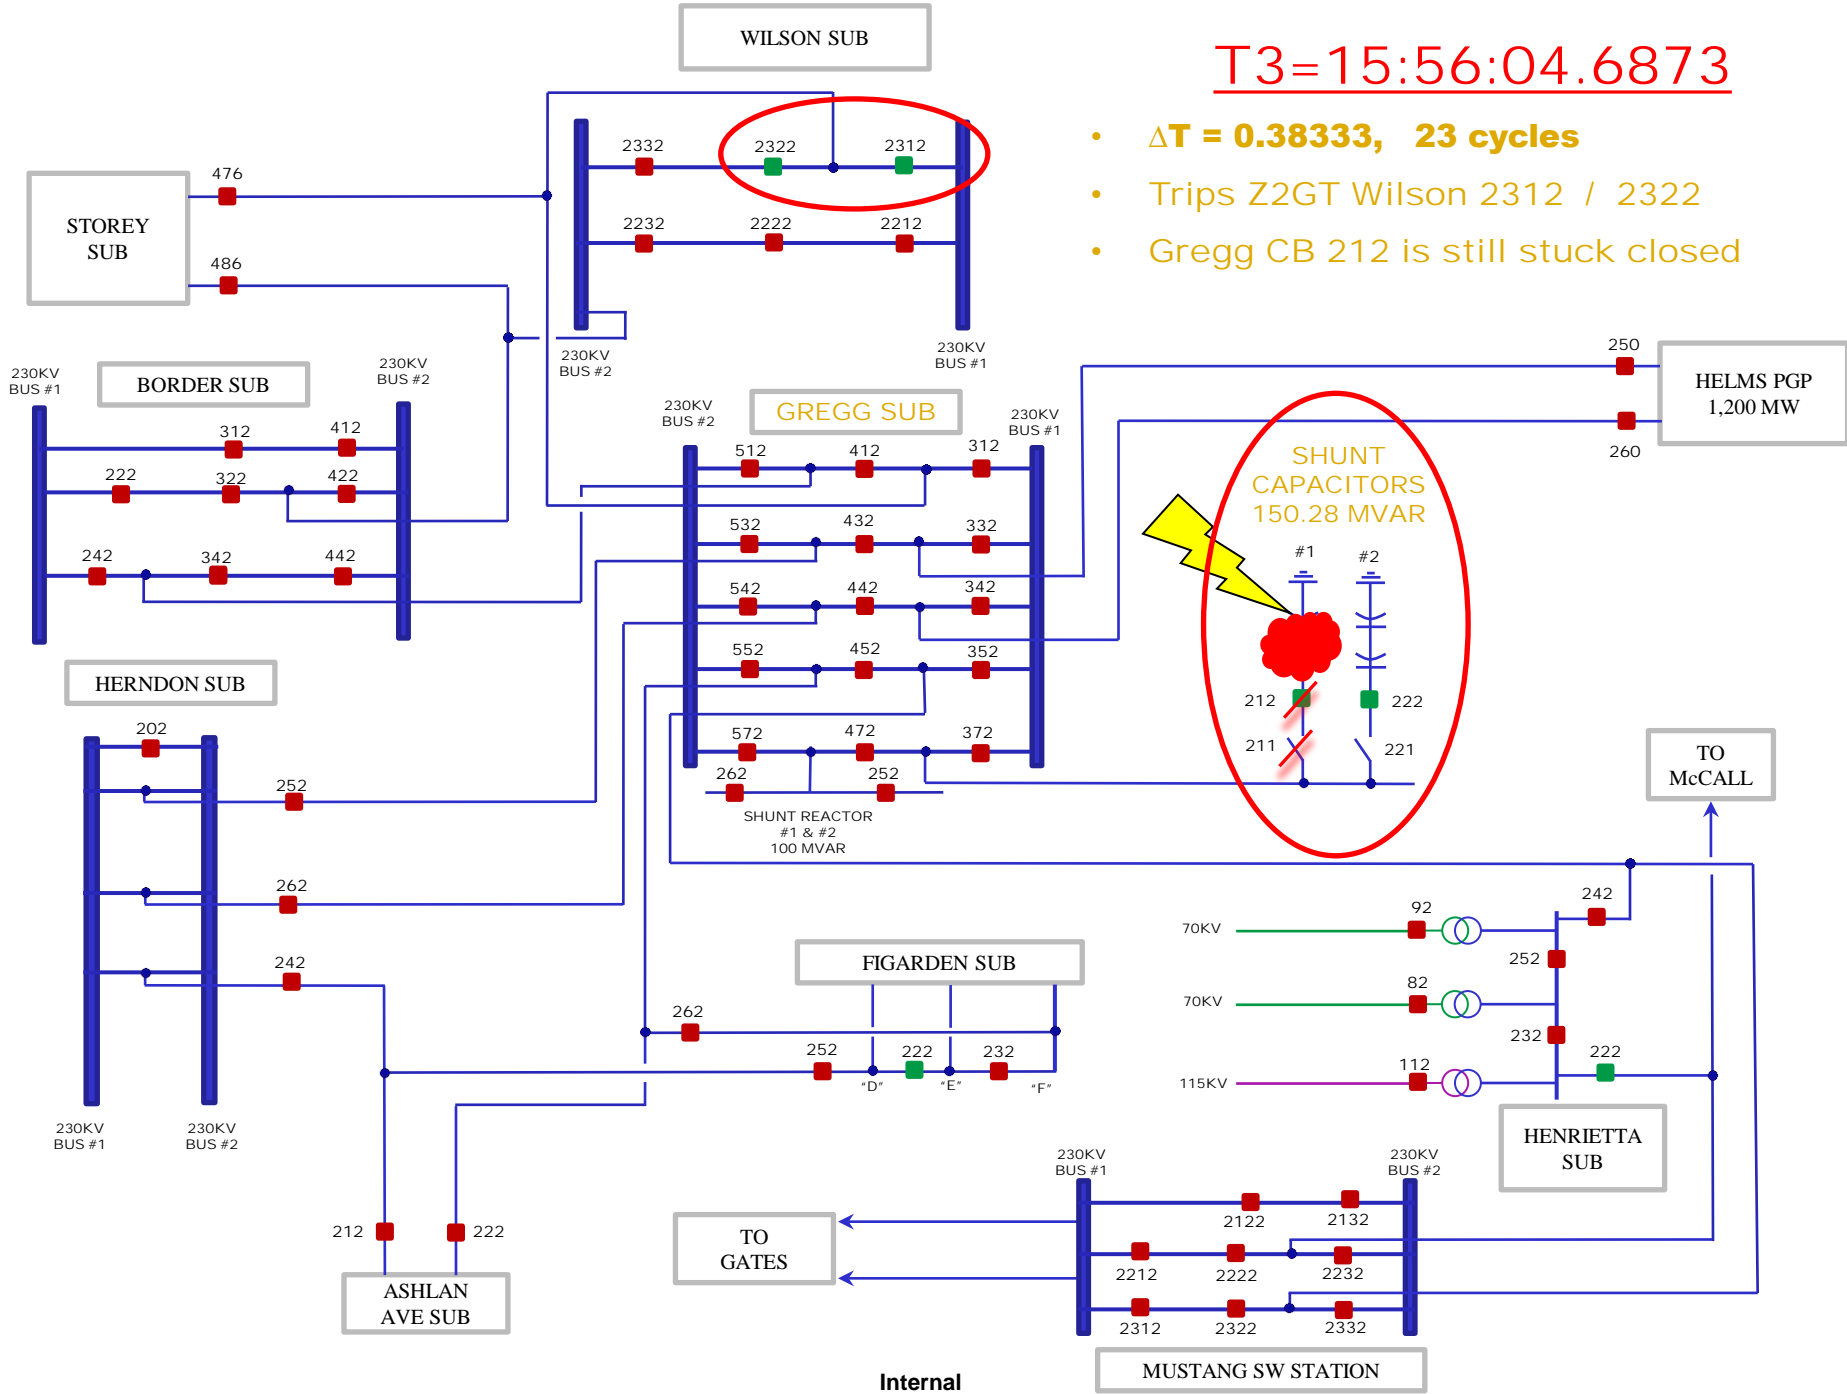
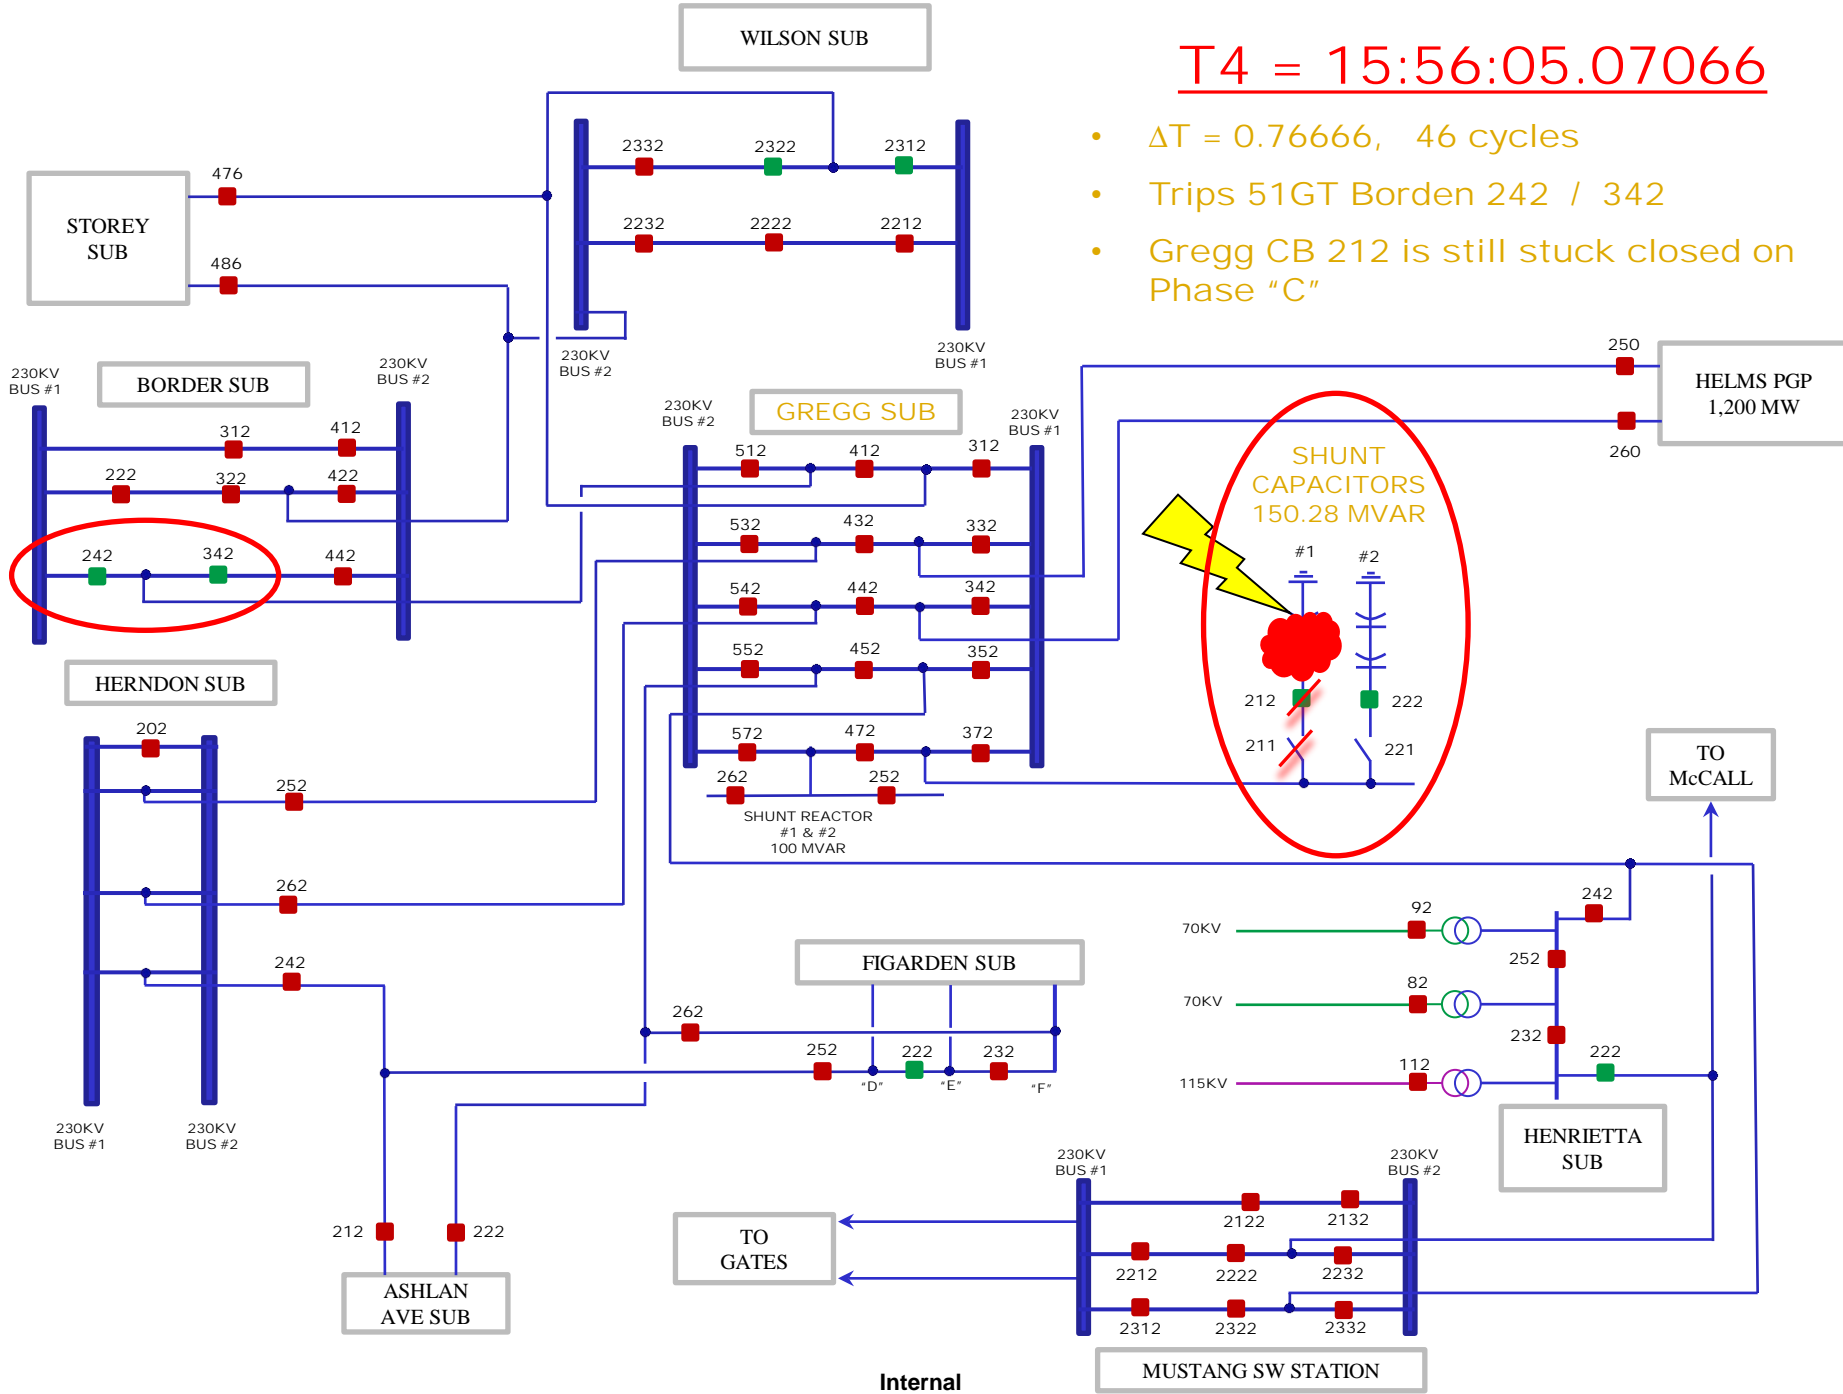
T3=15:56:04.6873

- $\Delta T = 0.38333$ , 23 cycles
- Trips Z2GT Wilson 2312 / 2322
- Gregg CB 212 is still stuck closed

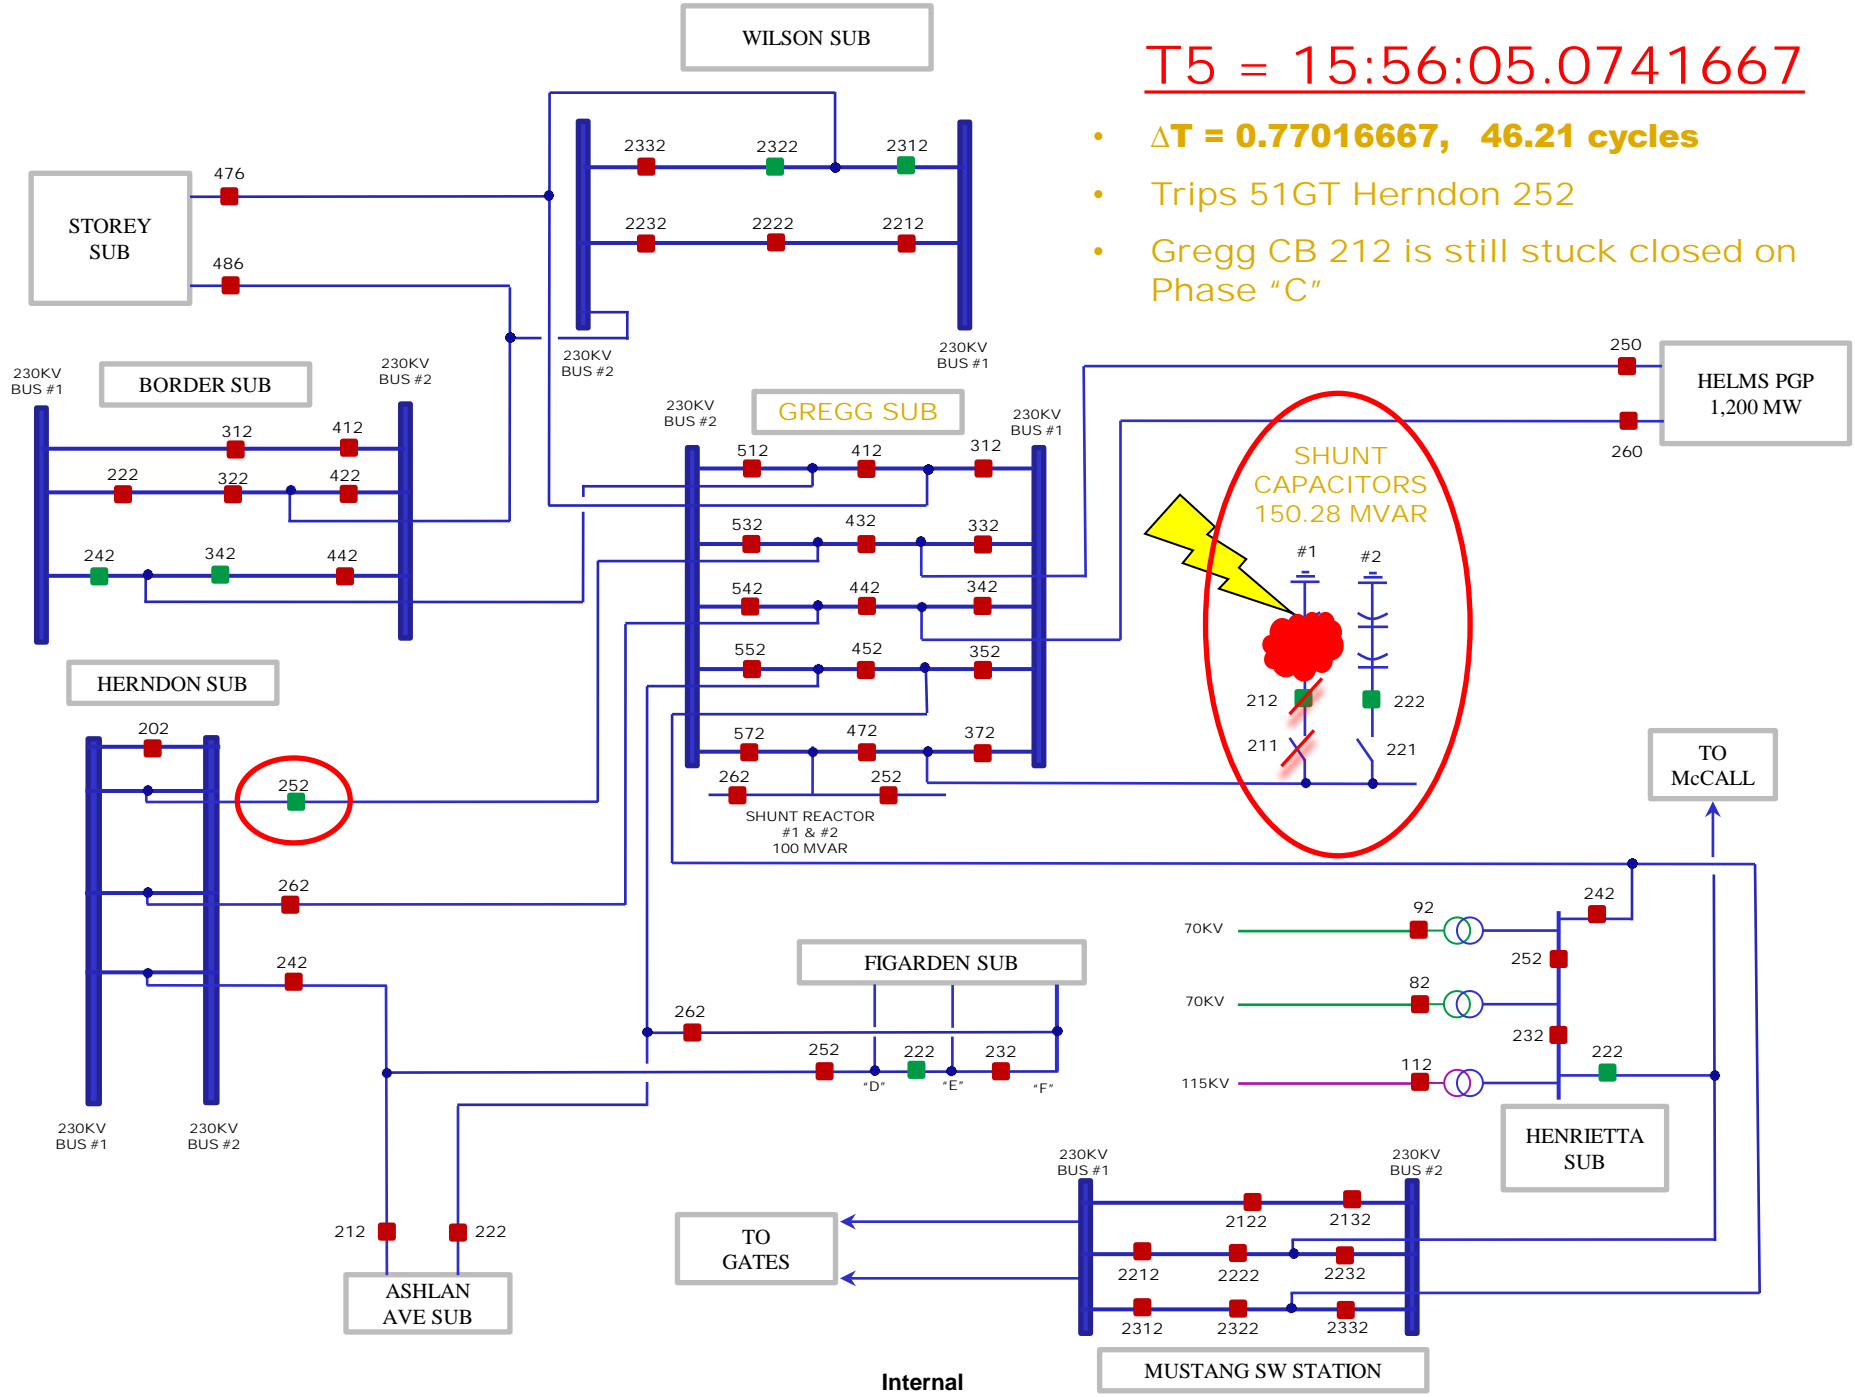
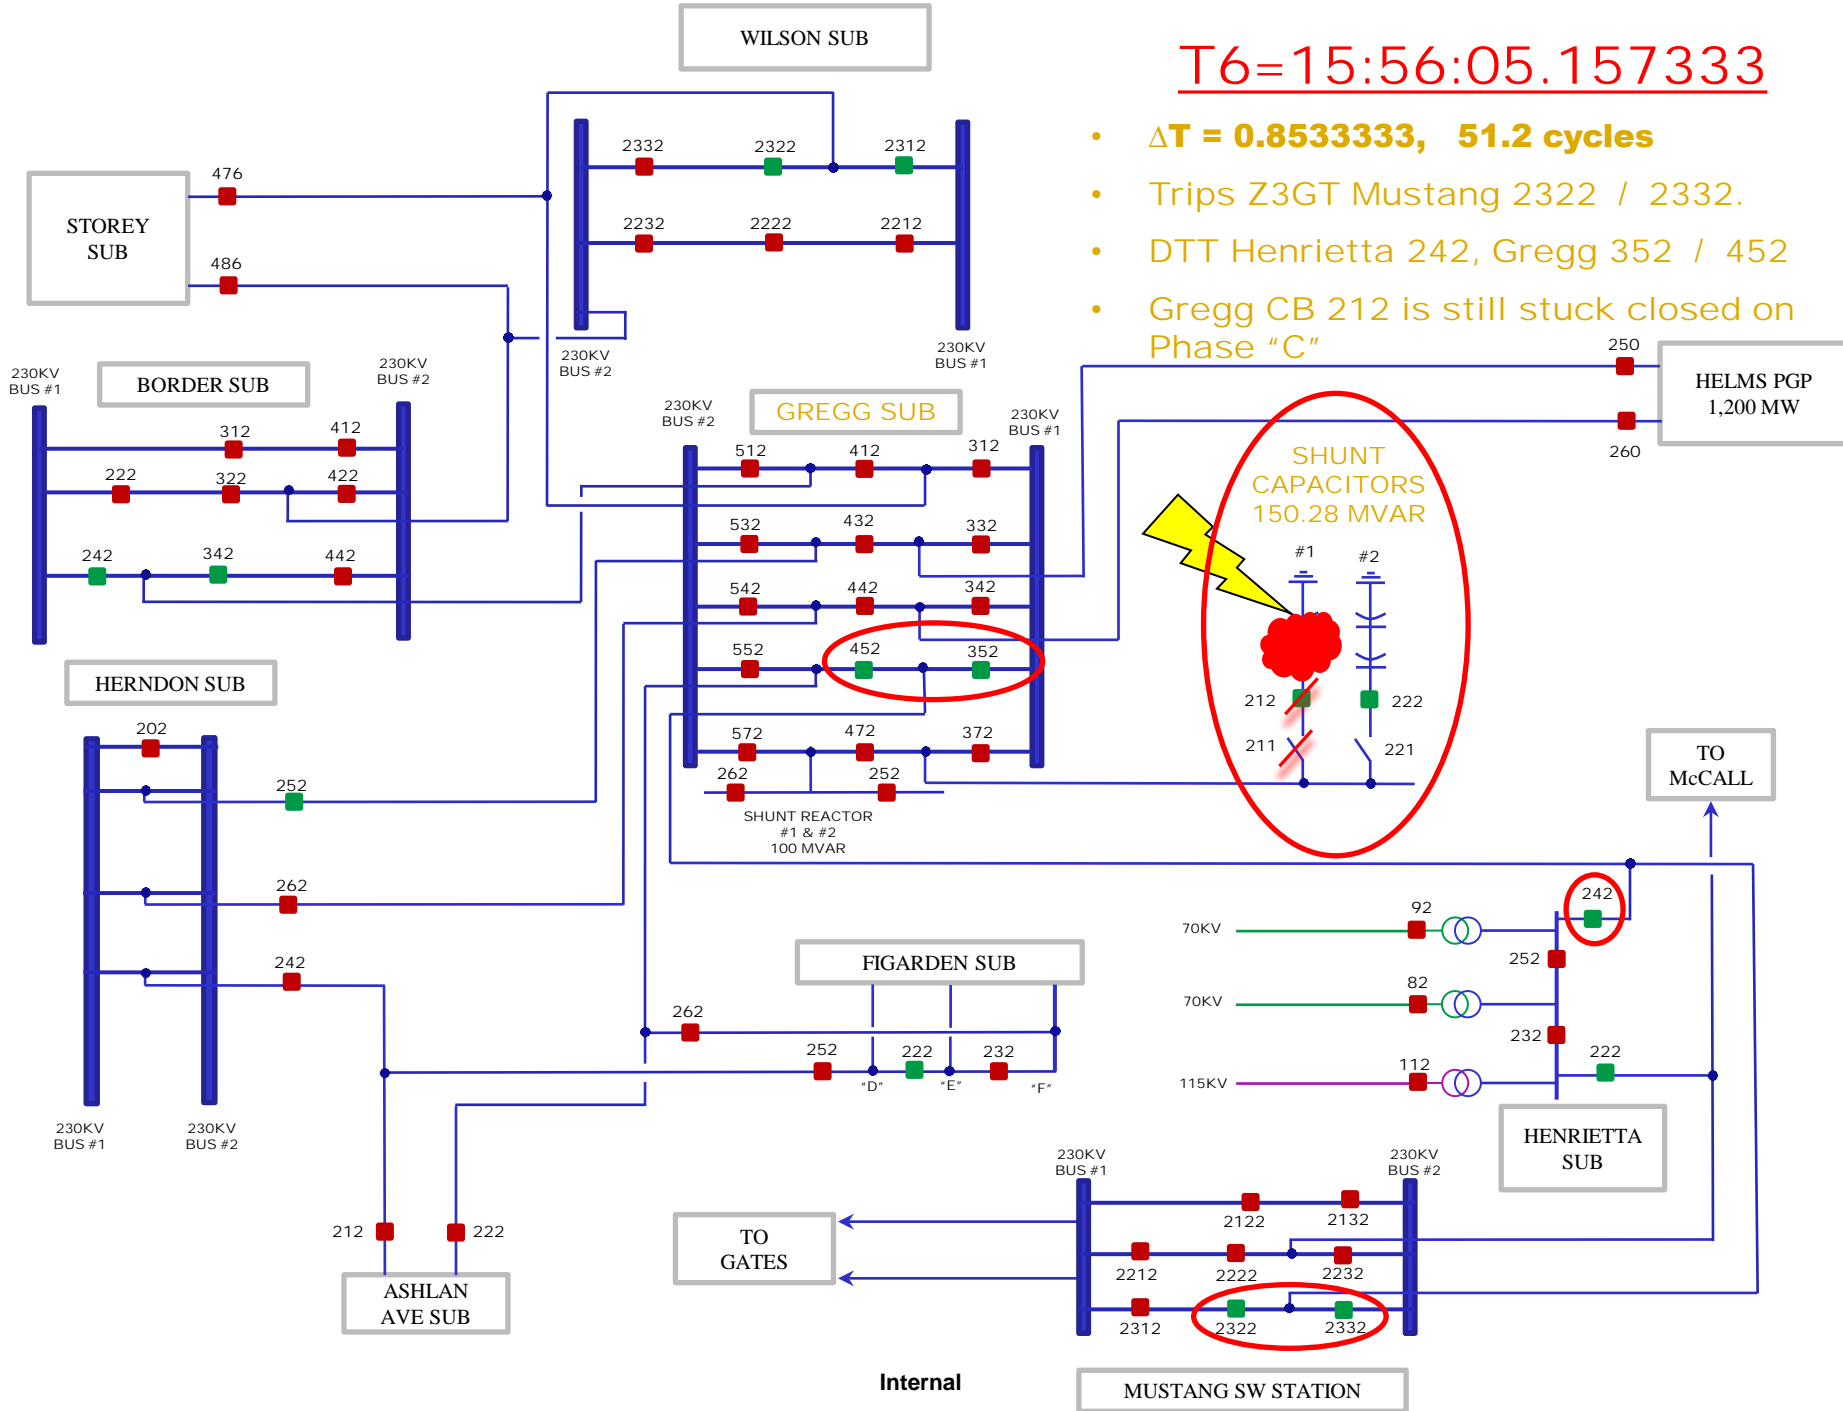
T5 = 15:56:05.0741667

- $\Delta T = 0.77016667$ , 46.21 cycles
- Trips 51GT Herndon 252
- Gregg CB 212 is still stuck closed on Phase "C"
