FDA Conference April 30 to May 1, 2018

# Gregg 230 kV SS Shunt Capacitor Bank Failure and Cascading Area Disturbances

Leo B. Hisugan, P.E., Supervising Protection Engineer, PG&E  
Aaron M. Feathers, P.E., Principal Protection Engineer, PG&E

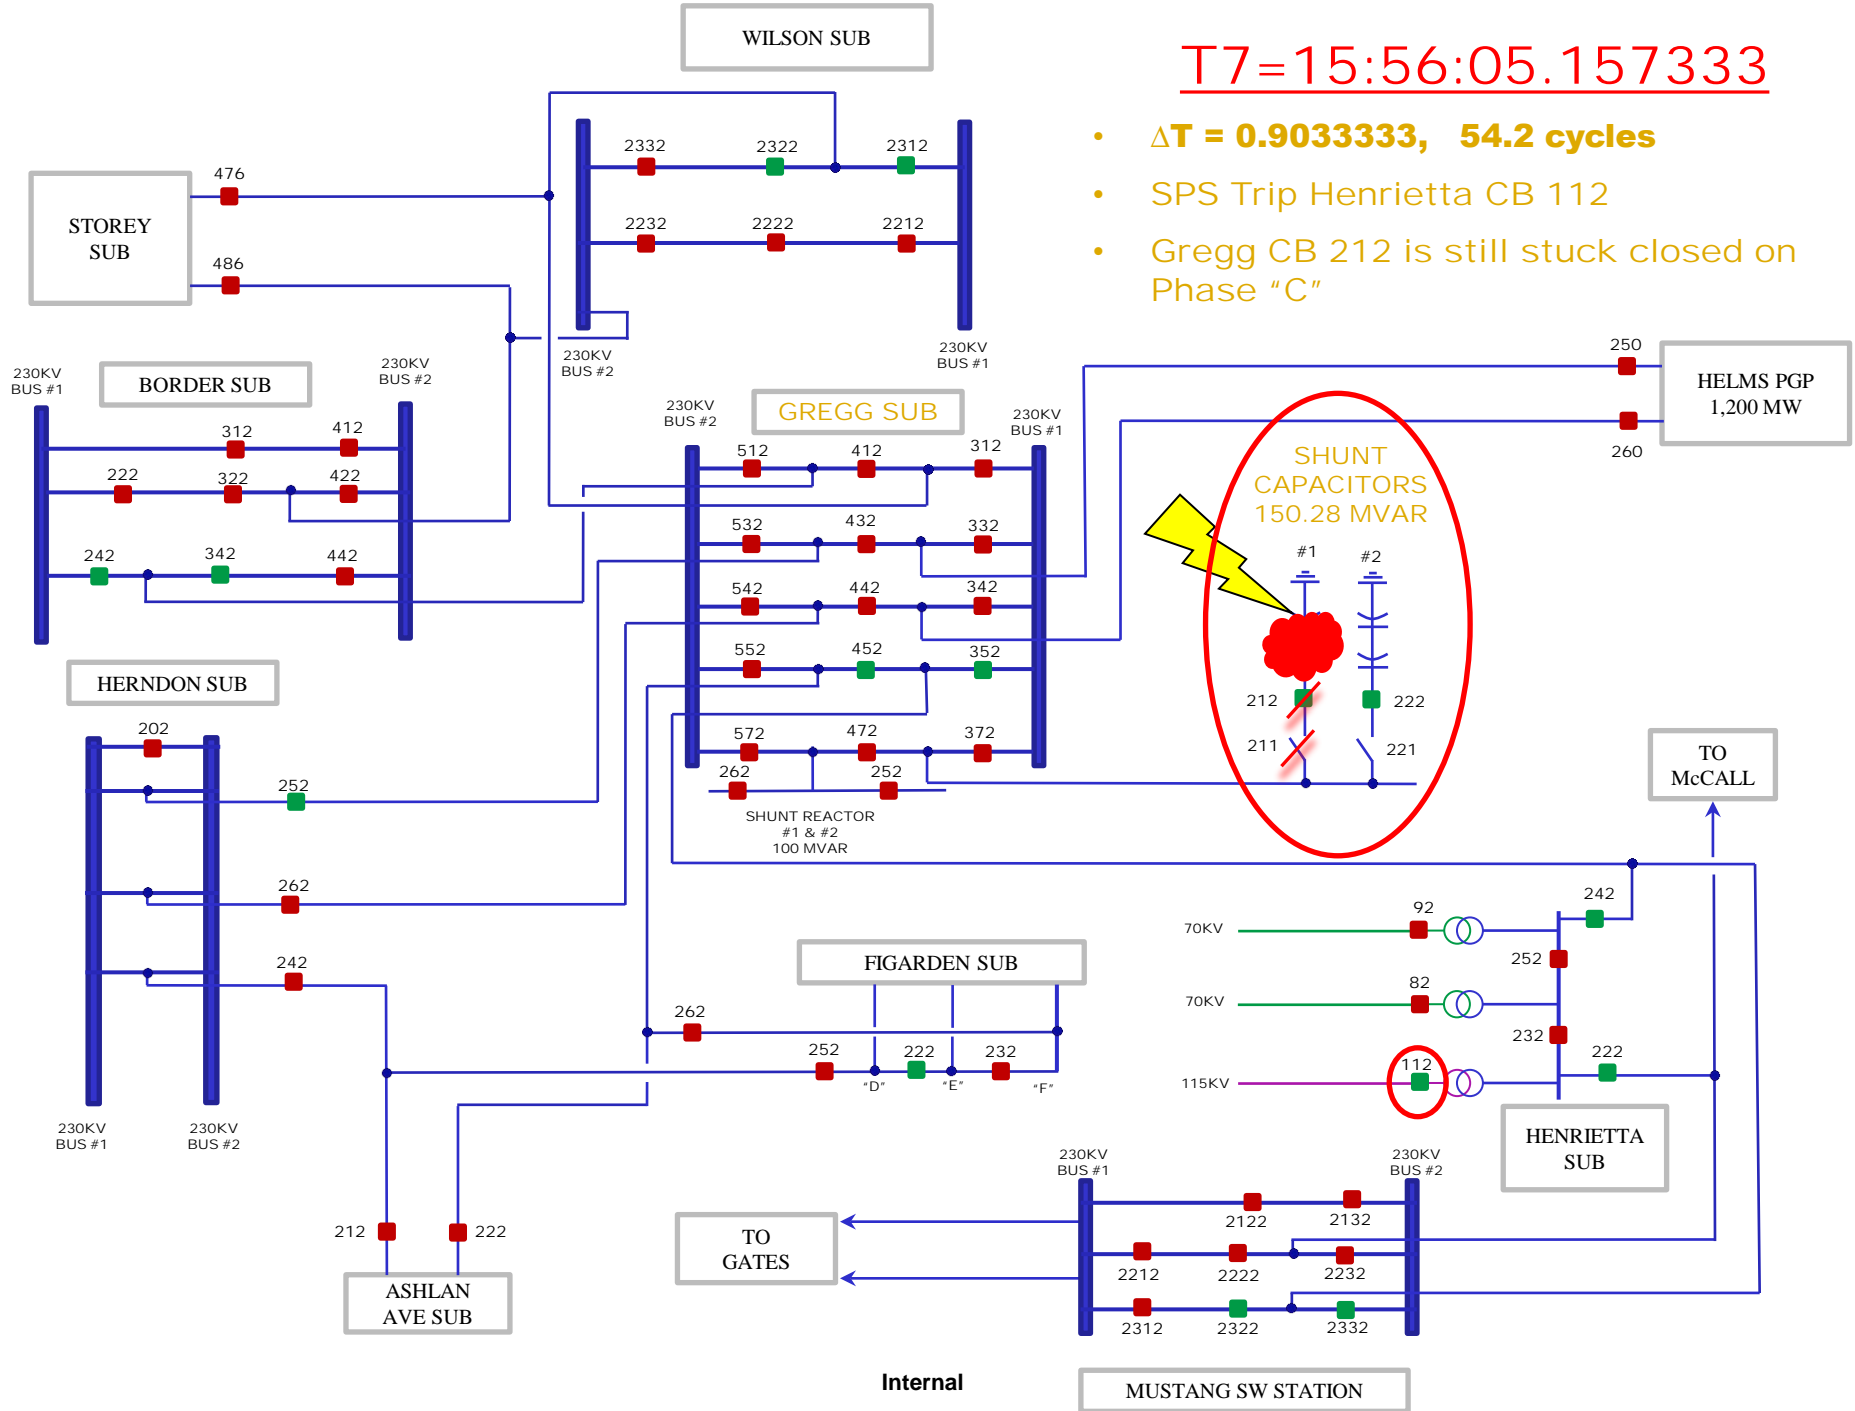
T7=15:56:05.157333

- $\Delta T = 0.9033333$ , 54.2 cycles
- SPS Trip Henrietta CB 112
- Gregg CB 212 is still stuck closed on Phase "C"

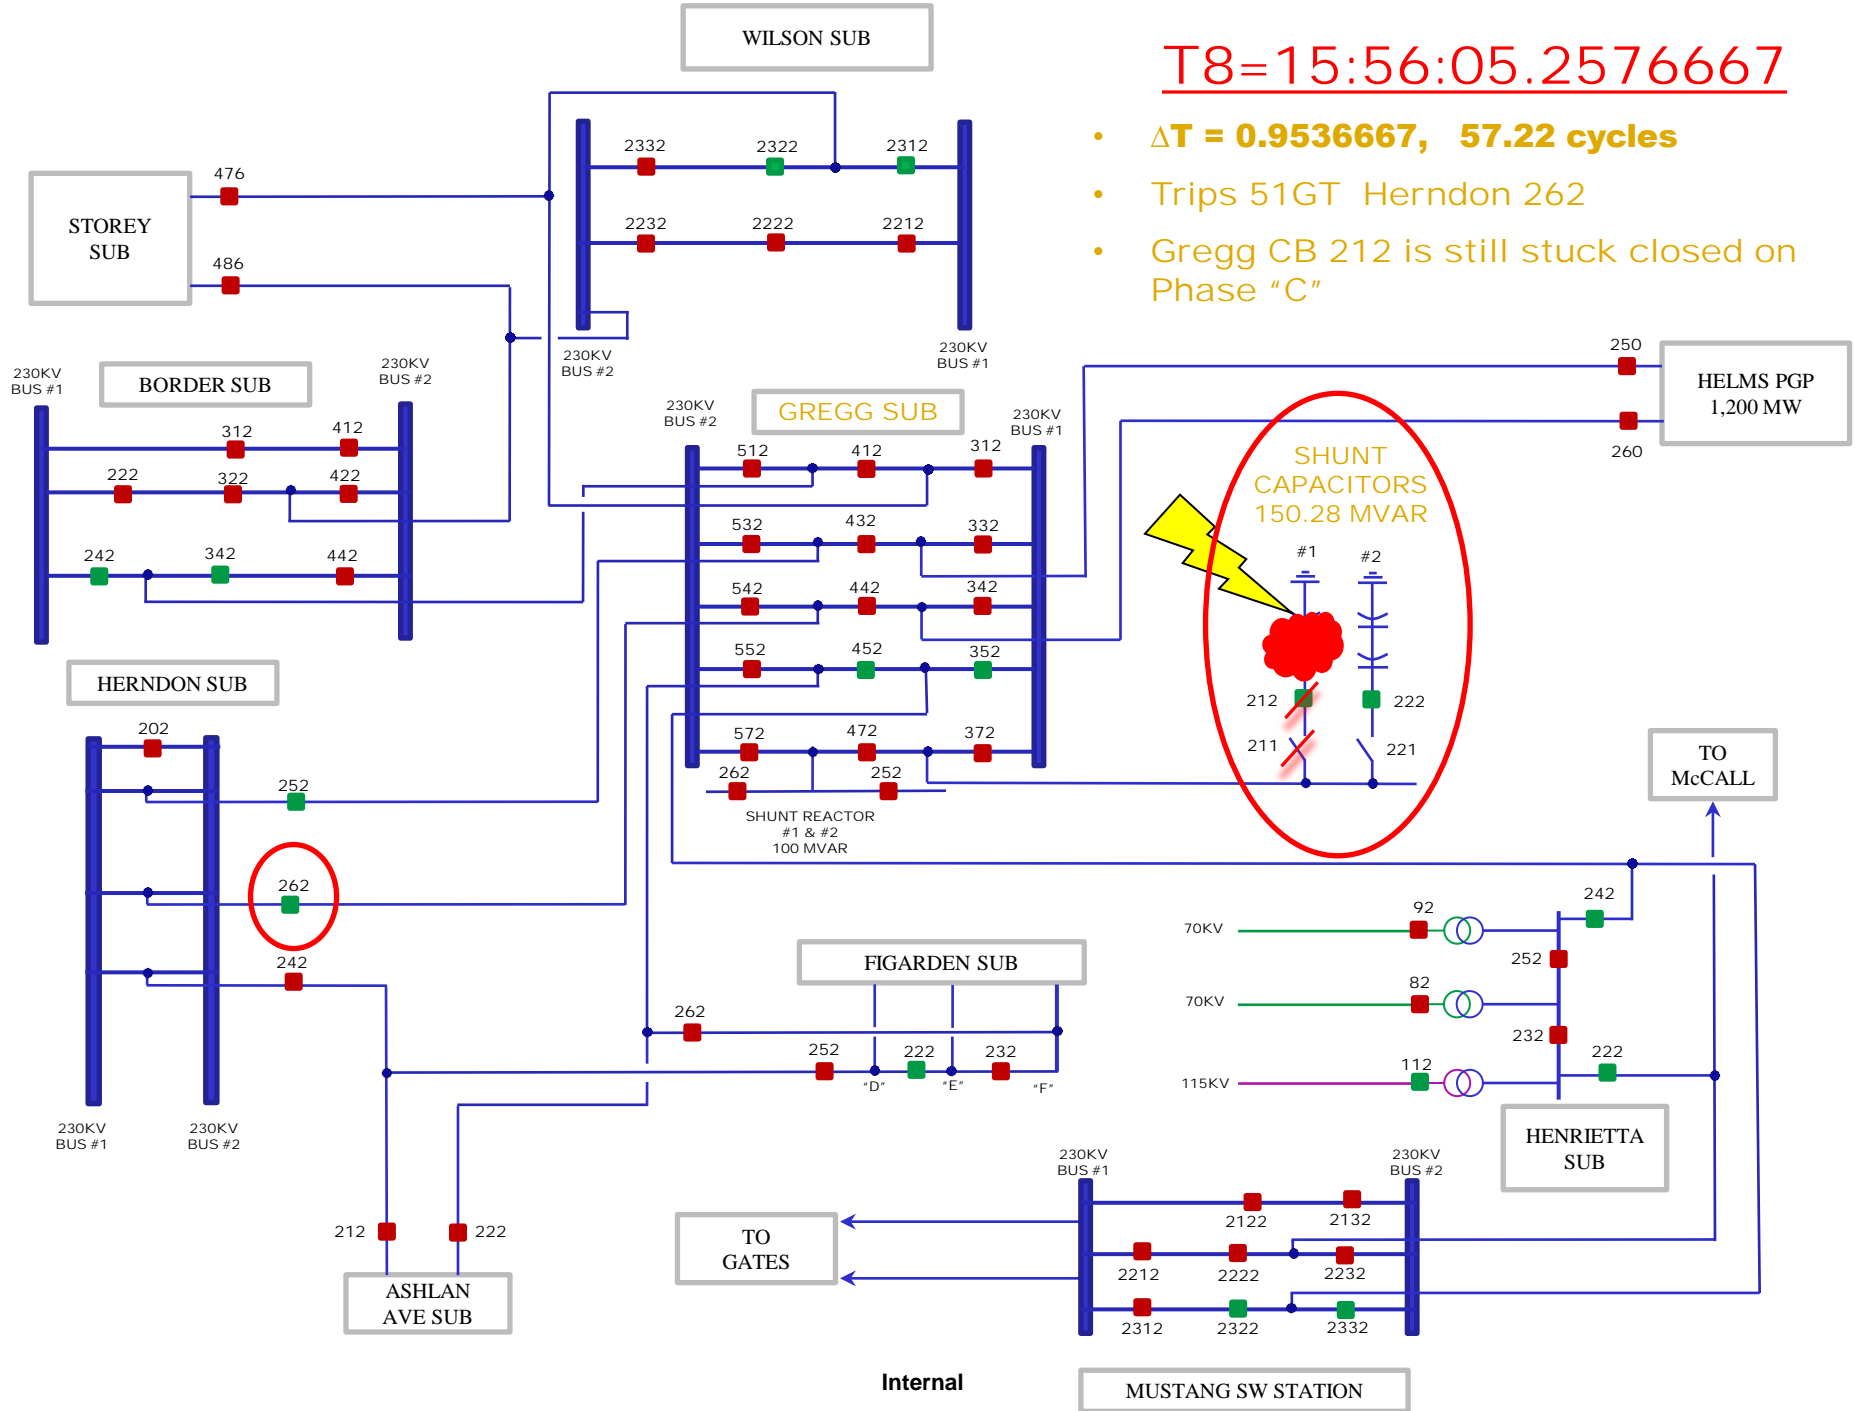
T8=15:56:05.2576667

- $\Delta T = 0.9536667$ , 57.22 cycles
- Trips 51GT Herndon 262
- Gregg CB 212 is still stuck closed on Phase "C"

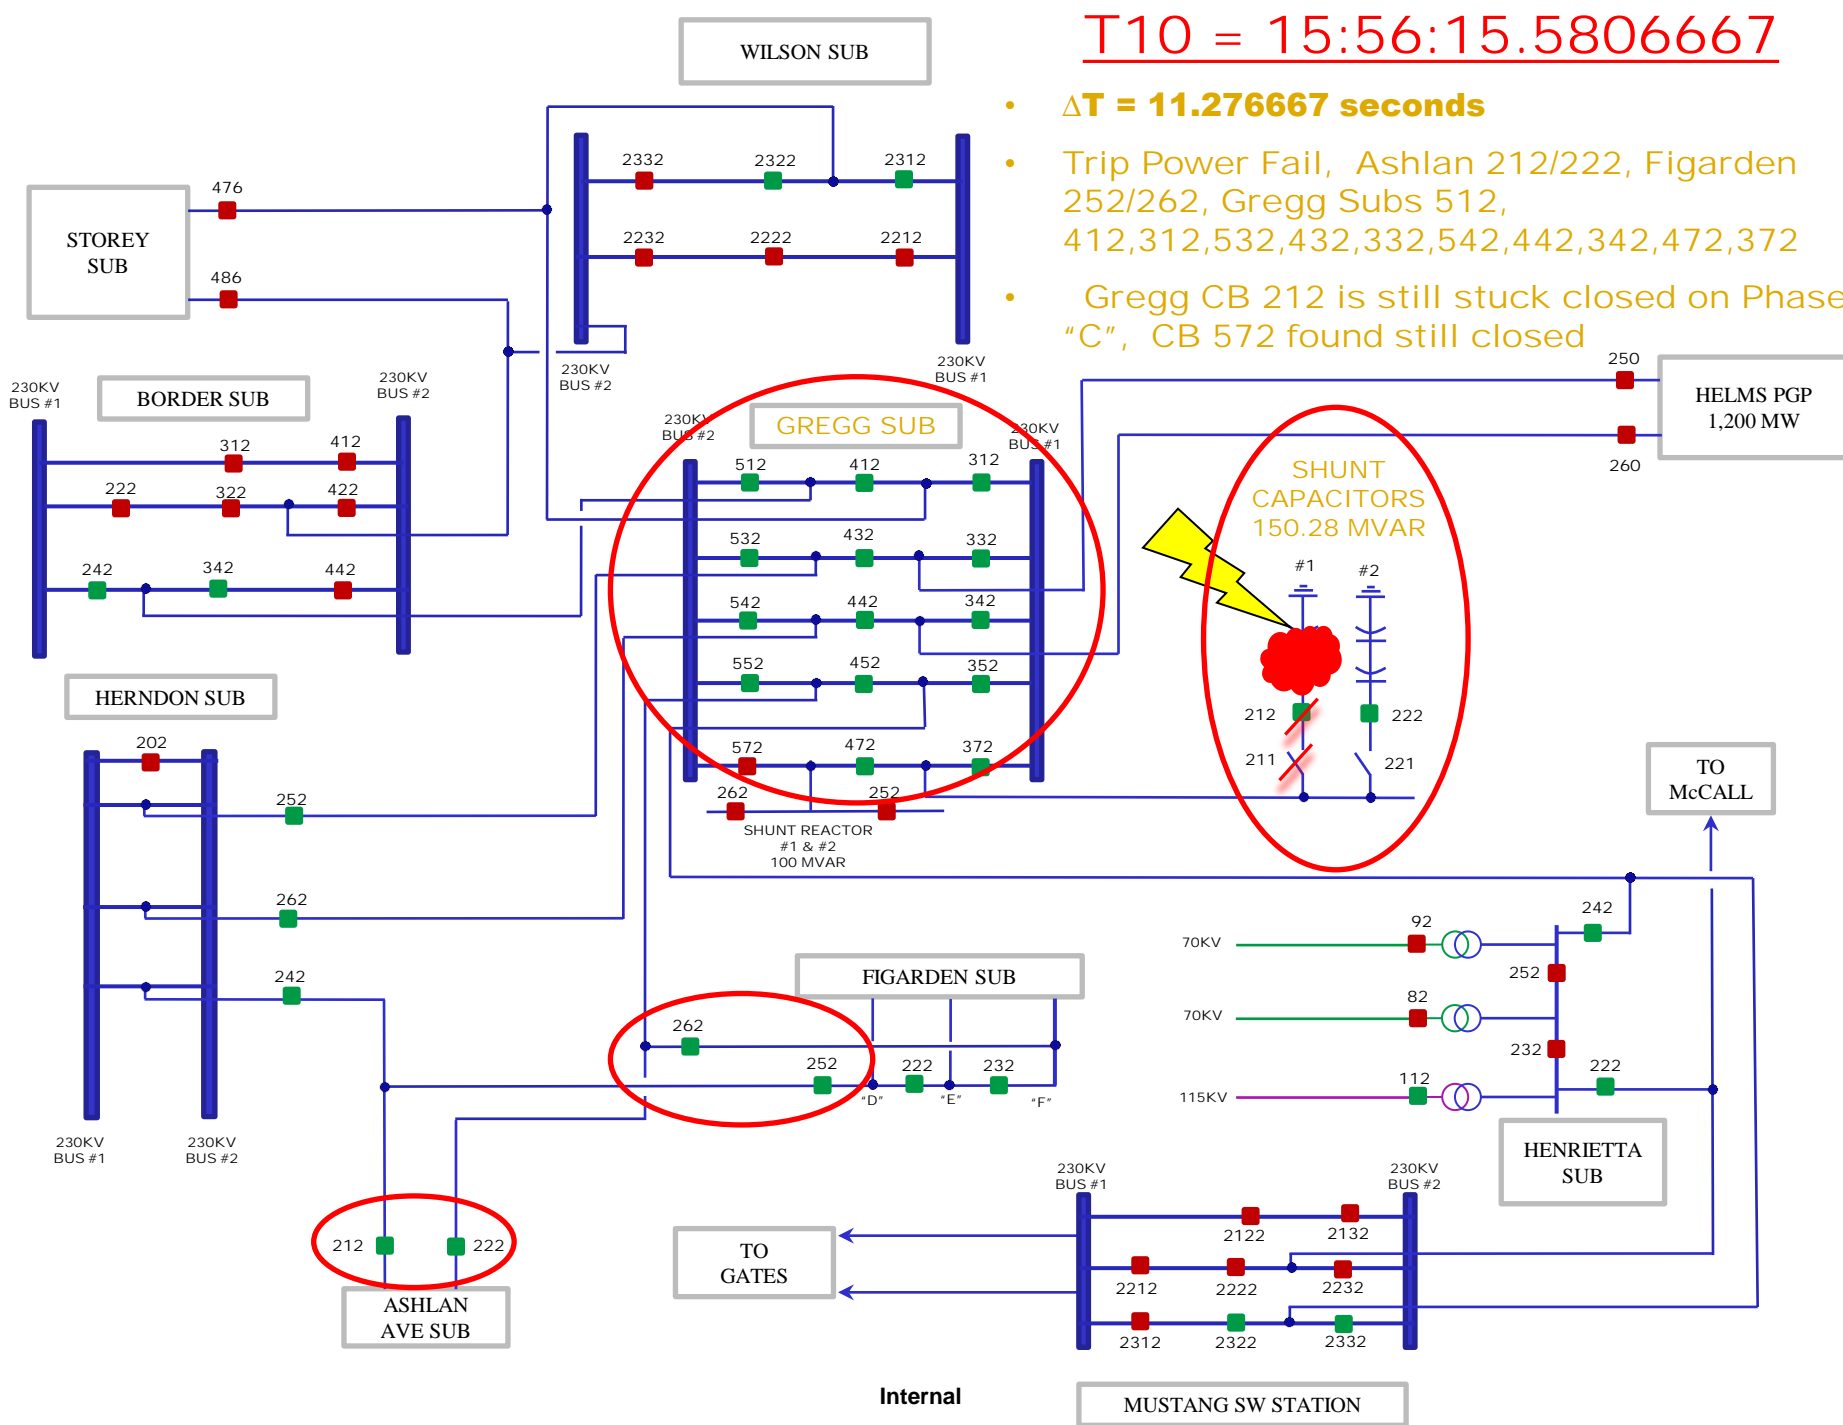
T10 = 15:56:15.5806667

- $\Delta T = 11.276667$  seconds
- Trip Power Fail, Ashlan 212/222, Figarden 252/262, Gregg Subs 512, 412, 312, 532, 432, 332, 542, 442, 342, 472, 372
- Gregg CB 212 is still stuck closed on Phase "C", CB 572 found still closed

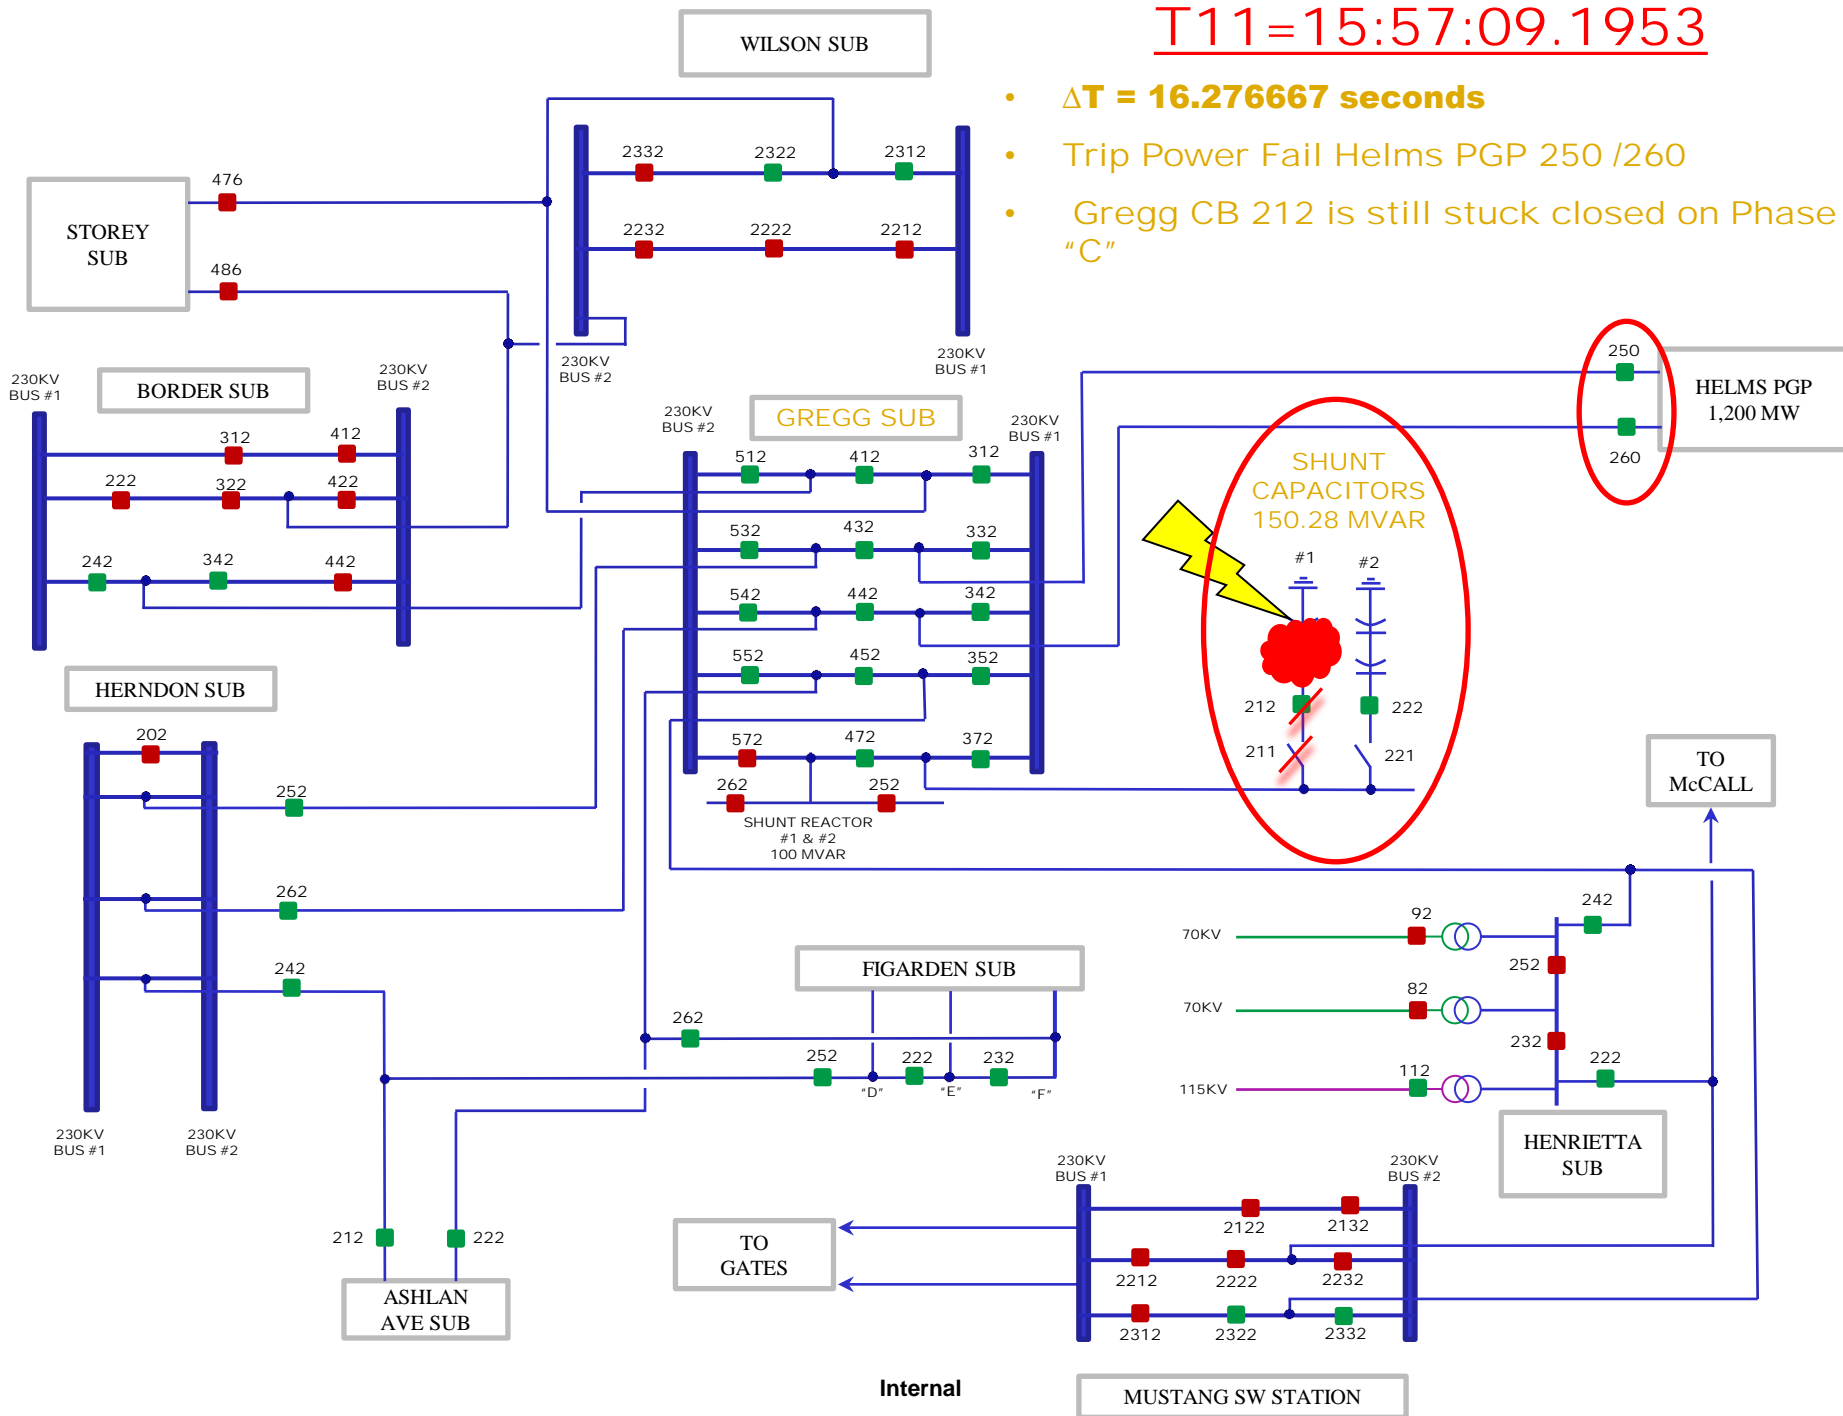
T11=15:57:09.1953

- $\Delta T = 16.276667$  seconds
- Trip Power Fail Helms PGP 250 /260
- Gregg CB 212 is still stuck closed on Phase "C"

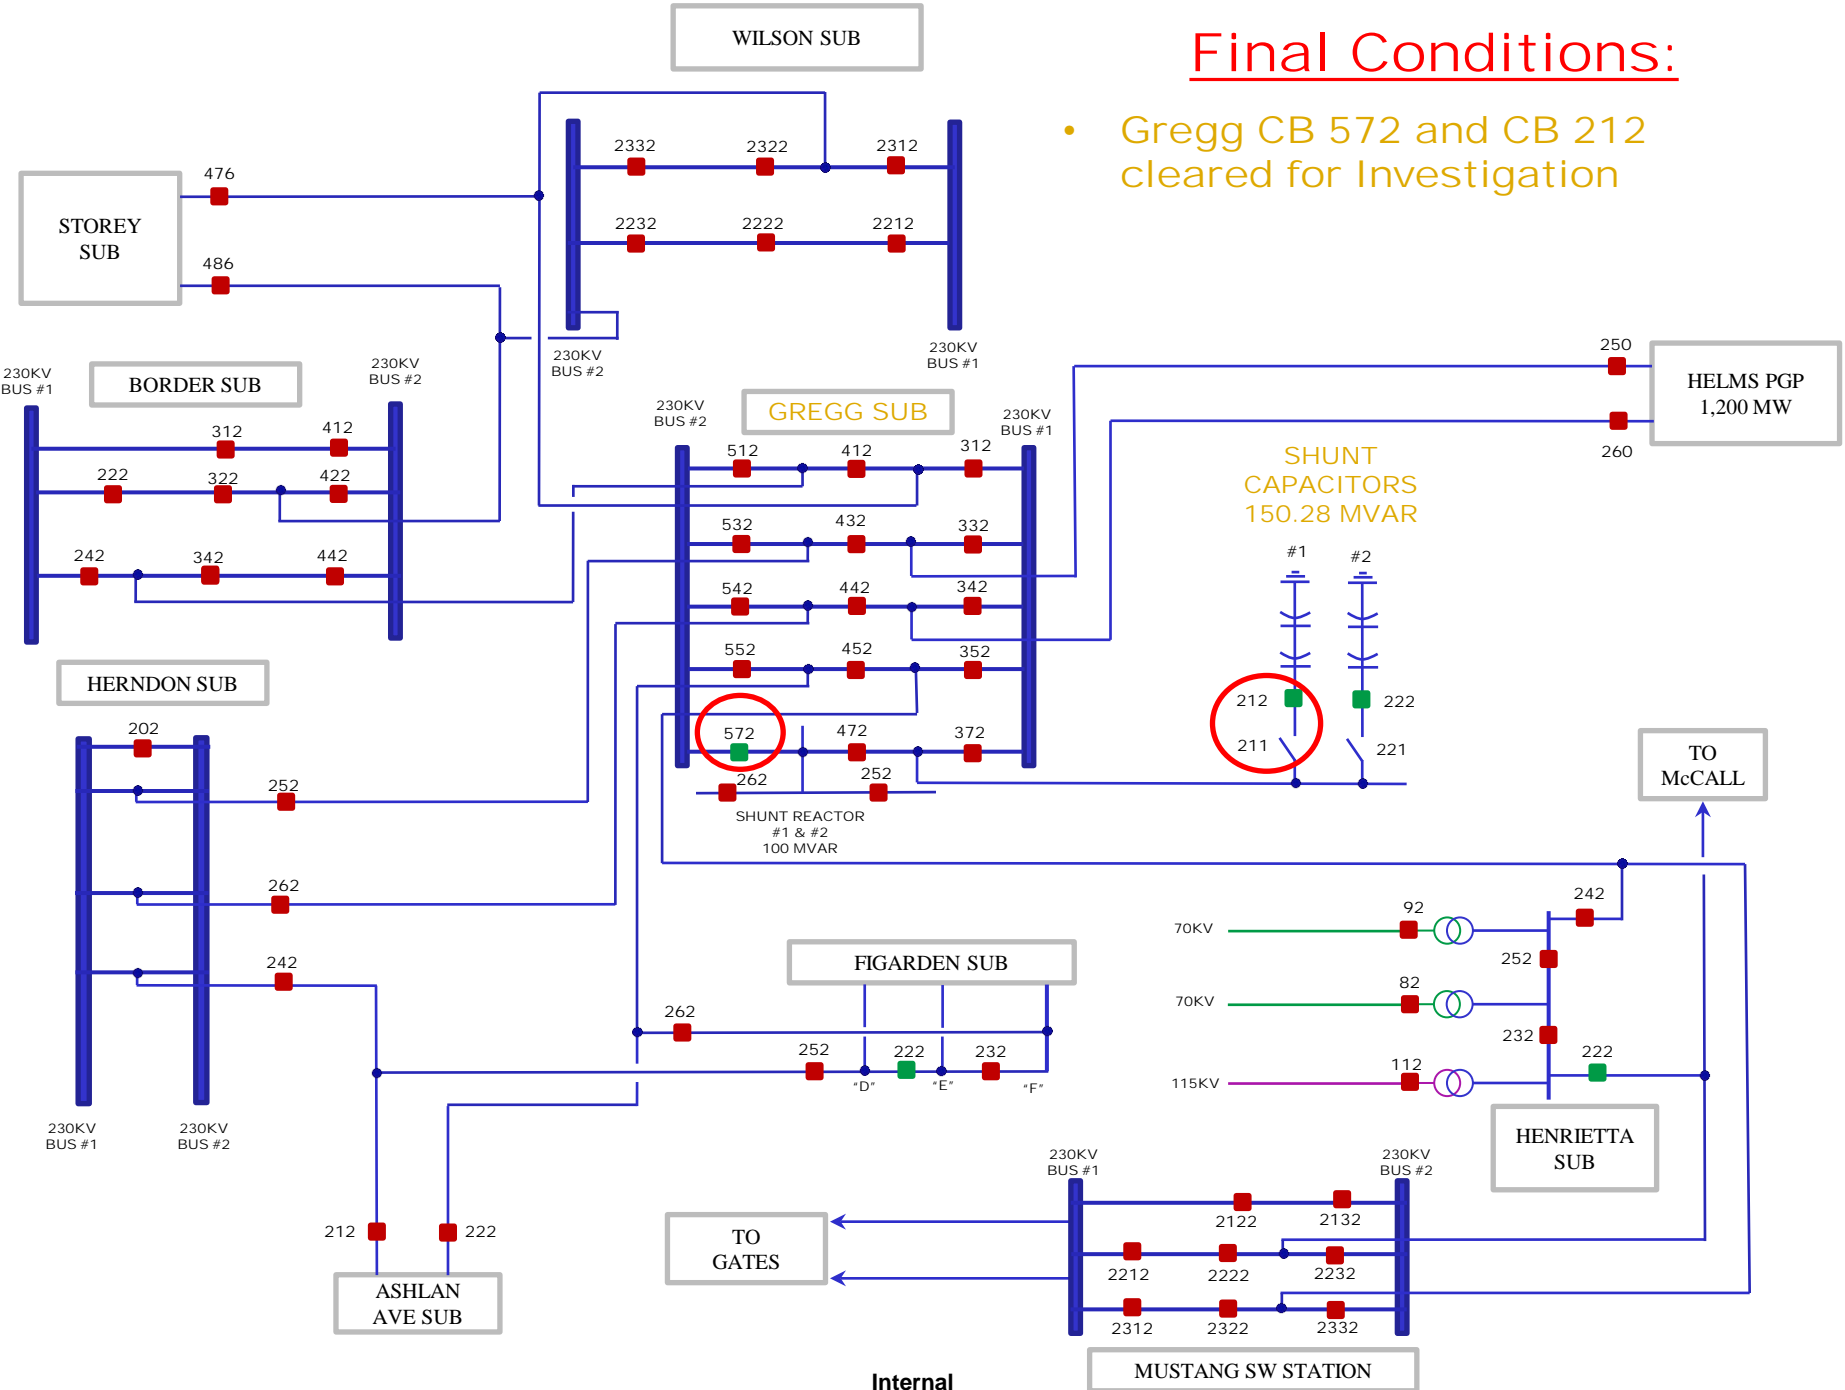
# Final Conditions:

- Gregg CB 572 and CB 212 cleared for Investigation

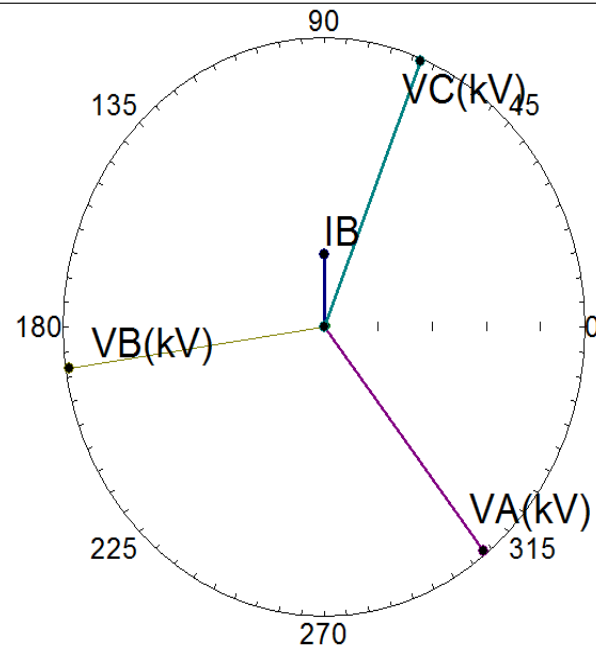
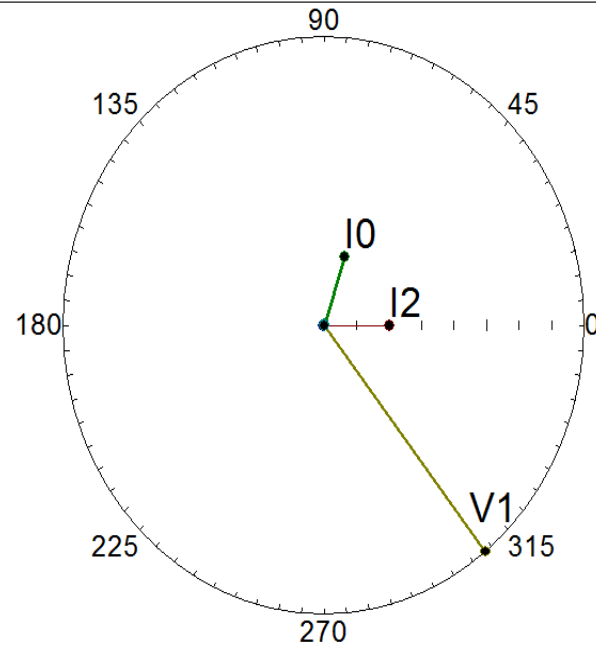
# PRE-FAULT VOLTAGE, $3V0 = 0\text{ V}$ , $VS = 0\text{ V}$ , $VB = 137.4\text{ KV}$

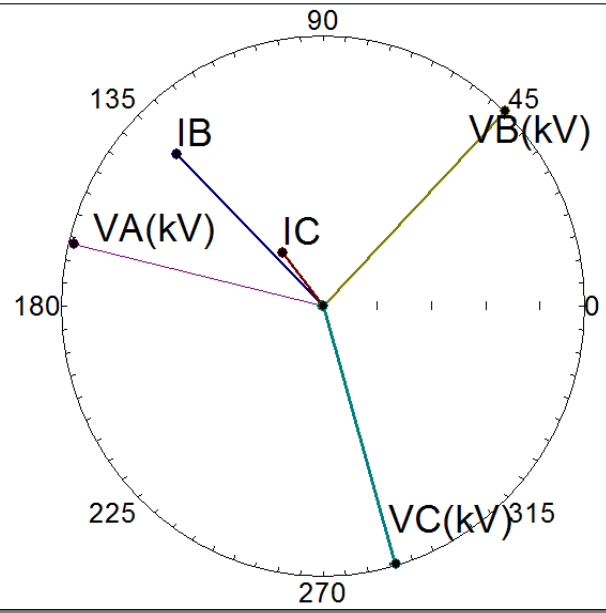
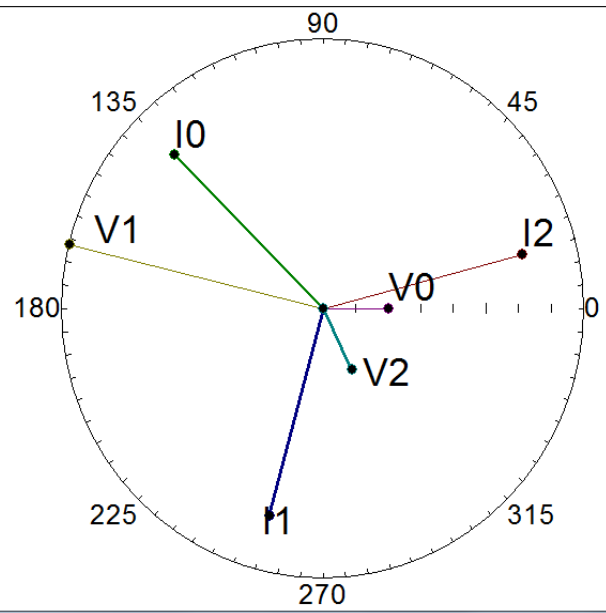
FAULT VOLTAGE CB 212 DEV 267-C1 , 3VO = 3X 800V = 2400 V ,  
VS = 1100 VOLTS , VB = 139.4 KV , DIFF = 2000 VOLTS

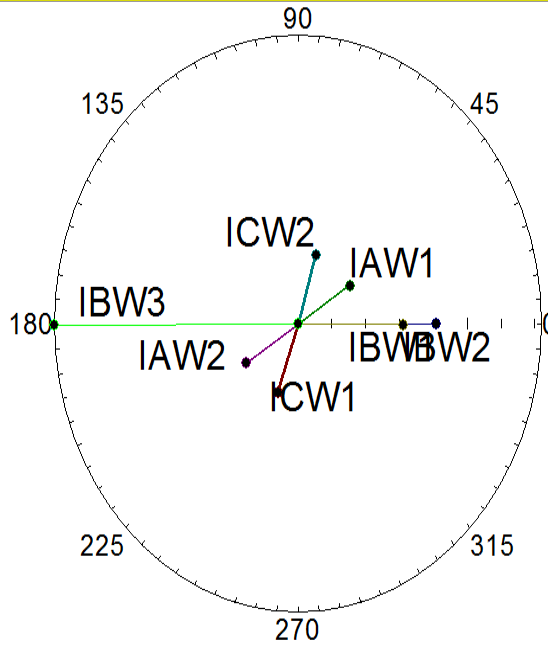
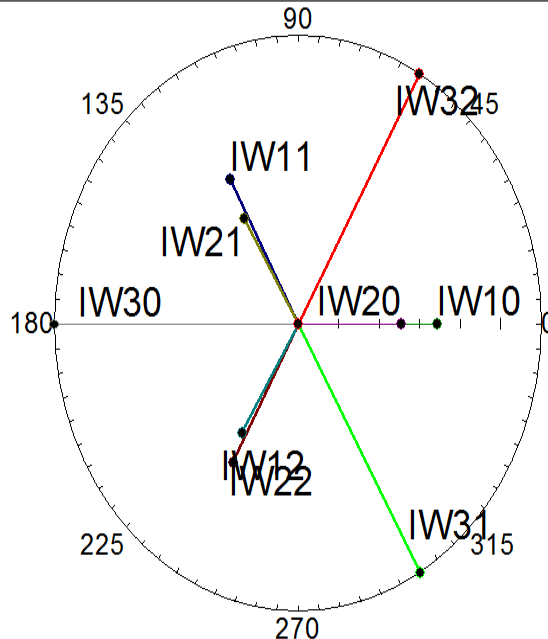
# CB 212 IBW3 = 36.1 X 400 CTR = 14,440 AMPS FAULT CURRENTS TO CAPACITOR BANK 1
