The Blimp Event of 2015

Description and Analysis of the Outages caused by a runaway blimp on PPL Electric Utilities Transmission System

Glenn Bray, PPL Electric Utilities

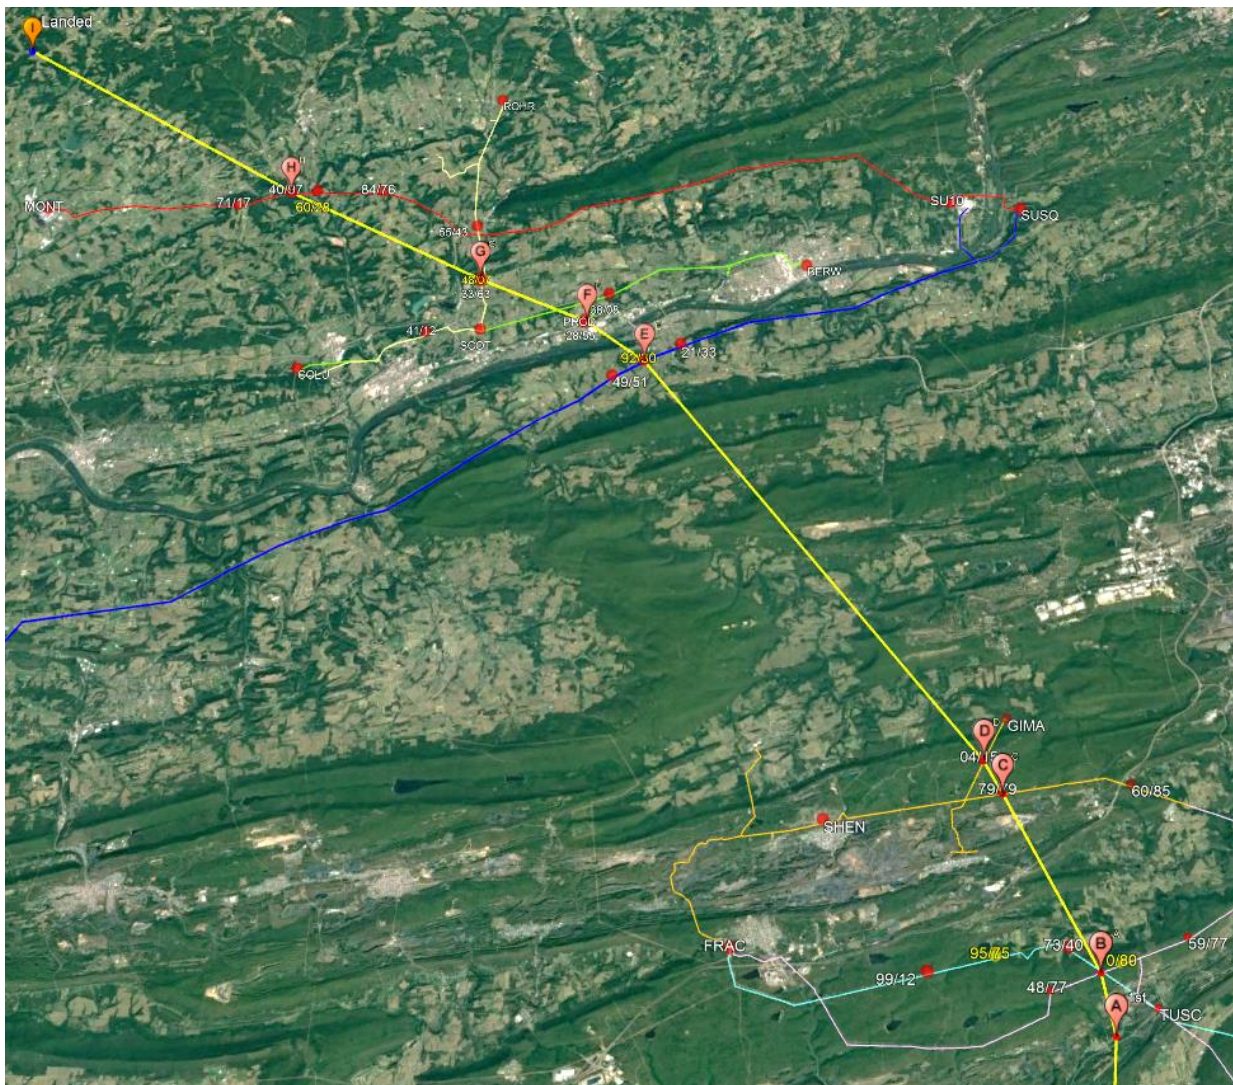
Figure 1 – Blimp Tether Contact Locations

While the weather was rainy, surface winds were generally from the southeast, averaging 15 to 25 mph. However, at altitudes above 5,000 feet, the winds were 50 mph and greater from the south.^[2] This explains the blimp's trajectory of traveling due north and then changing to a northwest direction as it descended (Figure 2). The blimp slowed during the line contacts and significantly slowed when its tether began dragging on the ground. Via Google Earth, the blimp's tether contact locations and the nine transmission lines are shown in Figure 1.

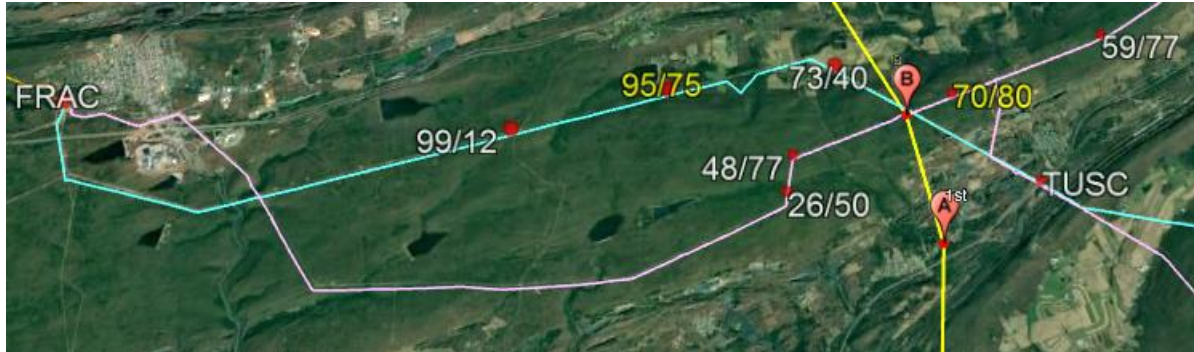
Figure 3 – Hauto-Frackville-1 (pink) and Frackville-Siegfried (light blue) Lines

Utilizing short circuit simulations, both the ground and phase-to-phase fault values from the distributed event recorder (DER) on the Hauto-Frackville-1 line yielded an estimated fault location of 11.8 miles from Frackville at structure 46870s53080 (70/80). The patrol area was from 48/77 to 59/77 and included the Tuscarora Tap (Figure 3).

Utilizing fault values from the Frackville DFR, the estimated fault location for Siegfried-Frackville 230kV line was 8.0 miles from Frackville at structure 415195s53075 (95/75). The patrol area was from 99/12 to 73/40 (Figure 3). The helicopter patrol, performed the following day, did not discover any findings for either the line in the listed patrol areas.

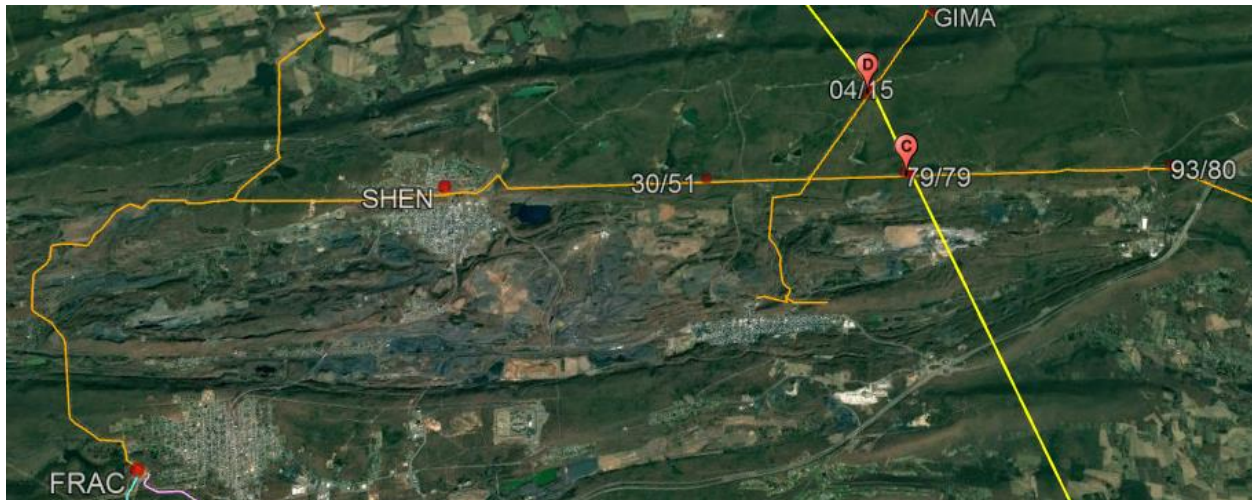
Figure 4 – Frackville-Shenandoah Line

With short circuit simulations, both the ground and phase-to-phase-ground faults yielded the same approximate location, 12 miles from Frackville at structure 45179/S55279 (79/79) and 44904s55715 (04/15) on the Girard Manor Tap. There were two possible fault locations, both with a distance of 12 miles from Frackville. The patrol areas were from 30/51 to Girard Manor (GIMA) sub and from 30/51 to 93/80 (Figure 4).

The foot patrol, performed a few hours after the operation, discovered structures with broken overhead ground wire (OHGW), conductor, and pole damage around structure 04/15 (Placemark D) on Girard Manor Tap (11.7 miles from Frackville). Helicopter patrol found nothing additional in the other patrol area for structure 79/79 (Placemark C). In order to restore power quickly, temporary repairs were made that night. The following permanent repairs were completed in July 2016 when outage conditions allowed:

- Replacement of OHGW between structures 44905s55715 and 44868s55628 (4 spans)
- Repair of the pole top damage at structure 44894s55687
- Replacement of middle phase conductor (2,800 feet) between 44905s55715 and 44894S55687

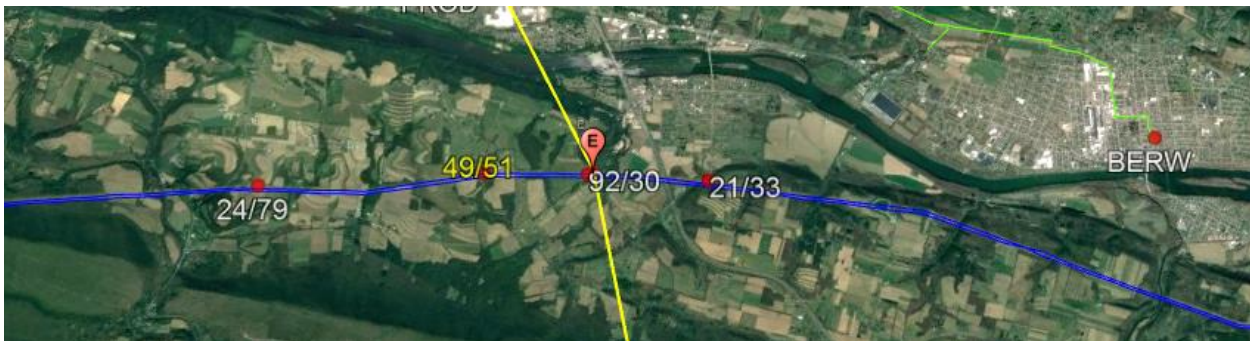
Figure 6 - Sunbury-Susquehanna 230kV line and 500kV lines

Approximately 20 minutes after the last line operation, the tether came in contact with Sunbury-Susquehanna 230kV and 500kV lines which are on separate towers but in the same right-of-way. The 500kV line was contacted first at 13:57:22 EDT and did not reclose while the 230kV tripped once and reclosed at 13:57:31 EDT.

For the initial analysis, short circuit simulations were performed utilizing DFR records that were accessed remotely from both substations. The estimated fault location was 30 miles from Sunbury at structure 39049n30851 (49/51). The patrol area was from 24/79 to 21/33 (Figure 6). At 17:10 EDT, field crews reported that portions of the tether were entangled around both lines and remnants were on the ground at structure 92/30 which was 31.44 miles from Sunbury (Placemark E) as shown in Figure 7. The following day, the sections of tether from both lines were removed during the helicopter inspection.

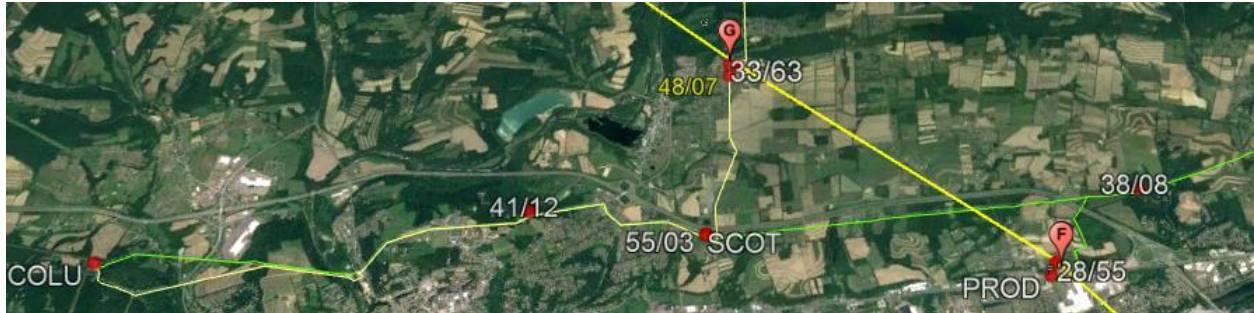
Figure 11 - Columbia – Berwick (green line) and Columbia - Scott (yellow line)

The event record from the Columbia-Scott relay listed a B phase-to-ground fault with a magnitude of 3163A and a fault distance 6.74 miles. Short circuit simulations estimated a fault distance of 7.4 miles from Columbia substation at structure 36848n32307 (48/07). The patrol area was from 41/12 to 55/43, as listed in Figure 11.

Noting the proximity of the lines, the blimp's tether should have contacted Columbia-Berwick at a similar fault location as Columbia-Scott. Based on that assumption, the patrol area was from 41/12 to 38/08 including Products Tap (Figure 11).

For Columbia-Berwick, foot patrol identified the static wire down on Products tap at 38528n31755 (28/55) which was 9.8 miles from Columbia and 7.8 miles from Berwick (Placemark G) as listed in Figure 11. The static wire sustained significant damage as shown in Figure 13. Helicopter patrol discovered no findings in addition to downed static wire; repairs were completed the following day. The relay event record from Berwick was retrieved weeks after the event. The relay record listed a B-phase-to-ground fault with a magnitude of 1,356A and a fault distance 9.30 miles. Short circuit simulation provided an estimated fault distance of 8.2 miles from Berwick.

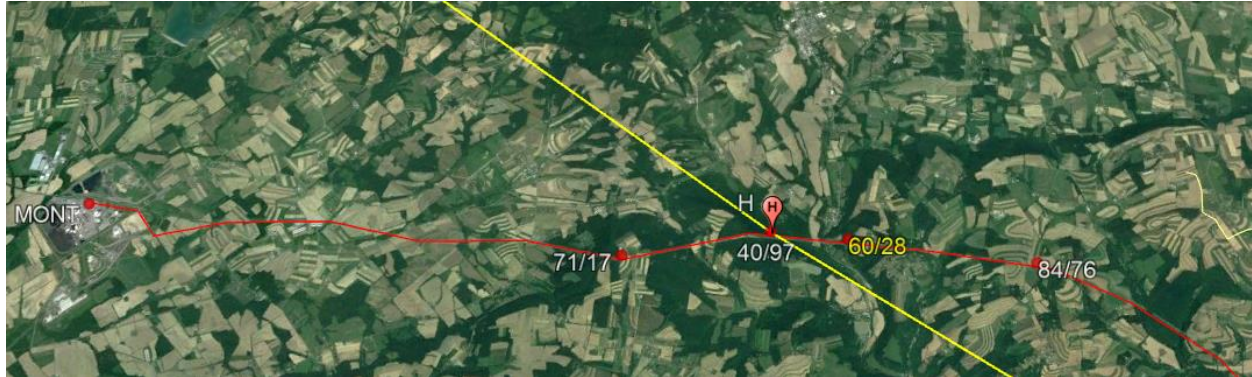
Figure 14 - Montour-Susq T10 and Montour-Susquehanna 230kV lines

At 14:36:34 and 14:36:56 EDT, the tether made contact with Montour-Susquehanna T10 and Montour-Susquehanna 230kV lines, respectively. Both lines did not reclose and both occupy same steel lattice tower structure. At this point, the blimp significantly slowed down.

For both lines, short circuit simulation using the DFR fault values resulted in a fault distance of 8 miles from Montour substation at structure 60/28. The patrol area was from 71/17 to 84/76 (Figure 14). Helicopter patrol found a piece of the tether attached to the line extending to the ground near structure 40/97 which was 7.3 miles from Montour (Placemark H) as shown in Figure 15. No foot patrol was performed on this line.

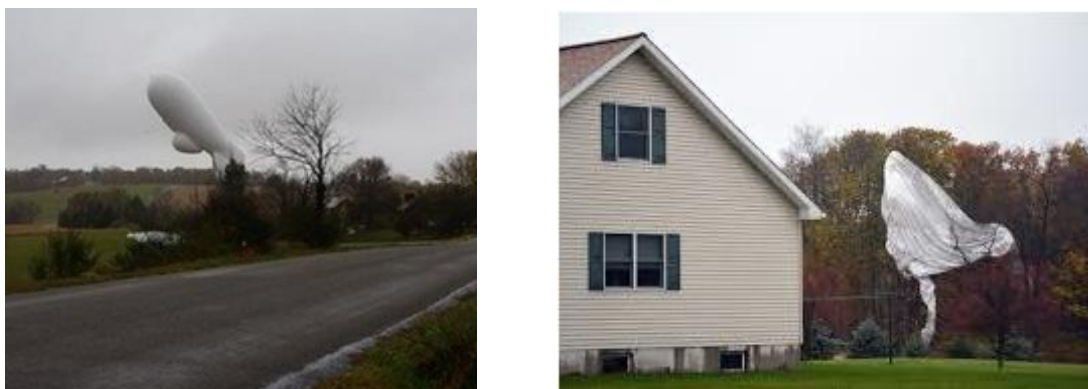
After the last transmission line contact, the blimp significantly slowed. There were reports of the blimp skimming treetops, damage to residential property damage, and tether marks. Around 15:45 EDT, Pennsylvania State Police reported that the blimp was brought down in a group of trees near a field in Anthony Township ^[3] (Figure 17), which is 10 miles from the last line contact. When the blimp went down, helium was still in the blimp’s nose. The state troopers fired shotgun rounds at the fallen blimp for it to fully deflate. ^[4] Local authorities secured the area and a military recovery team removed onboard electronics from the blimp. ^[4]

Figure 17 – Blimp Down in Anthony Township, PA (photos courtesy of WNEP)
