Analysis of Cascading Operations for Adjacent Line Faults At National Grid

By: Yujie Irene Lu, Song Ji & Scott J. Slaski (National Grid)

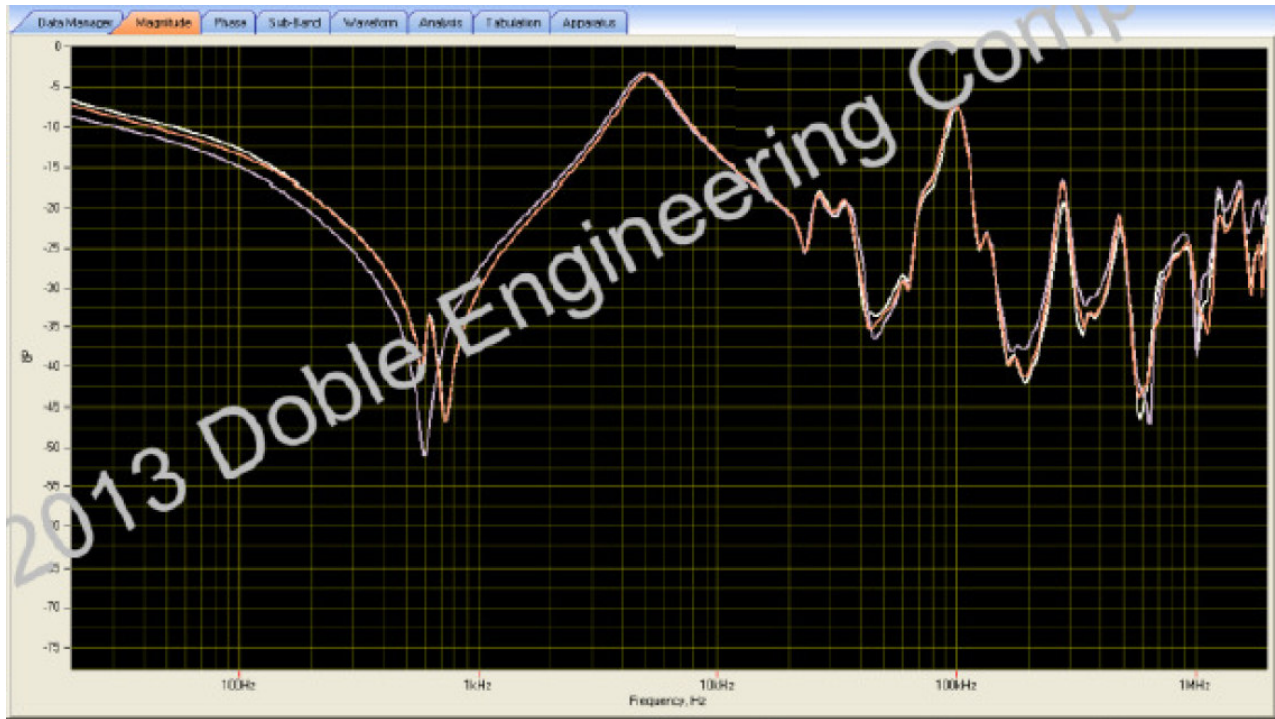
Figure 2: typical expectation of transformer SFRA results

A transformer Sweep Frequency Response Analysis (SFRA) test was performed by Doble Engineering on July 28th, 2013 on the Carp autotransformer. Doble and National Grid concluded that there is operational and testing evidence that the fault events have caused winding movement to the Carp #1 autotransformer since the time it was manufactured and sometime during the period between 2006 and 2013. The Doble SFRA testing indicates winding movement in the 13.2kV tertiary Y1-Y2 leg. The leakage Reactance testing performed on the same day and hinted the same winding movement happened that the SFRA highlighted ^[3]. The highlighted SFRA test result from Doble is listed in Figure 3.

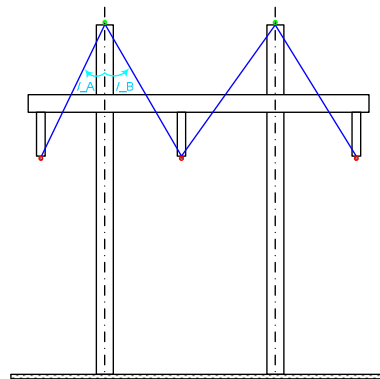
Figure 9: Typical 115kV line structure with dual overhead shield wires

Per DFR records, the first fault was phase B to C to ground and the second fault was phase B to ground only. 115kV line 73 is provided with dual overhead grounding shield wires. The typical 115kV NG line structure construction is shown in figure 8. The external and internal shielding angles are approximately 30 degrees, which are pursuant to the recommended shielding angles by IEEE Std. 998 - Guide for Direct Lightning Stroke Shielding of Substations.

Lightning strokes of low magnitudes (a few tens of kA) can bypass the overhead shield wire and can stroke directly on the phase conductor^[5]. The magnitude of second stroke was only 11kA and it was very likely the second line fault on line 73 was caused by direct lightning stroke on phase B conductor. To confirm the suspect, an EMTP simulation was performed to verify the overvoltage stress at line structure insulator and breaker 73 B-phase main contact.

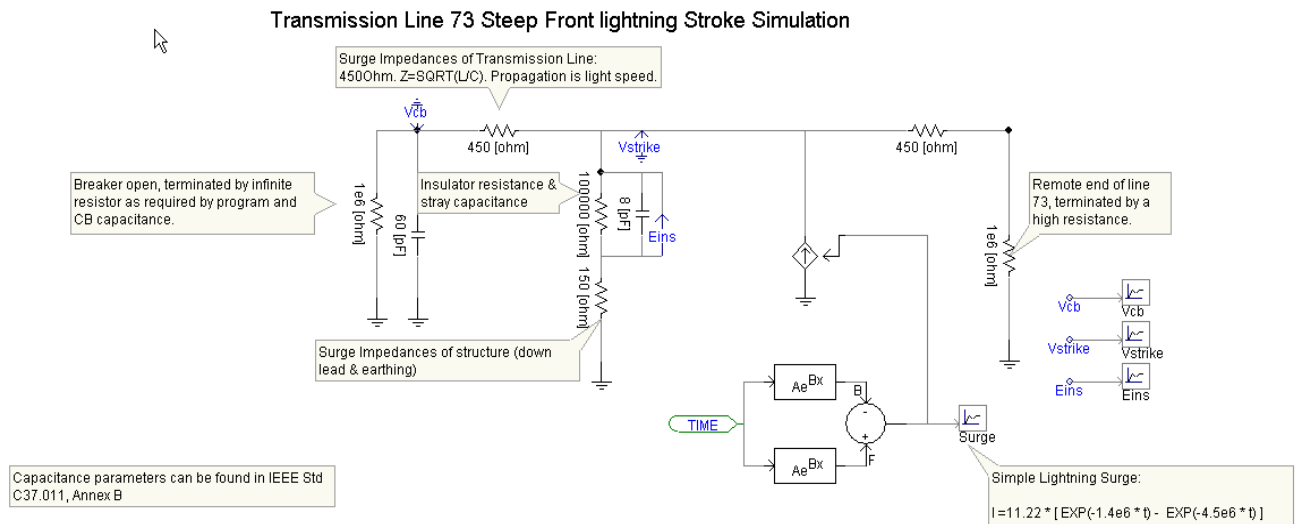
Figure 13: The modeling for the second lightning stroke simulation

A simplified model was made for the second direct lightning stroke on 115kV line 73 in PSCAD/EMTDC program. A lightning surge with 11kA magnitude was introduced to B-phase conductor of line 73. To simplify the study, the lumped parameters were used for the different system components.

The voltages for the insulator string at the nearest direct stroke structure and breaker 73 at substation are monitored. The simulation was performed in PSCAD to find out the voltage distribution right after the stroke. From the simulation, it can be seen that the voltage on the line side of main contact of the breaker started to rise and the voltage gradually reached to approximately the peak 750kV which exceeded the BIL of this 115kV breaker. Because there were no lightning arrestors on the line side, the high surge voltage would not be clamped. It should be also noted that the bus side of breaker was still energized with 115kV. As a result, the SF₆ gas insulation between breaker 73 B-phase contacts was broken down. The following figure 13 shows the typical interrupter of a dead tank breaker. When the fast front lightning surge arrived at the departed main contact on the line side, the very high electric fields were applied across dielectric material (SF₆ gas) between breaker contacts and a number of electrons may be suddenly excited to form the conduction path.
