# 2022 Fault and Disturbance Analysis Conference

## GTC Fault Trace Tool Case Studies

### **Abstract**

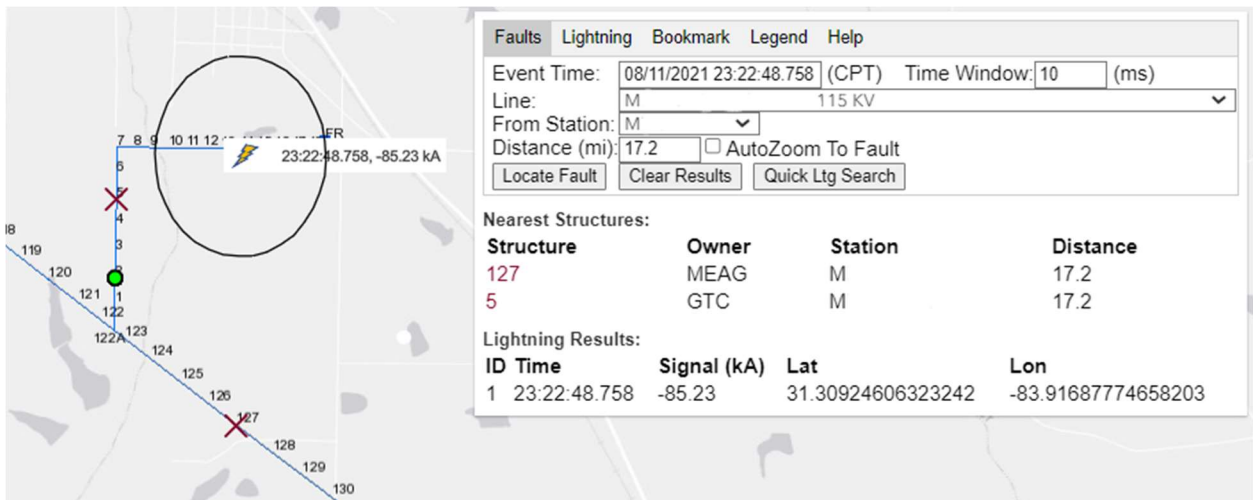
This paper ends with one last example that combines almost all of the tools previously overviewed. The fault below placed a fault location X on the main transmission line and one of the small taps. Additionally, lightning was in the area and a fault indicator was on the line. The combination of an X on the line, lightning ellipse, and an activated fault indicator quickly narrowed down the fault location to the tap line, showcasing how the visualization of data provides quick fault analysis and response opportunities. We are excited about this tool and appreciative of the opportunity to share it at the FDA conference.
