Using Power Quality Data for Capacitor Bank Health Assessment and Failure Prevention

By Theo Laughner and Anthony Murphy

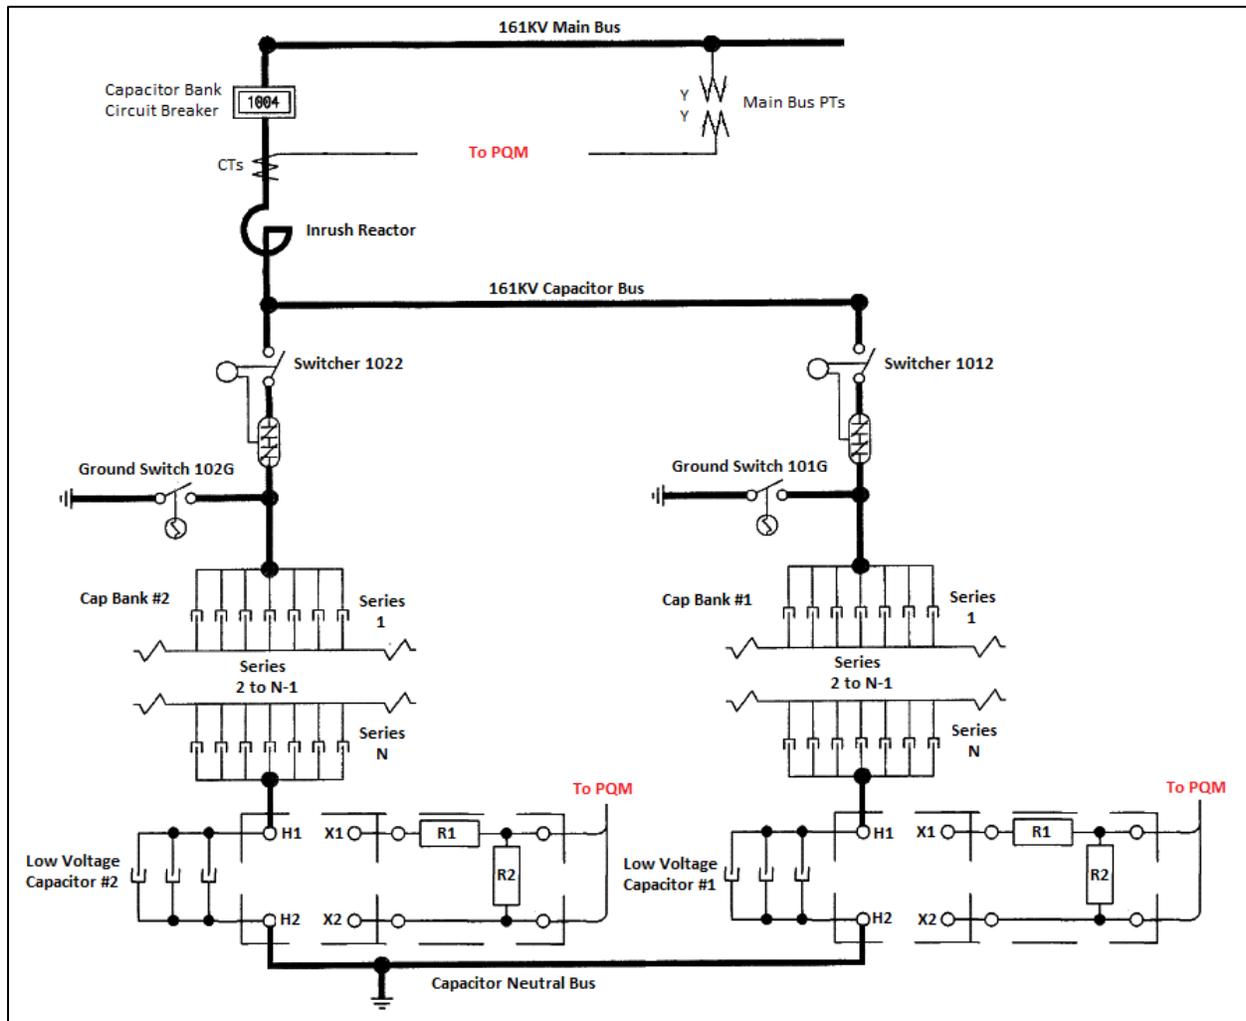
Note: Older designs include control elements in the common neutral only. Newer designs include control elements at the neutral terminal in each of the three phases separately.

The PQMs were used to monitor the three phase voltages from the station bus PTs and the three phase currents from the CTs in the capacitor bank breaker. In some cases, the PQMs also monitored the control voltages to the capacitor bank protective relay. TVA commonly has one or more capacitor banks served from a capacitor bus which is protected by a single capacitor bank breaker. Each capacitor bank is then switched by a dedicated circuit switcher which utilizes pre-insertion inductors for switching transient mitigation. Figure 1 illustrates a typical PQM installation. By utilizing the voltage and current signals from the existing PTs, CTs, and controls, the PQM could easily and affordably be retrofitted into the existing capacitor bank panel in the control room.

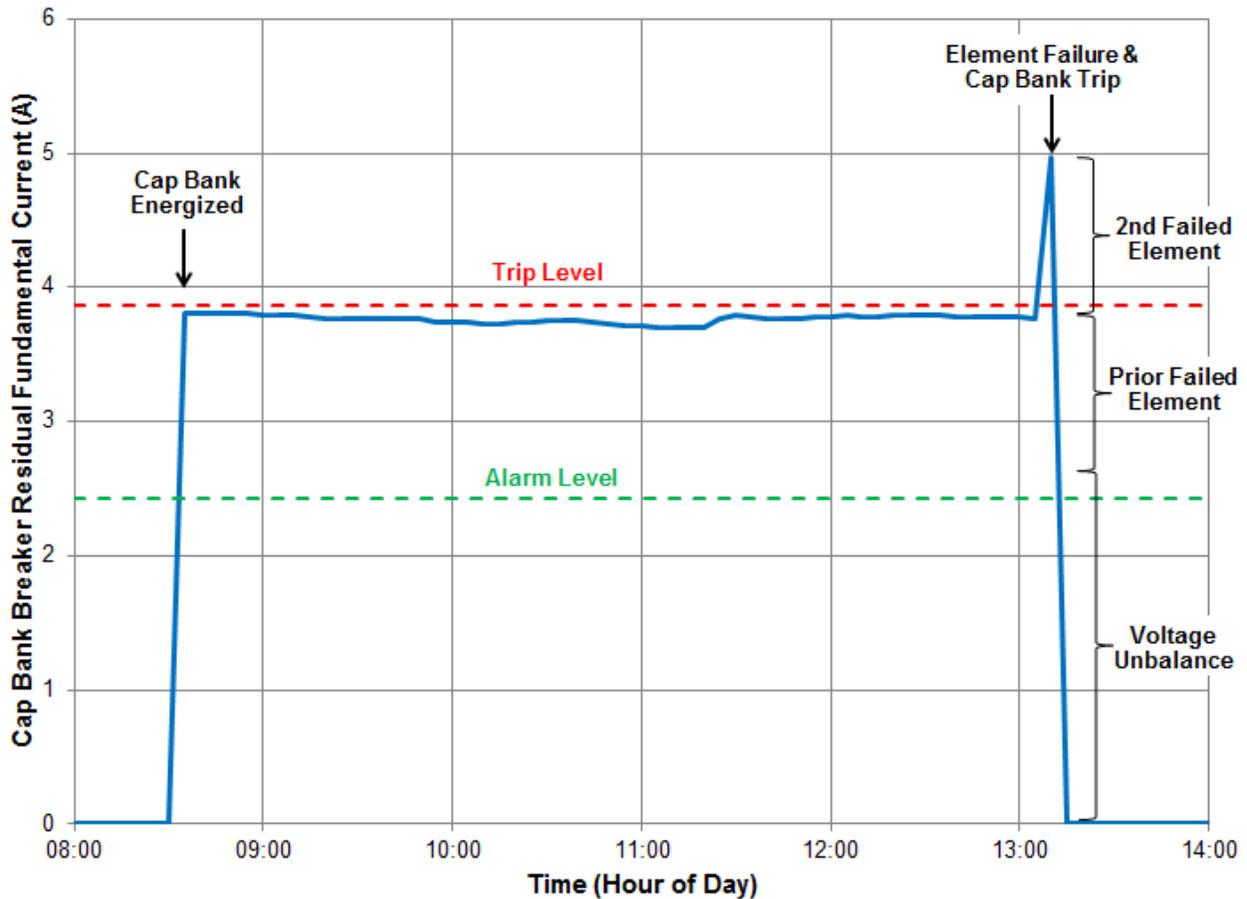
Figure 2 illustrates a case where a capacitor bank tripped offline a few hours after energization due to the unbalance protection. The unbalance protection was configured to trip upon the fourth shorted element. After reviewing the data from the PQM, it was determined that an element in B-phase had

indeed shorted just prior to the capacitor bank trip; however, the data also indicated that this was only the second shorted element in B-phase and there were no shorted elements in the other two phases. The remainder of the unbalance was attributable to the system voltage unbalance for which the protection relay was not compensated. The system voltage unbalance was of sufficient level that it placed the unbalance protection above the alarm limit resulting in continuous alarming. This also only allowed enough margin for two element failures (instead of four) before the unbalance protection would trip the capacitor bank. Waveform data recorded by the PQM proved very beneficial in making this detail of determination.

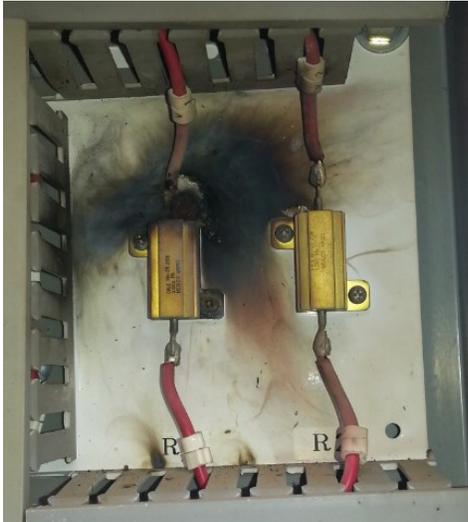
Figure 3

TVA has experienced cases of catastrophic failure of capacitor banks. The cost to replace such a failed capacitor bank has been over \$300,000. In such cases, the unbalance protection had effectively been disabled due to a failure of a capacitor or resistor (as shown in Figure 3) in the low voltage protection circuit. At some later time, the capacitor units would also fail. In the absence of effective unbalance protection, the remaining good capacitor units would be subjected to increasing levels of overvoltage leading to a cascading failure and eventual bus fault. The PQM can also monitor the control voltage at the back of the relay. Analysis of this data may be automated and notifications sent should the control voltage be lost before a catastrophic failure occurs.

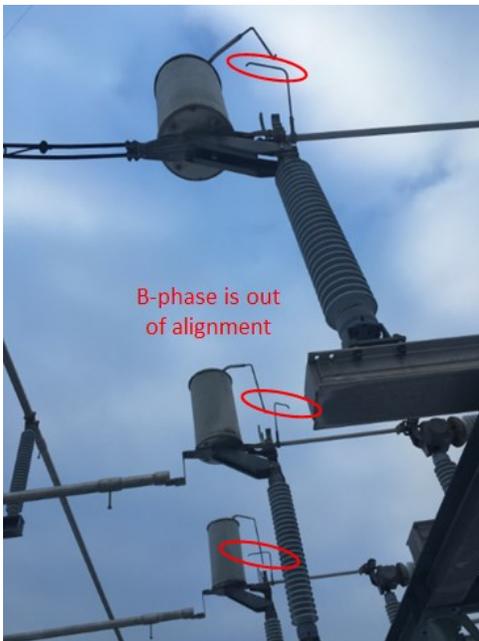
The same data recorded by the PQM can also be used to assess issues with the breaker and circuit switchers used to operate the capacitor banks. Each time a breaker or switcher is opened or closed the PQM will trigger a waveform event. From this waveform data, the timing of the device may be determined and compared against historical operations in order to alert any changes. Alignment issues with the switcher mechanism can also be determined. TVA has experienced instances where the pre-insertion inductors were never contacted during the closing sequence which led to higher than expected transient overvoltages during capacitor energization. The PQMs record these transient overvoltage waveforms from which automated analysis can be made and notifications sent. Figure 4 shows a switcher where the set bolt had come out allowing the B-phase arcing horn to rotate out of alignment. Multiple PQMs had recorded the excessive transient overvoltage on B-phase.

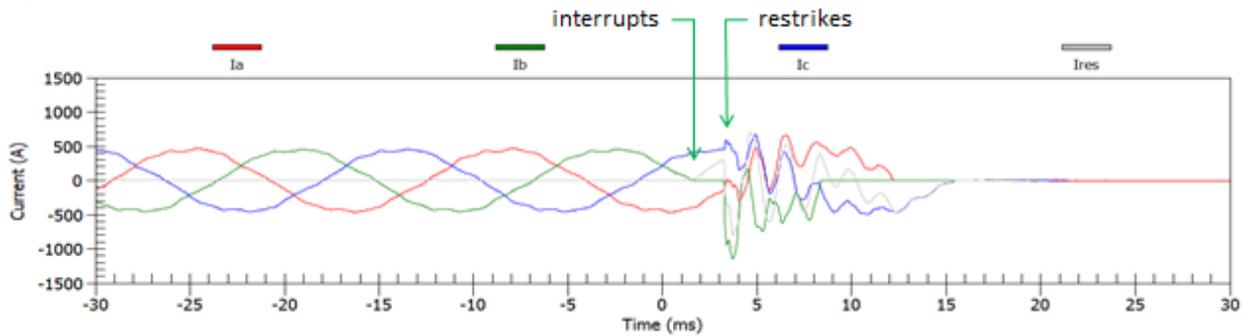
Since the PQMs record a waveform each time the switcher or breaker is opened, alerts for restrikes can also be made. Figure 5 shows an example restrike waveform recorded by a PQM. A subsequent investigation found an alignment issue with the capacitor switcher which had led to arcing and pitting along the arcing horn as shown in Figure 6.
